Collision with terrain involving a Cessna 182, VH-AHC

100 km SW of Bourke, New South Wales, on 5 July 2015

ATSB Transport Safety Report
Aviation Occurrence Investigation
AO-2015-073
Final – 27 August 2015

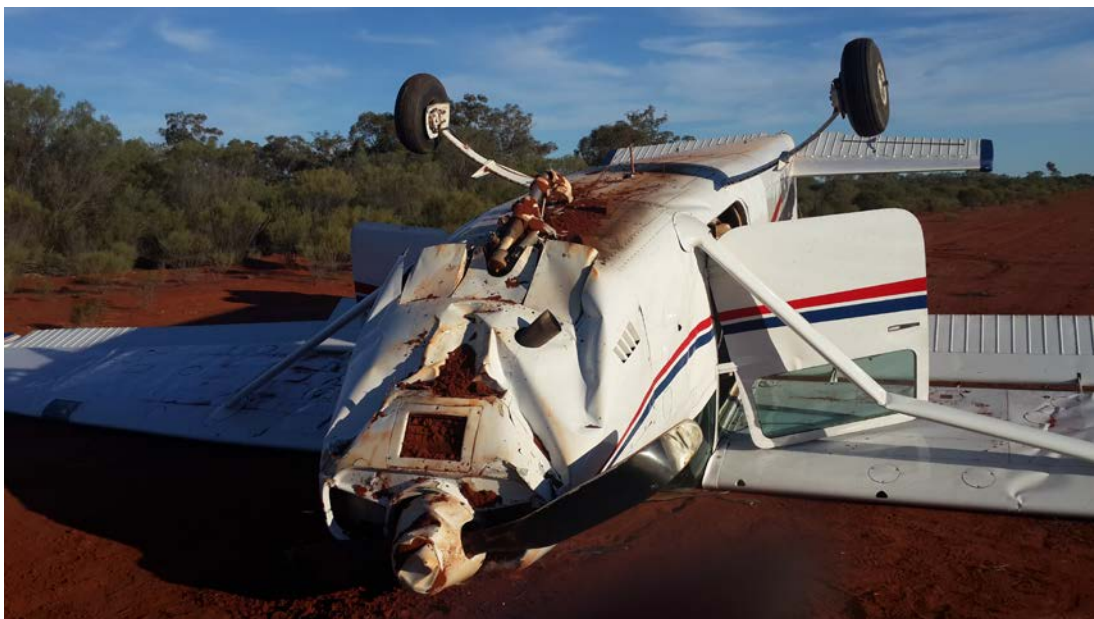
Figure 1: Accident site

When on final approach to land, at about 5 ft above ground level, the aircraft sank rapidly. The aircraft landed heavily and the nose wheel detached from the aircraft. The aircraft then bounced into the air, touched down for a second time, and dug into soft ground. The aircraft flipped over and came to rest inverted, resulting in substantial damage (Figure 1). The pilot and two passengers sustained minor injuries.

The pilot reported that the property had received about 100 mm of rain over a period of 2 weeks, which had stopped about 7 days prior to the incident. Cold weather in the intervening period had prevented the soil from drying. Prior to taking off, the pilot had driven over the runway surface and assessed the surface to be suitable for landing. However, below the runway surface, there was a soft layer of earth. This layer extended about 500 mm down and was not evident during the runway inspection.

The pilot was unsure what caused the aircraft to sink faster than usual. The wind was light and variable. The additional sink and high rate of descent combined with the soft surface led to the aircraft landing gear digging in and flipping the aircraft over.

This incident highlights the importance of the identification and management of risks associated with unsealed airfields. Potential hazards such as changes in the runway surface following rain can be hard to detect. Changes in the runway surface can adversely affect the outcome of a hard landing.
