# Wirestrike involving a Robinson R44, VH-LOL

142 km WSW of Adelaide, South Australia, 10 April 2015

**ATSB Transport Safety Report**  
Aviation Occurrence Investigation  
AO-2015-037  
Final – 27 August 2015

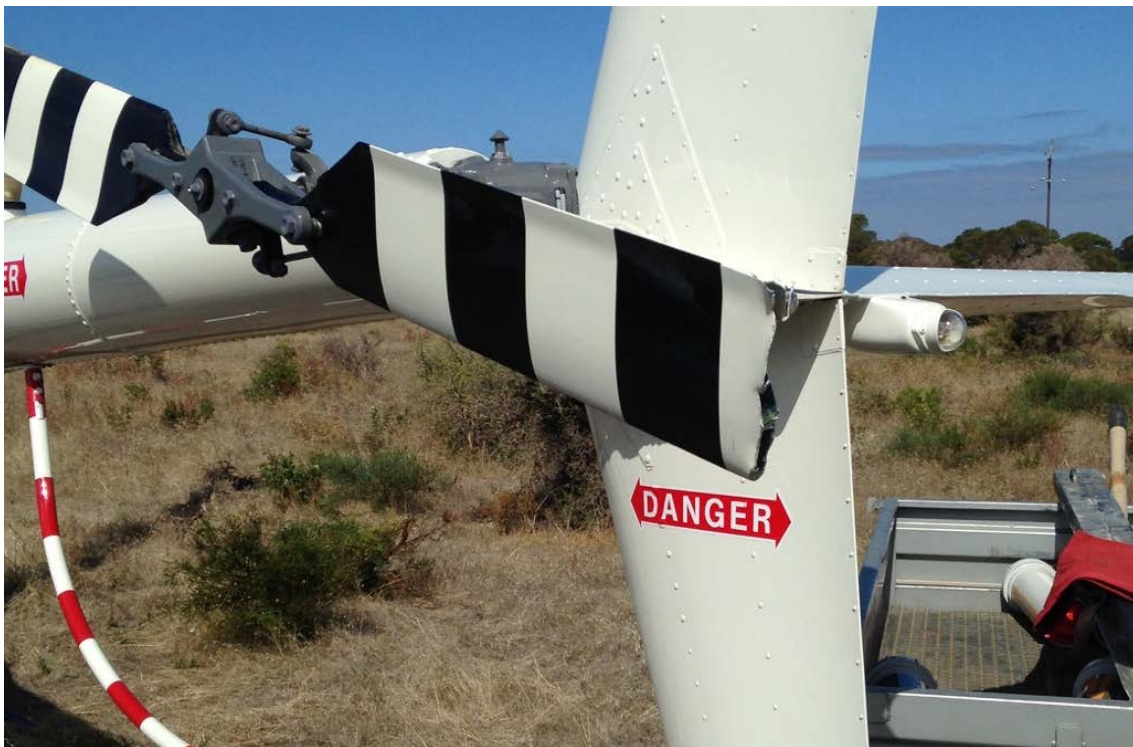
Figure 1: Tail rotor blade damage to VH-LOL

Also on board were client representatives who were directing the noxious weed management operation and manually dispensing the chemical into each bush. In the course of traversing the field at low level in search of the weed, the helicopter struck a previously unidentified power line. The helicopter's main rotor blade made initial contact with the power line and during the avoidance manoeuvre, the tail rotor blades also made contact, severing the blade tips (Figure 1). The pilot landed the helicopter safely. The helicopter was substantially damaged but the occupants were uninjured.

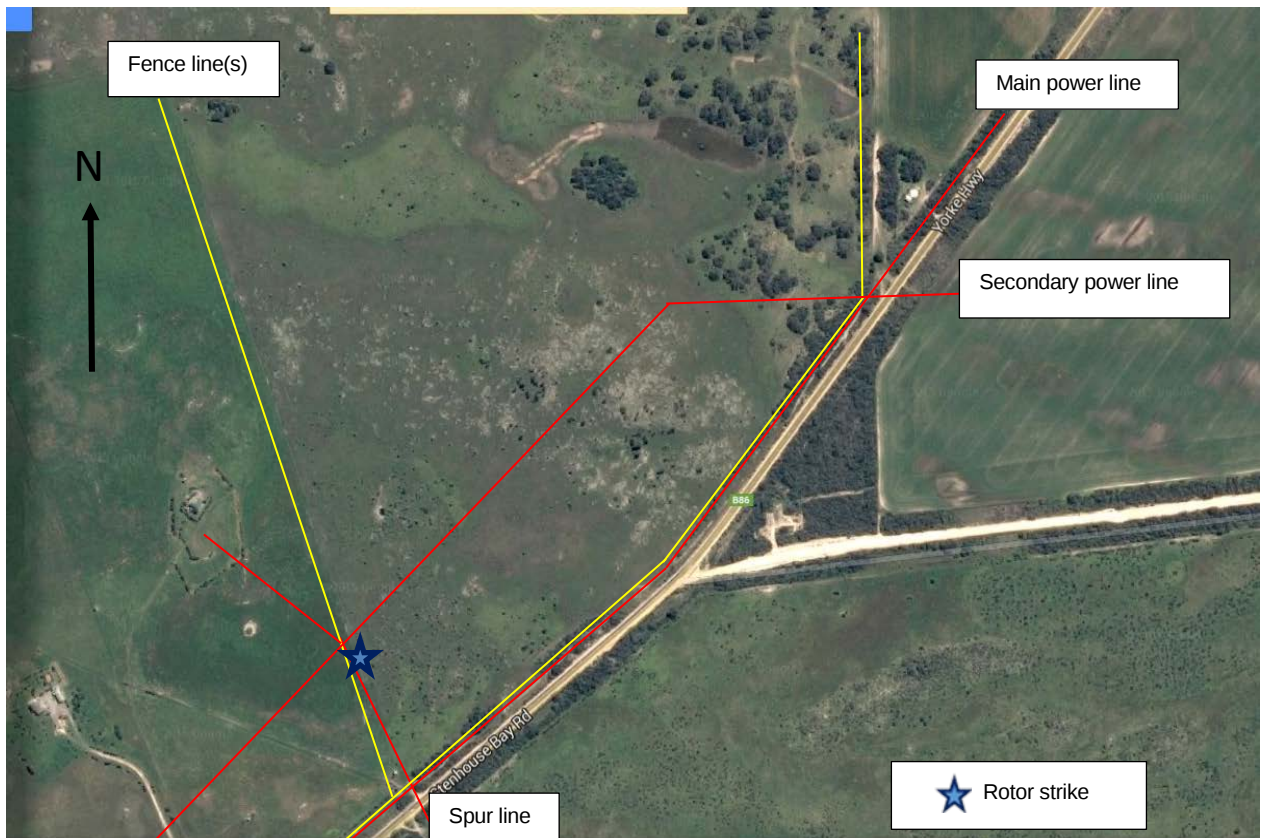
**Figure 2: Powerlines and boundary fencing**

The unidentified powerline was a single wire that was strung between the poles supporting the main and secondary powerlines and traversed, unsupported, through the southern boundary of the operational area. It was not mentioned by the locals, nor marked on the data logger map. It was not readily discernible from the air although additional support poles did lead the wire away from the secondary power line towards a distant building.

The operator has reviewed the risk assessment and moved to standardise procedures and now place greater emphasis on employee inductions with a focus on hazards and published information relating to high risk activities. Whilst the published information was generally available to company pilots, a greater focus on promulgating this information was recognised as beneficial. The use of non-permanent staff was to be reconsidered along with the dissemination and acknowledgement of receipt of safety critical information specific to the contracted flying program.
