Collision between track worker and passenger train

Guildford, Western Australia, 10 February, 2015

ATSB Transport Safety Report

RO-2015-002

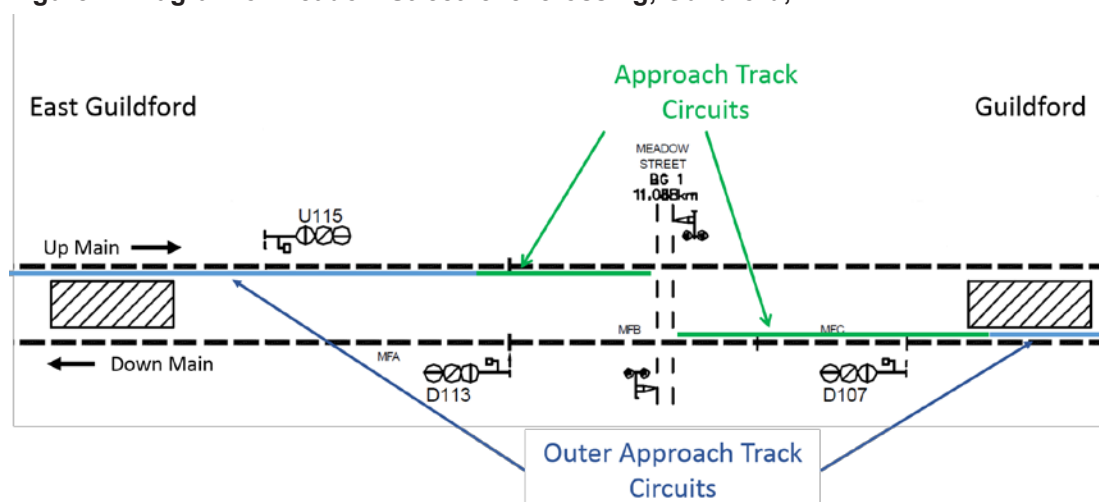
Figure 2: Diagram of Meadow Street level crossing, Guildford, WA

The Meadow Street level crossing used electronic approach and outer approach track circuits to detect the approach of trains from either direction on either line (Figure 2). When a train is detected on the approach, the control circuit causes the level crossing bells and lights to activate, and the boom gates to lower. In addition, the automatic pedestrian gates close and the pedestrian alarms sound. Due to the proximity to the James Street intersection, an indication is provided to the road traffic light control system to manage any traffic intending to turn into Meadow Street.

The purpose of the outer approach circuits is to prevent the level crossing boom gates from rising and descending in quick succession if a second train is approaching the crossing. If the level crossing equipment is already operating and a train detected on the outer approach, the boom gates remain lowered and the pedestrian gates remain closed until the second train has passed.

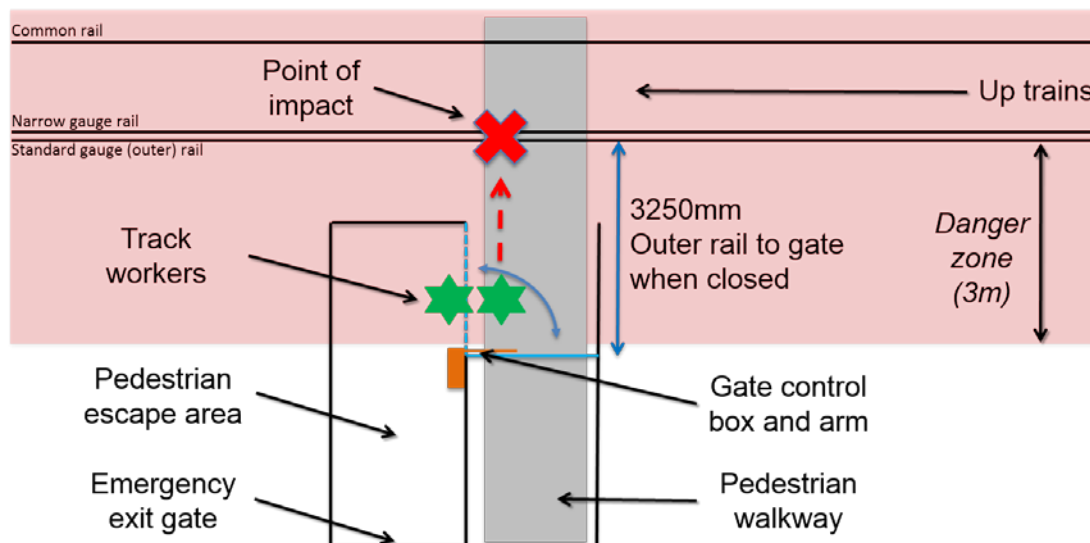
Figure 3: General arrangement of south-western pedestrian gate

One such task was the inspection and, if required, adjustment of the pedestrian gate closing mechanism. The gate control box was located inside the pedestrian escape, with the control arm running from the box to the gate on the track side (Figure 3) - about 3 m from the railway line.

Maintenance personnel advised that to assess or adjust the control arm required track workers to stand inside the three metre danger zone. Some maintainers would carry out the task with the gate open, working in the escape area with the gate acting as a barrier to the track. However, it was evident that some other maintainers carried out the task when the gate was closed, in which case there was no barrier protecting them against inadvertently stepping onto the track.

It was apparent that the process for conducting maintenance on level crossing pedestrian gates varied between maintenance personnel. In this case, the workers adopted a process whereby the presence of a train was used to operate the level crossing equipment and maintenance and/or adjustment of the gate control arm was undertaken while the gate was in the closed position. This process meant that workers would be positioned within the danger zone, and focused on the maintenance task, at a time when trains were present and without a barrier between themselves and the track.
