Smoke event involving a Cirrus SR22T, VH-EPG

44 km W of Bendigo Airport, Victoria, on 19 May 2015

ATSB Transport Safety Report
Aviation Occurrence Investigation
AO-2015-058
Final – 7 October 2015

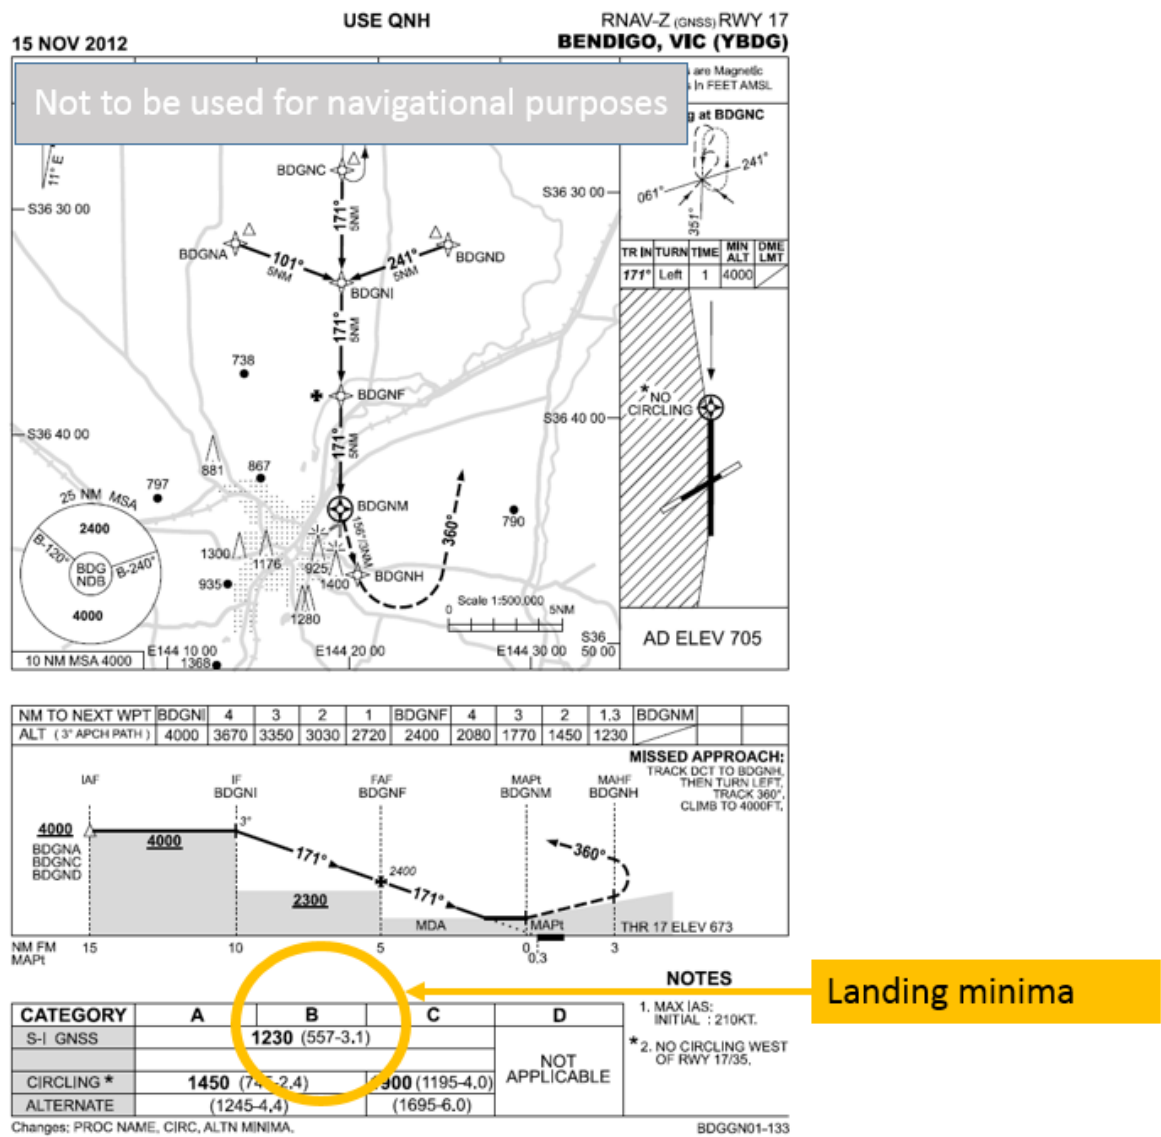
Figure 1: RNAV-Z (GNSS) approach for runway 17 Bendigo

The pilot selected the radio navigation (RNAV) global navigation satellite system (GNSS) approach to runway 17 at Bendigo Airport (Figure 1). They then conducted the descent and approach using the autopilot and the flight director. At about 0904, the aircraft turned left to track towards the initial approach fix for the RNAV approach procedure (Figure 2). The aerodrome

After arriving at the final approach fix 'BDGNF', the autopilot disengaged and the pilot took over manual control of the aircraft. No vertical profile guidance was available to the pilot from the navigation system. They reported being in heavy rain, and that visibility through the windscreen was obscured by the contamination. The pilot could see the runway lights through the contaminated windscreen and rain, but reported difficulty in identifying the exact location of the ground. The aircraft was clear of cloud, but in rain, and the pilot estimated the visibility to be about 2 km. The flight data indicated that the aircraft's rate of descent in this section of the approach reached about 1,200 ft per minute.

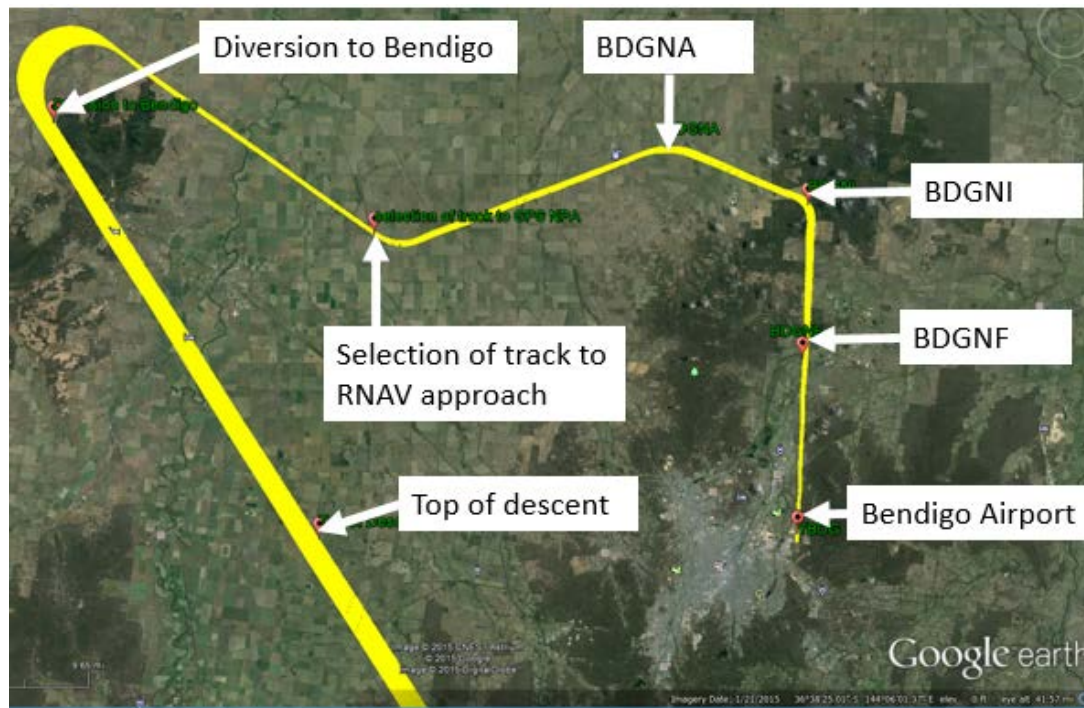
Figure 2: Aircraft track showing diversion to Bendigo and RNAV approach

When on final approach to runway 17, about 0.6 NM from the runway threshold, the pilot suddenly sighted a row of trees. The pilot immediately conducted a climb to avoid them, and estimated that the aircraft cleared the trees by a few feet. The pilot then landed the aircraft on the runway threshold. The pilot and passenger were uninjured and the aircraft was not damaged.

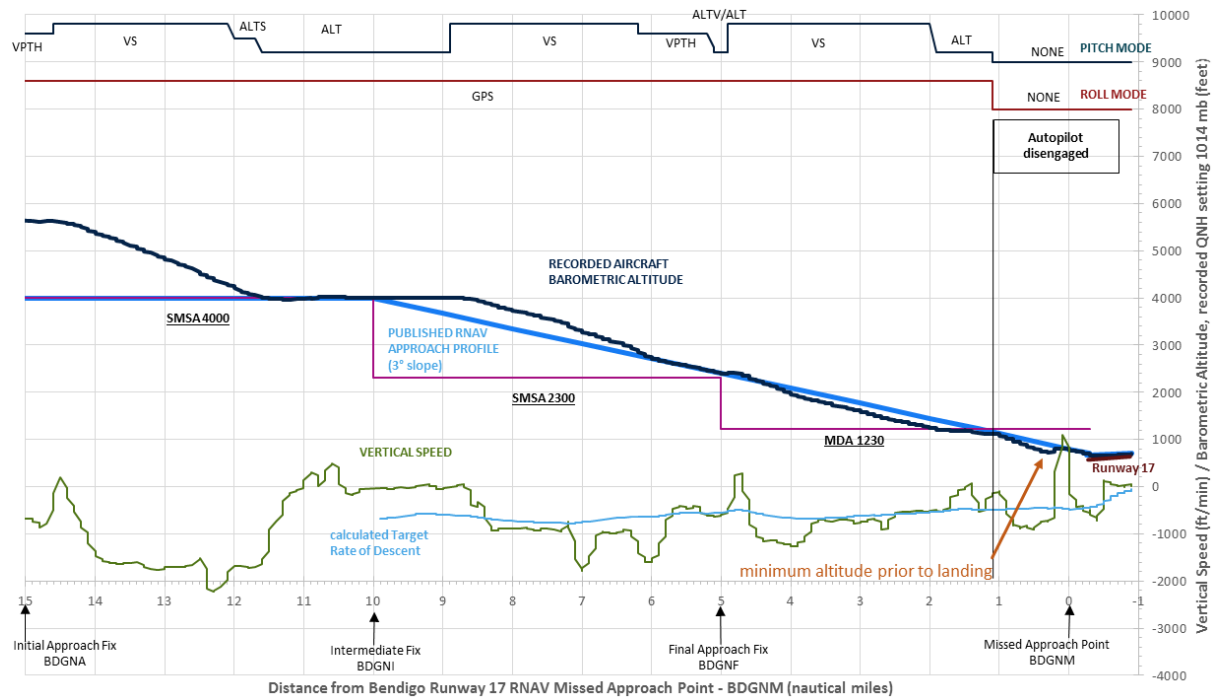
Figure 3: Comparison of recorded aircraft altitude and published approach procedure vertical profile

The vertical profile recorded by the aircraft systems showed significant variation both above (about 350 ft high) and below (about 120 ft low) the 3° approach path angle shown in the published RNAV procedure (black line in Figure 3). The aircraft pitch modes during the approach were predominantly vertical speed with altitude capture hold and vertical path also becoming active. The aircraft recorded vertical speed was plotted in comparison with a target rate of descent calculated using the recorded groundspeed (light blue line in Figure 3).

Descent from sector minimum safe altitude of 4,000 ft was initiated using vertical speed as the pitch mode. The aircraft was above the published approach profile when the descent began (black line in Figure 3). The aircraft recorded a vertical speed of about 900 ft per minute. At about 6.2 NM from the missed approach point, as the aircraft was descending through 2,900 ft, the pitch mode changed to vertical path. The rate of descent reduced and the aircraft followed the published descent profile to about 5.1 NM, where the pitch mode changed to VNAV target altitude capture and then altitude hold (recorded barometric altitude of 2,393 ft, FAF published altitude 2,400 ft) modes at the final approach fix. About 8 seconds after altitude hold mode became active the pitch mode changed to vertical speed. The rate of descent increased to about 1,200 ft per minute and the aircraft descended below the published approach profile. The rate of descent reduced to a value similar to the calculated target rate of descent at 9:13:28, as the aircraft was passing through about 2,000 ft. This rate of descent was maintained until 9:14:26 when the pitch mode changed to altitude hold (recorded barometric altitude 1,235 ft, MDA 1,230 ft) at about 1.9 NM from the missed approach point.

The autopilot was disengaged at 9:14:59, about 1.1 NM from the missed approach waypoint, 'BDGNM'. Following the autopilot disengaging, the rate of descent increased and the aircraft reached a barometric altitude of about 715 ft at 9:15:33, about 0.3 NM from 'BDGNM'. The aircraft then proceeded to pitch up, to about 15°, and climbed to about 810 ft. The aircraft regained the published approach path angle and continued the approach to land at Bendigo Airport. The estimated touchdown was about 9:15:57, on the runway threshold – about 0.3 NM beyond the missed approach point), and the barometric altitude recorded was about 670 ft.

A certified Cirrus instructor advised the ATSB that the Bendigo RNAV could be flown in VS mode using the appropriate power settings without pilot intervention. This should be done rather than manually overriding the vertical speed mode to reduce pilot workload and maintain the optimal vertical profile.
