Loss of separation involving a Cessna 441, VH-JLT, and a Raytheon B200, VH-ZCJ

near Darwin Airport, Northern Territory, on 10 June 2015

ATSB Transport Safety Report
Aviation Occurrence Investigation
AO-2015-061
Final – 7 October 2015

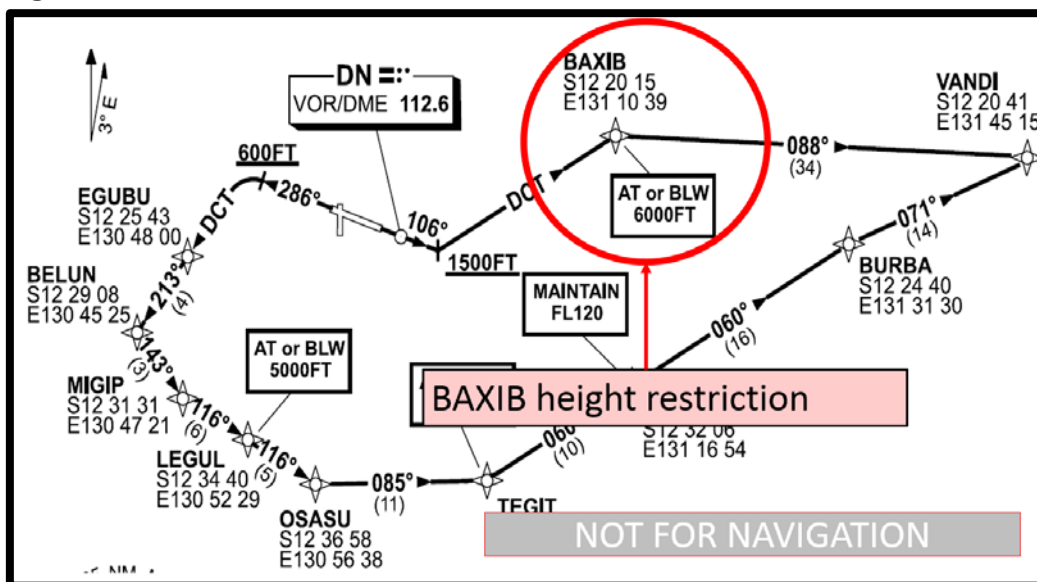
Figure 1: Extract of VANDI ONE SID

On 10 June 2015, the pilot of a Cessna 441 aircraft, registered VH-JLT (JLT), conducted pre-flight preparations for a charter flight from Darwin to Oenpelli, Northern Territory with 6 passengers. The pilot planned to track direct to Oenpelli, but on requesting an airways clearance, was advised by the clearance delivery controller that there was a requirement to plan via the VANDI ONE standard instrument departure (SID) (Figure 1). The pilot then reviewed the SID chart and noted the left turn on departure and the height limit of 6,000 ft at waypoint BAXIB. The pilot wrote '6,000' on the navigation log. As part of the airways clearance issued to JLT, the pilot was initially issued a clearance to climb to 3,000 ft. The pilot entered '3000' into the aircraft's altitude alerter.

At 0900:44, the approach controller cleared JLT to climb to flight level (FL) 130.² The pilot then selected 13,000 in the altitude alerter. The controller did not cancel any requirements, hence JLT was still required to be at or below 6,000 ft at waypoint BAXIB in accordance with the SID. Shortly after that communication, the pilot of JLT inadvertently selected Brisbane Centre frequency (on COM1), and was no longer able to hear Darwin Approach frequency.

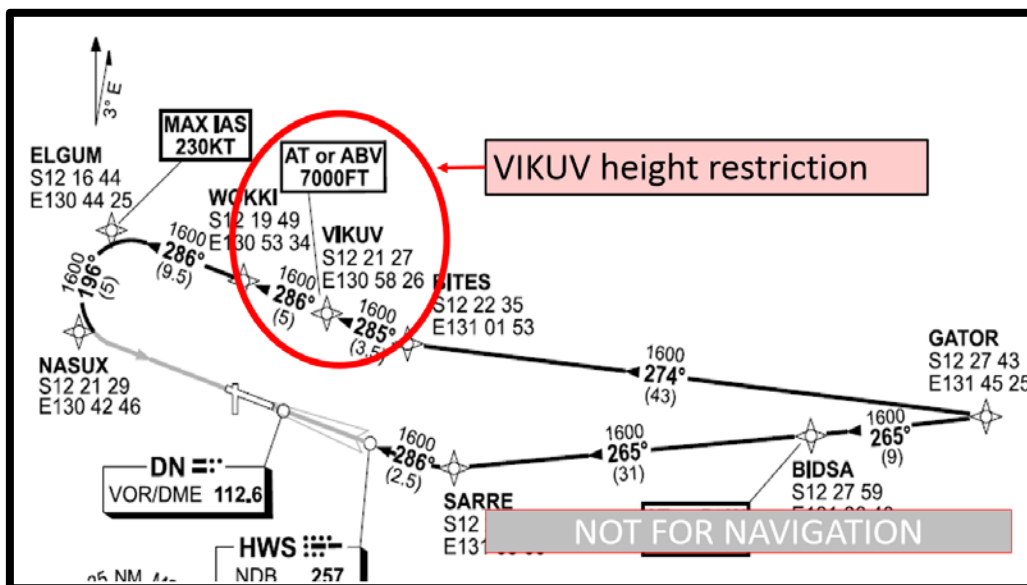
Figure 2: Extract of GATOR THREE A STAR

At about 0856 Central Standard Time (CST), a Raytheon B200 aircraft, registered VH-ZCJ (ZCJ), operating an aeromedical flight with a pilot, a flight nurse and four passengers on board, was approaching Darwin from Elcho Island, Northern Territory, on the GATOR THREE A standard arrival route (STAR) (Figure 2). The pilot had been advised to expect track shortening and a visual approach to runway 11. At 0856:16, the Darwin approach controller cleared ZCJ to descend to 7,000 ft.¹

At 0901:00, the approach controller cleared ZCJ, which was then passing about 7,700 ft, to descend to 3,000 ft. In accordance with the STAR, that could only be complied with after passing waypoint VIKUV at or above the 7,000 ft height restriction published for that point on the STAR.

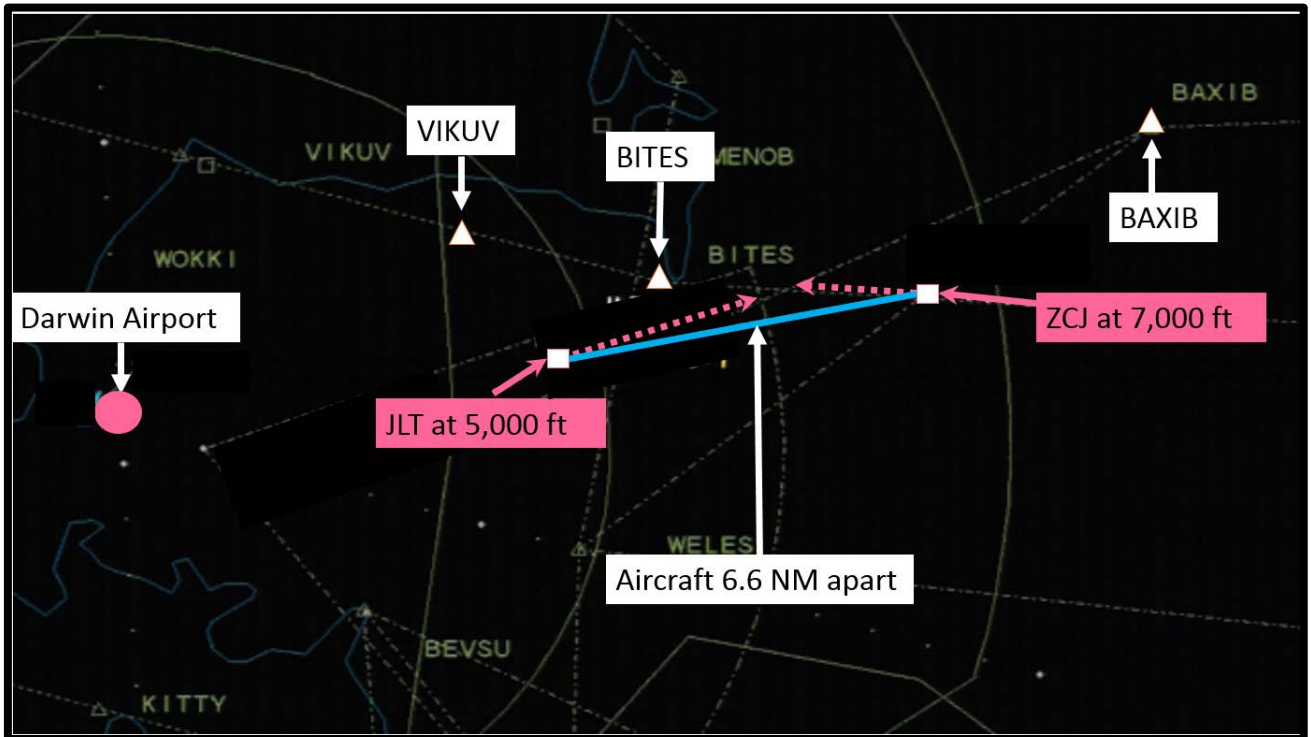
Figure 3: Situation display showing JLT at 5,000 ft and ZCJ at 7,000 ft

At about 0902, ZCJ was approaching waypoint BITES at 7,000 ft, JLT was at 5,000 ft and the aircraft were about 6 NM apart (Figure 3). The controller then issued JLT as traffic to the pilot of ZCJ, and advised that JLT had been assigned FL130 and had a 6,000 ft requirement at BAXIB. The pilot of ZCJ acknowledged the traffic and could see it on the aircraft's traffic collision avoidance system (TCAS). The pilot of JLT did not hear that communication as they were not listening on the approach frequency at that time.

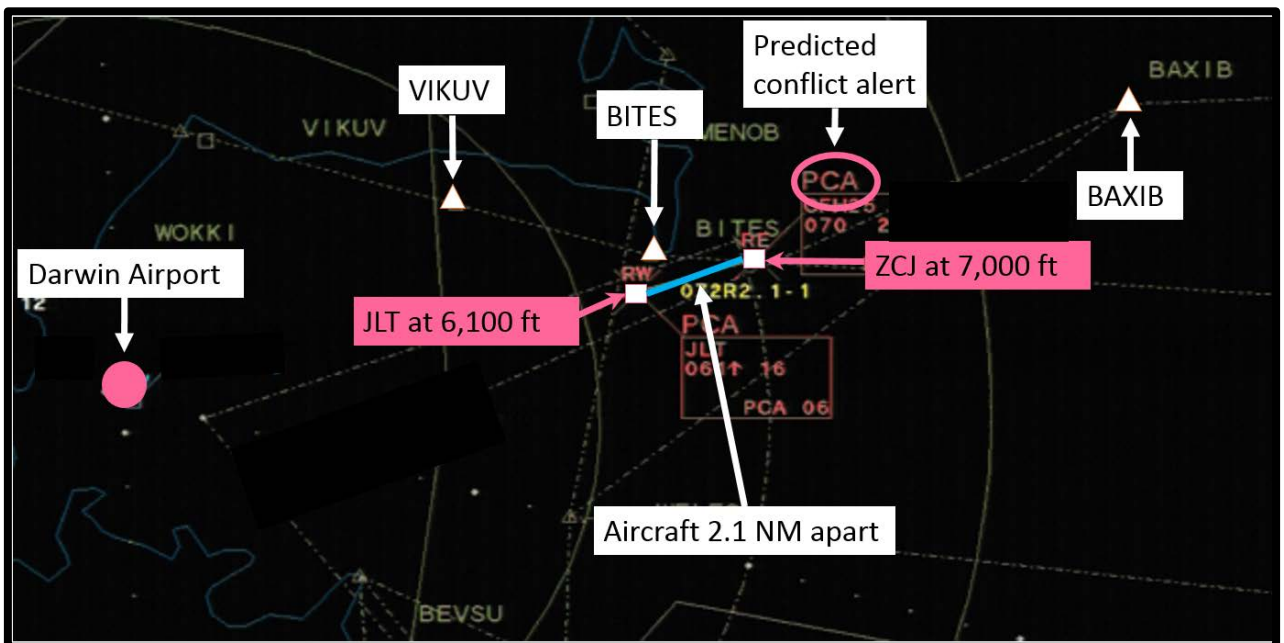
Figure 4: Situation display showing the predicted conflict alert, with JLT at 6,100 ft and ZCJ at 7,000 ft

At 0902:41, as the two aircraft converged, an Australian Defence Air Traffic System (ADATS) predicted conflict alert (PCA) activated on the controller's situational display (Figure 4). The controller advised the supervisor, as required following a PCA activation, that vertical navigation 'strategic' separation was in place (see right). JLT was then at 6,100 ft, above the level restriction of 6,000 ft, and ZCJ at 7,000 ft with less than 2 NM between the aircraft. At 0903:07, 1.6 NM and 800 ft existed between the aircraft, and the pilot of ZCJ reported that they had JLT in sight. The approach controller confirmed that the pilot of ZCJ was able to maintain separation with JLT. The pilot of ZCJ then received a TCAS 'TRAFFIC TRAFFIC' alert and disconnected the autopilot in anticipation of taking avoiding action. The approach controller quickly attempted to contact JLT, advising that ZCJ was maintaining separation with them and to confirm they were complying with the level restriction, but did not receive a reply; JLT continued to climb. The controller then advised the pilot of ZCJ that the aircraft had climbed through the 6,000 ft level restriction and issued a requirement to the pilot of ZCJ to maintain separation with that aircraft. By the time the controller had completed that transmission, the two aircraft had passed. The approach controller then cancelled ZCJ's level restrictions, and cleared the aircraft to descend to 4,000 ft. ZCJ continued to descend in accordance with the STAR route and the pilot did not take any avoiding action.

With immediate effect, Darwin ATC implemented a new procedure following this incident. If a VNAV restriction is in place and one aircraft has not complied, the controller is to immediately resort to tactical separation until that confliction is cleared.
