# Collision with terrain involving a Robinson R22, VH-RBO

near Daly Waters (ALA), Northern Territory, on 28 June 2015

**ATSB Transport Safety Report**  
Aviation Occurrence Investigation  
AO-2015-071  
Final – 7 October 2015

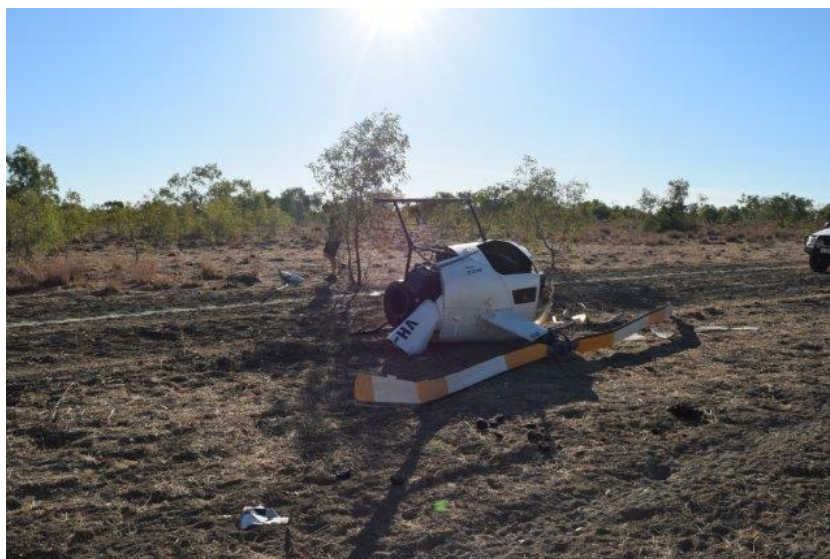
**Figure 1: Accident site**

The pilot sustained minor injuries and the helicopter was substantially damaged (Figure 1).

- Icing was found to have been unlikely.
- Drive belts were still on and intact.
- Clutch engagement position appeared normal.
- Main rotor blades were buckled and damaged, partly from falling onto a fence, but were still attached to the hub.

- Main rotor blades were evidently not turning fast when they hit the ground.
- The engine was running on impact.
- The governor switch was in the OFF position. The engineer turned on the master switch, and the governor light (GOV OFF) illuminated.
