Wirestrike involving an Eagle DW1, VH-FHP

150 km SE of Townsville, Queensland, on 27 July 2015

ATSB Transport Safety Report
Aviation Occurrence Investigation
AO-2015-087
Final – 7 October 2015

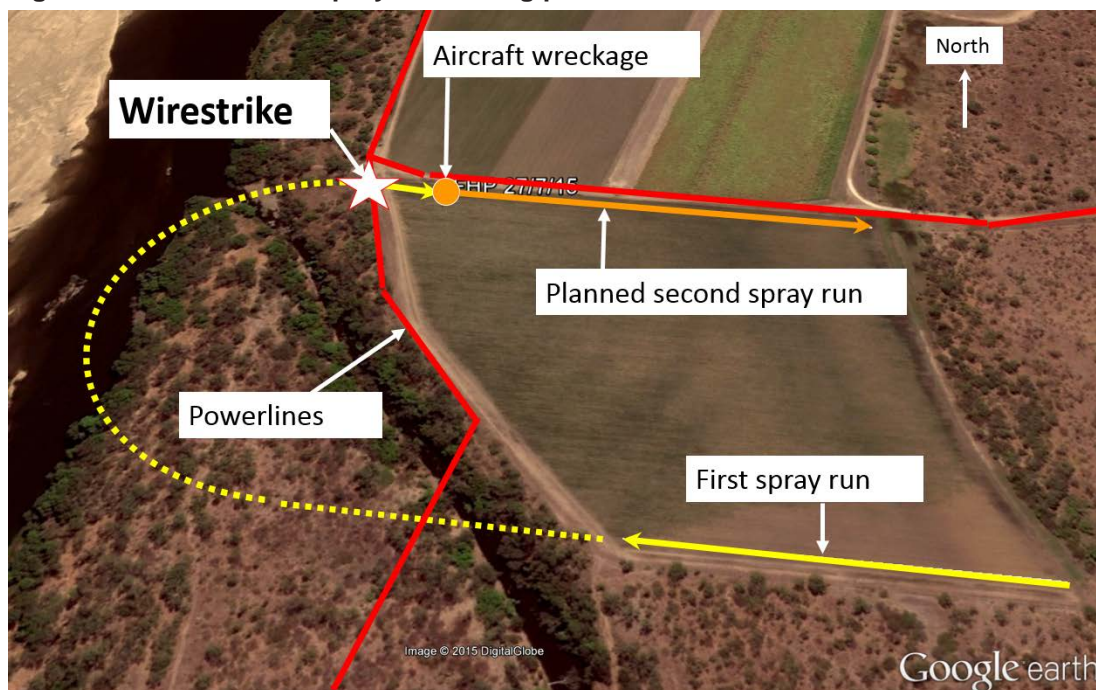
The pilot completed the first spray run towards the western powerline, overflew it, and then turned to line up for the second spray run (Figure 1). A small area of about 30 m of trees had been cleared for a pump installation and the clearing was in line with the start of the second spray run. The pilot noted the powerline ahead, but then diverted their attention to the other powerline, running parallel to the direction of flight, and about 5 m off the left wingtip. The pilot also looked inside at the GPS to check the aircraft's line for the spray run.

Figure 1: Paddock to be sprayed showing powerlines and wirestrike location

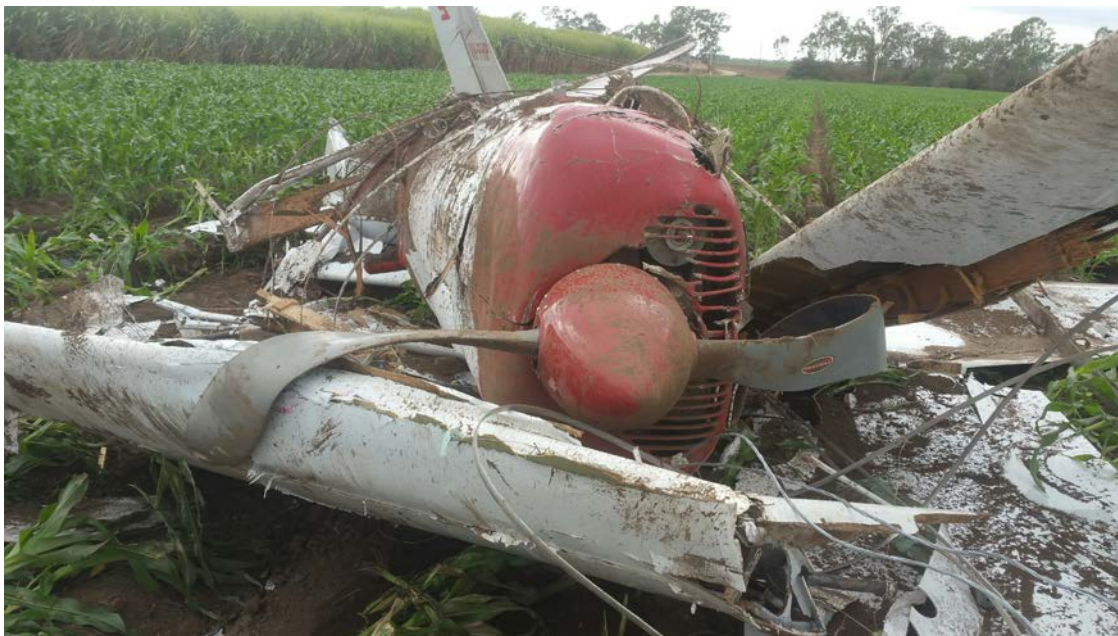
The pilot commenced the descent into the paddock through the clearing in the trees and did not see the powerline at that time. As the aircraft descended, the pilot looked up and suddenly sighted the powerline. The pilot elected to push forwards on the controls to make the aircraft descend. The aircraft then struck the powerline above the propeller on the wing struts.

The aircraft decelerated rapidly and the wires pulled the aircraft towards the ground. The pilot landed the aircraft with the wings level. The landing gear sheared off, the propeller struck the ground and the aircraft ground-looped, coming to rest facing the opposite direction. The pilot sustained minor injuries and the aircraft was destroyed (Figure 2).

Figure 2: Photo of VH-FHP at the accident site showing damage to the aircraft and wires
