Low fuel event involving a Piper PA-28, VH-MHI

28 km SE of Adelaide, South Australia, on 10 July 2015

ATSB Transport Safety Report
Aviation Occurrence Investigation
AO-2015-076
Final – 7 October 2015

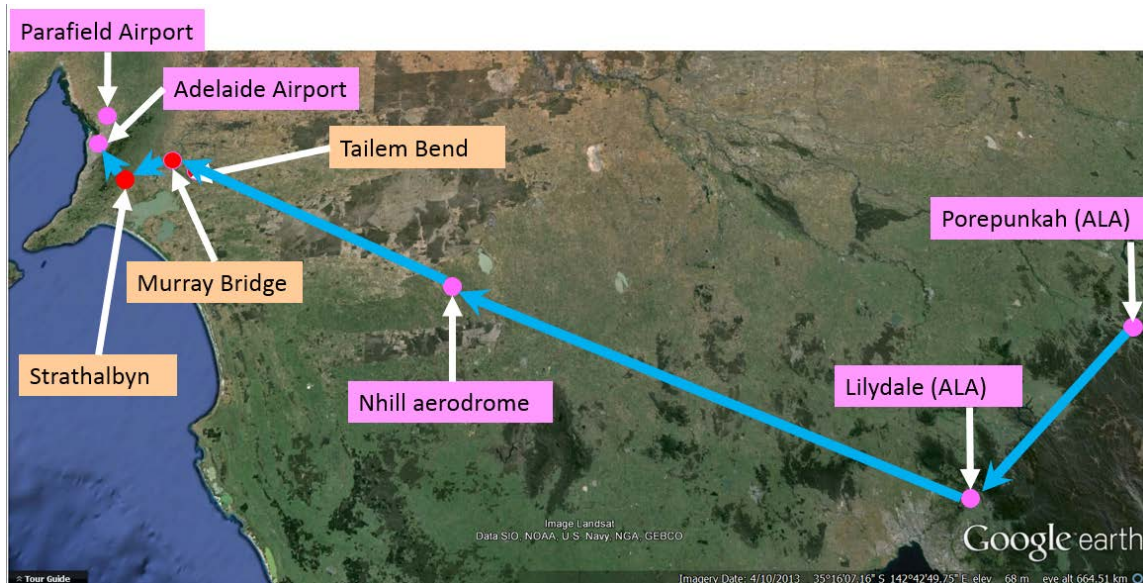
Figure 1: Approximate aircraft track from Porepunkah to Lilydale and Adelaide

On 10 July 2015, the pilot of a Piper PA-28 aircraft, registered VH-MHI (MHI), conducted a flight from Porepunkah to Lilydale, Victoria (Figure 1). In Lilydale, the pilot refuelled the aircraft, filling the tanks to full (189 L). Then the aircraft departed for Parafield, South Australia at about 1400 Eastern Standard Time (EST), with the pilot and two passengers on board.

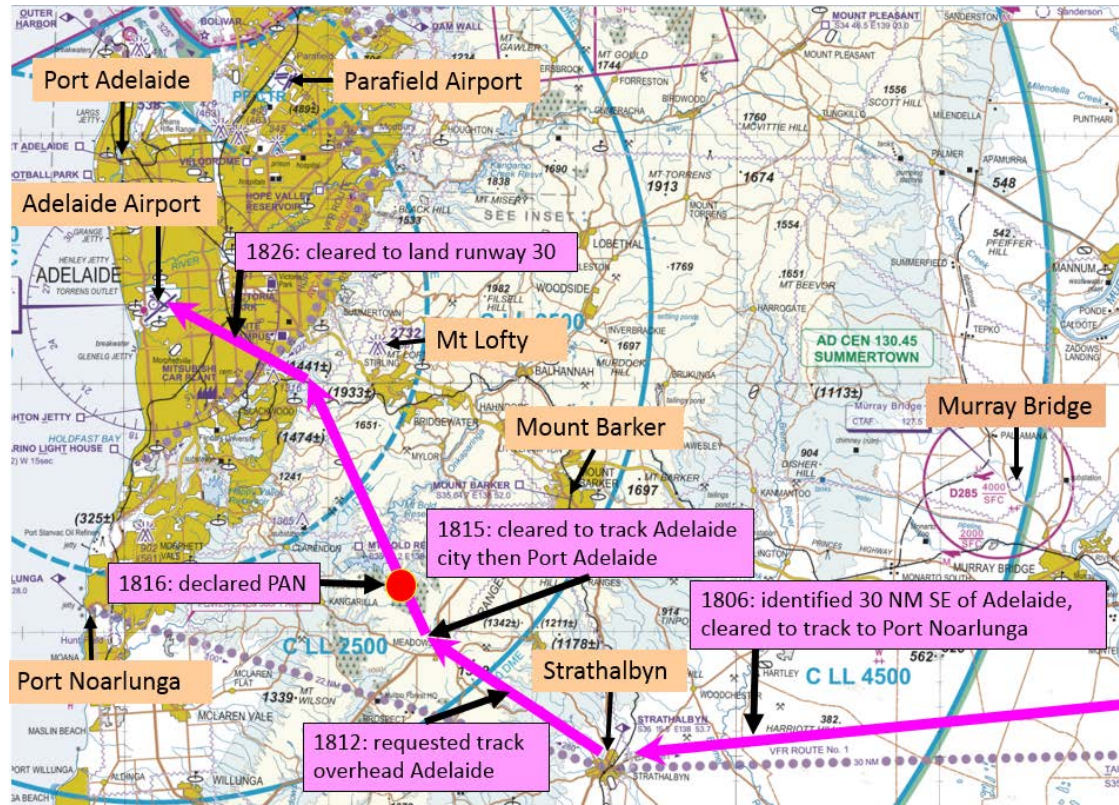
Figure 2: Approximate aircraft track from Strathalbyn to Adelaide

The pilot then switched the transponder off for about one minute, before switching it back on. At about 1803, the Adelaide Centre controller told the pilot that the Tower controller at Parafield Airport had advised that they were unable to see Mt Lofty from Parafield due to cloud. The pilot advised the controller that the aircraft was then approaching Strathalbyn and the weather appeared to be clear towards Adelaide (Figure 2). The controller then stated that the aircraft was now visible on the radar display.
