Derailment of train 5DD2

Thevenard, South Australia | 23 October 2014

ATSB Transport Safety Report
Rail Occurrence Investigation
RO-2014-018
Final – 15 October 2015

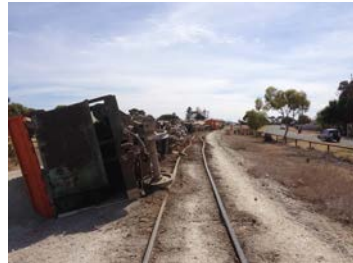
Derailed wagons of train 5DD2

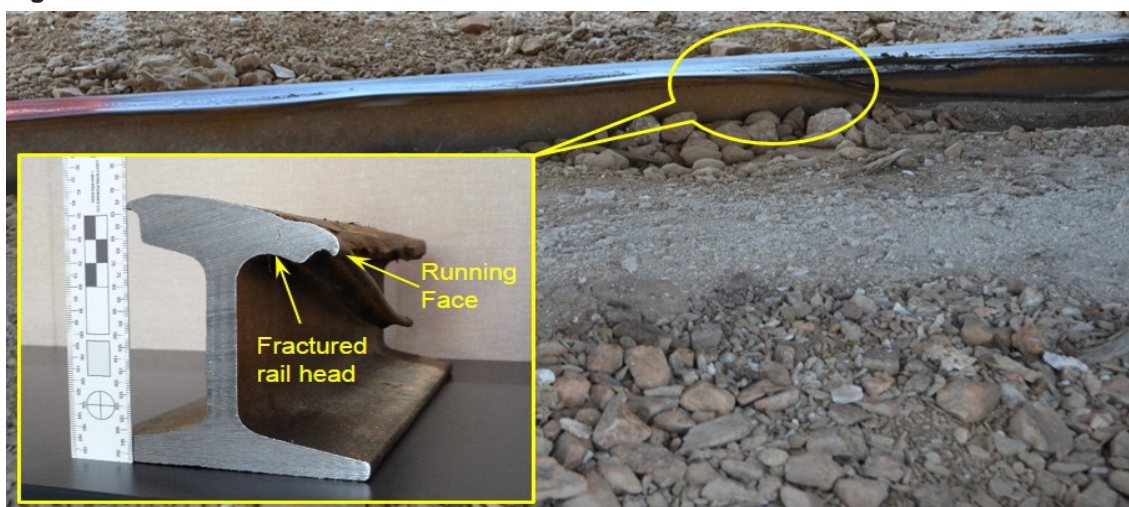
Figure 3: Fractured rail head

Examination of the rail in the area immediately prior to, and at the point of derailment (POD), indicated that the left hand side rail head (in the direction of travel) had fractured near the running face (Figure 3).

The combination of substantial head wear and the wheel tracking location increased the likelihood of rail head failure during the passage of a train. From the extent of wear and deformation of the rail head, the lateral movement of the track, and the inboard tracking position of the wheels, the ATSB concluded that the rail had been structurally unable to support the wheel loads, resulting in the vertical collapse and fracturing of the rail head during the passage of train 5DD2.

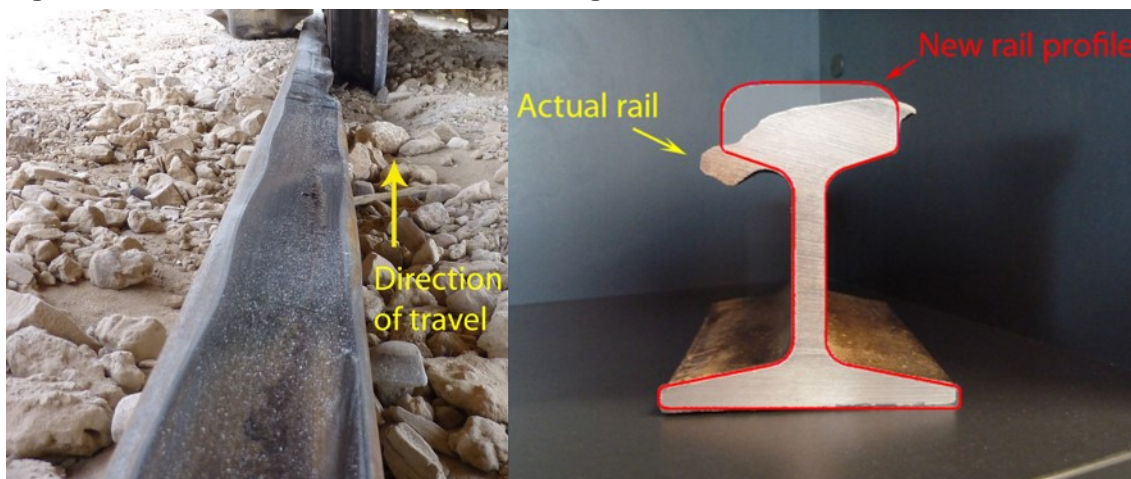
Figure 4: Rail head wear, metal flow and corrugations

The track showed substantial rail head wear, with evidence of significant metal flow and corrugation (Figure 4). In addition, the wear pattern on the rail face indicated that wheel flanges had been tracking at least 20mm inboard from the rail running face, suggesting lateral (gauge-widening) movement of one or both rails through the POD.

Given the extent of the rail head wear sustained, and that this type of damage develops progressively over time, it is very likely that the degradation would have been evident during any previous scheduled track inspections.

Corrugation of the rail was also evident at the point of derailment – a defect which develops over time and can lead to failure of the rail if left untreated. It was evident that this condition had been present for some time and would likely have been visible during scheduled track inspections.

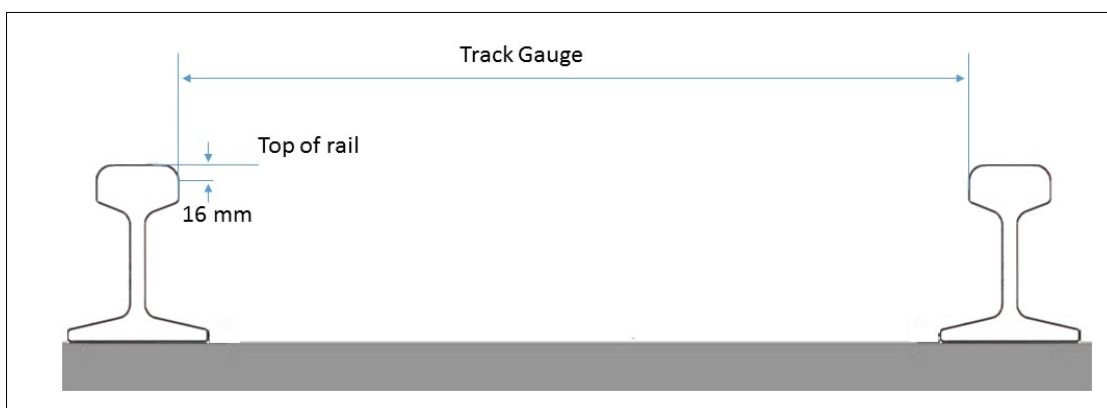
Figure 5: Track gauge measurement point

Track gauge is the distance between the gauge faces of the two rails and is normally measured at a point 16 mm below the top of the rail head (Figure 5). In this case, the rail head was so worn and distorted that track gauge could not be effectively measured in this manner during post-derrailment inspections. Considering the evident running position of the rail wheels however, (Figure 6), the track gauge had very likely exceeded the maximum limit documented in the CoP addendum.

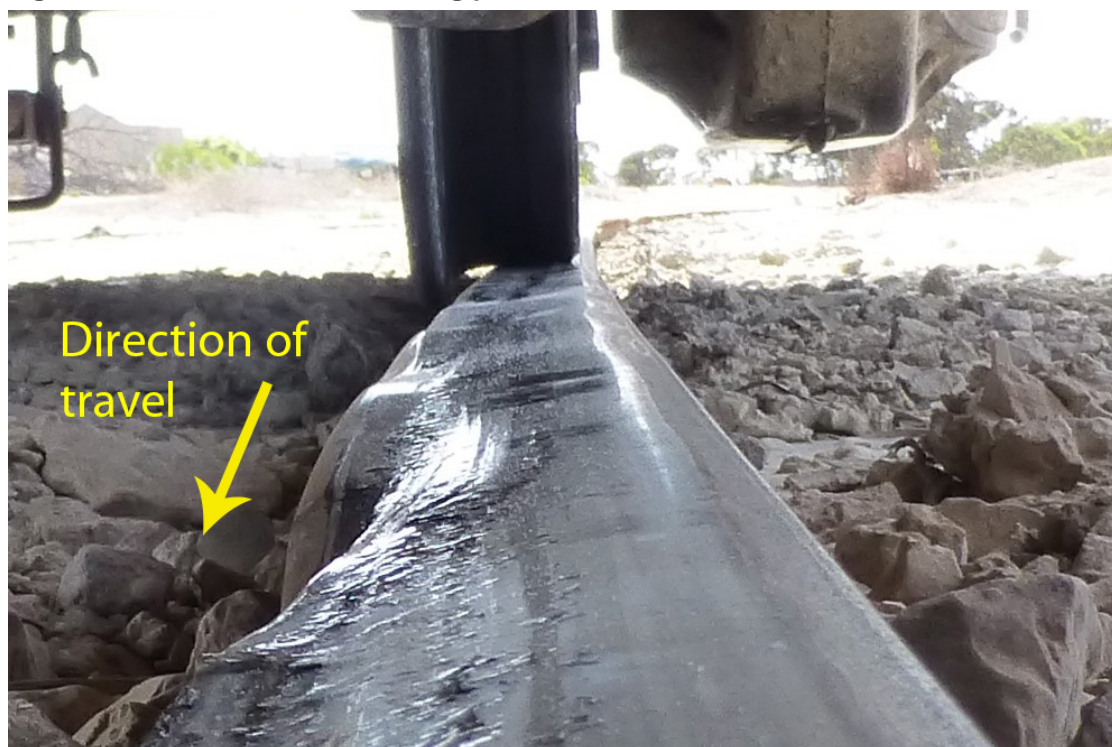
Figure 6: Rail condition and running position of wheels

The condition of sleepers and fasteners is critical for maintaining track gauge. In this case, their condition would have been difficult to determine visually, due to extensive coverage by gypsum product (Figure 7). Post-derailment examination however, found that the sleepers were in a poor condition, with limited gauge-holding capacity at the point of derailment. While the period over which gauge widening and poor sleeper/fastener condition had developed was unable to be determined, the level of rail wear and sleeper condition suggested that the track had been operating in a degraded condition for some time.

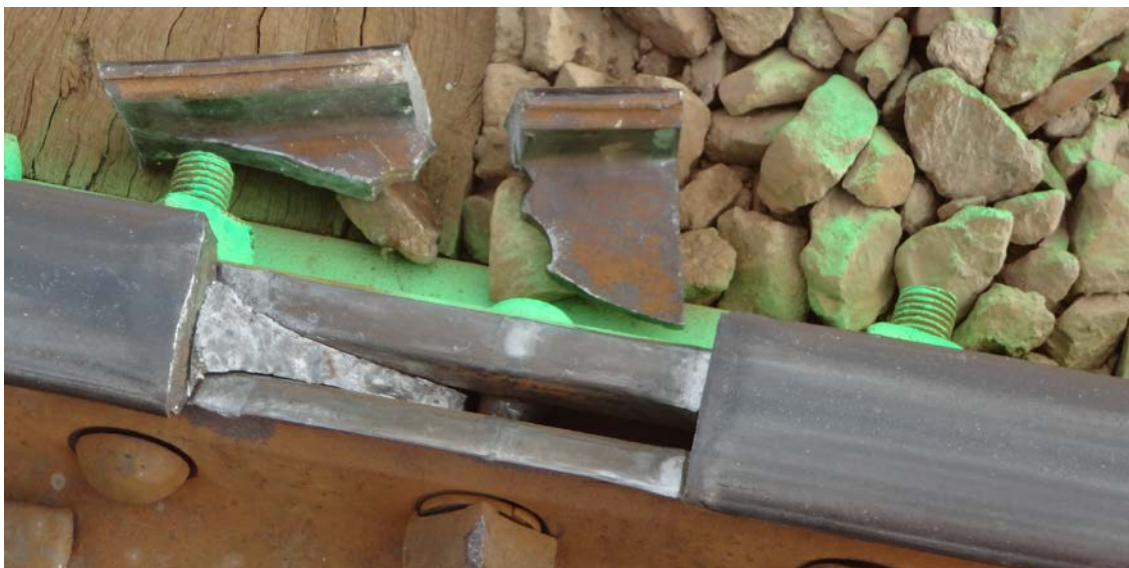
Figure 8: Rail defect in mechanical joint

At about 1800 hours on 2 November 2014, train 1DD5 derailed at the 473.938 km mark between Kevin and the Penong junction. Subsequent investigation found a 200 mm section of broken rail associated with a mechanical joint. It was concluded that the broken section had separated during the passage of 1DD5 (Figure 8).

While records of the inspections conducted after June 2014 were unavailable, the evidence of forced surface contact across the fractured web suggested the fracture within the mechanical joint had likely been present for a period longer than the time between inspections.
