# Collision with terrain involving a Grumman G164, VH-LKN

near Tharwa, Australian Capital Territory, on 6 August 2015

**ATSB Transport Safety Report**  
Aviation Occurrence Investigation  
AO-2015-092  
Final – 4 November 2015

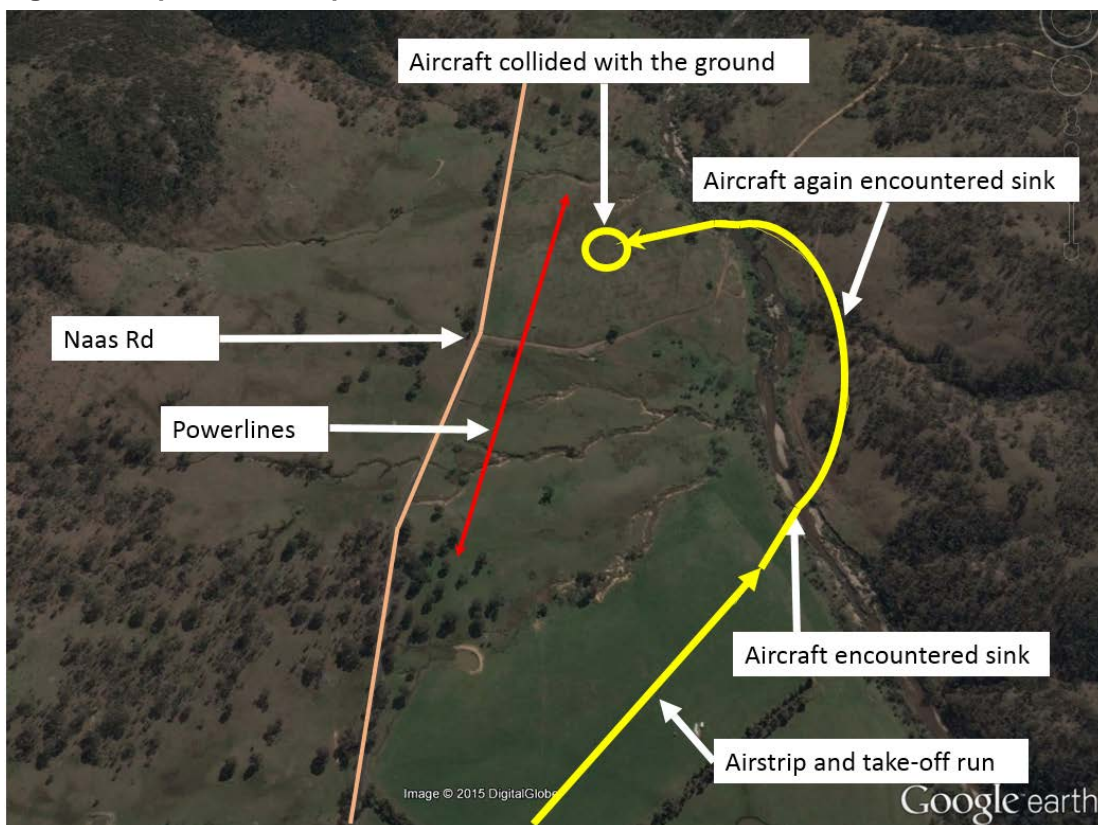
**Figure 1: Departure airstrip, aircraft track and accident location**

At about 1400, the pilot commenced the take-off run for the seventh load of the day. As the aircraft became airborne, the aircraft started to sink (Figure 1). To stop the aircraft sinking, the pilot applied the dump lever to start dumping the load of superphosphate. The aircraft then started to climb, so the pilot stopped dumping the load. The pilot also commenced a shallow left turn, away from rising terrain. As the aircraft turned, when at about 100 ft above ground level, it started to sink again. As it sank, the pilot felt a shake through the airframe, indicating that the aircraft was close to stalling. The pilot re-applied the dump lever to open the hopper door and try to reduce the aircraft load. Simultaneously, the pilot lowered the aircraft's nose and rolled the wings level, to try to recover from the incipient stall.

The pilot sighted powerlines, a road and a row of trees ahead, beyond which the terrain rose steeply. The aircraft continued to descend and the pilot maintained the aircraft in a normal nose attitude for landing. As the aircraft neared the ground, the pilot reduced the throttle to idle and held the aircraft control stick in the full back position. The tailwheel struck the ground first, and then the right main landing gear dug into soft ground. The aircraft flipped over and came to rest inverted.

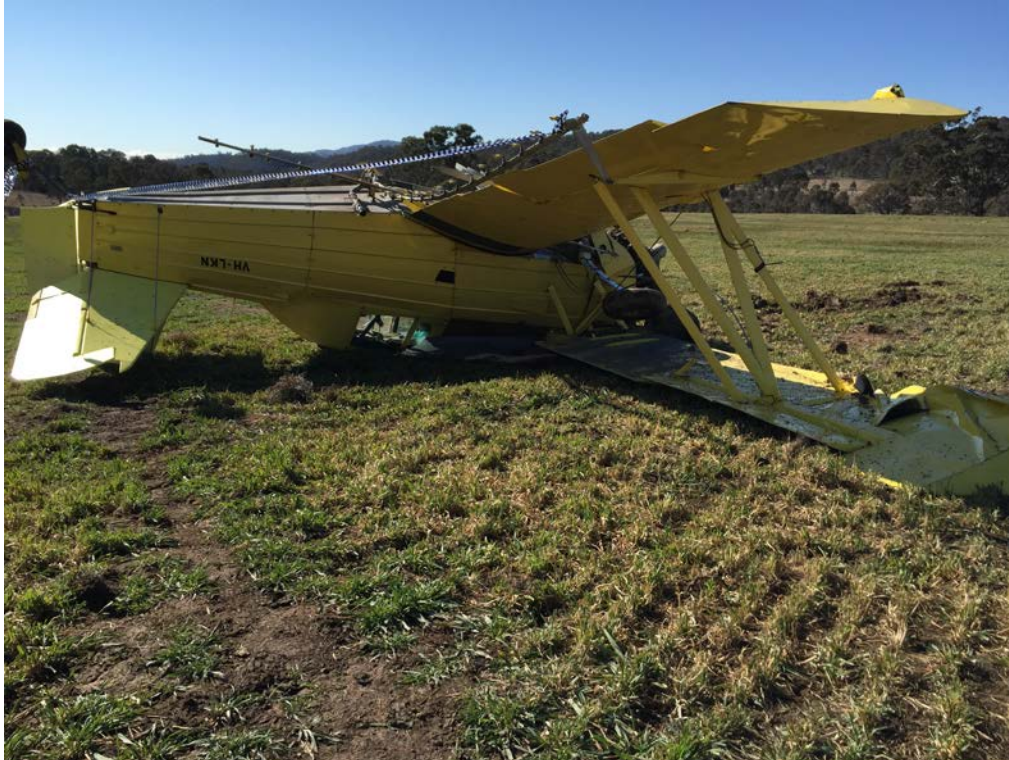
**Figure 2: Damage to VH-LKN**

The pilot sustained minor injuries and the aircraft was substantially damaged (Figure 2).

- Dumping liquid takes a few seconds, but granular substances like superphosphate take minutes for the hopper to empty when dumping the load.
- After the accident, the pilot verified that the hopper door was open, and superphosphate was present in the paddock, indicating that it had been dumping at the highest rate. Despite that, about 300 kg of superphosphate remained in the hopper.
