# Machinery failure on *HC Rubina* and subsequent contact with the wharf

Brisbane, Queensland | 29 October 2013

**ATSB Transport Safety Report**  
Marine Occurrence Investigation  
305-MO-2013-012  
Final – 14 November 2014

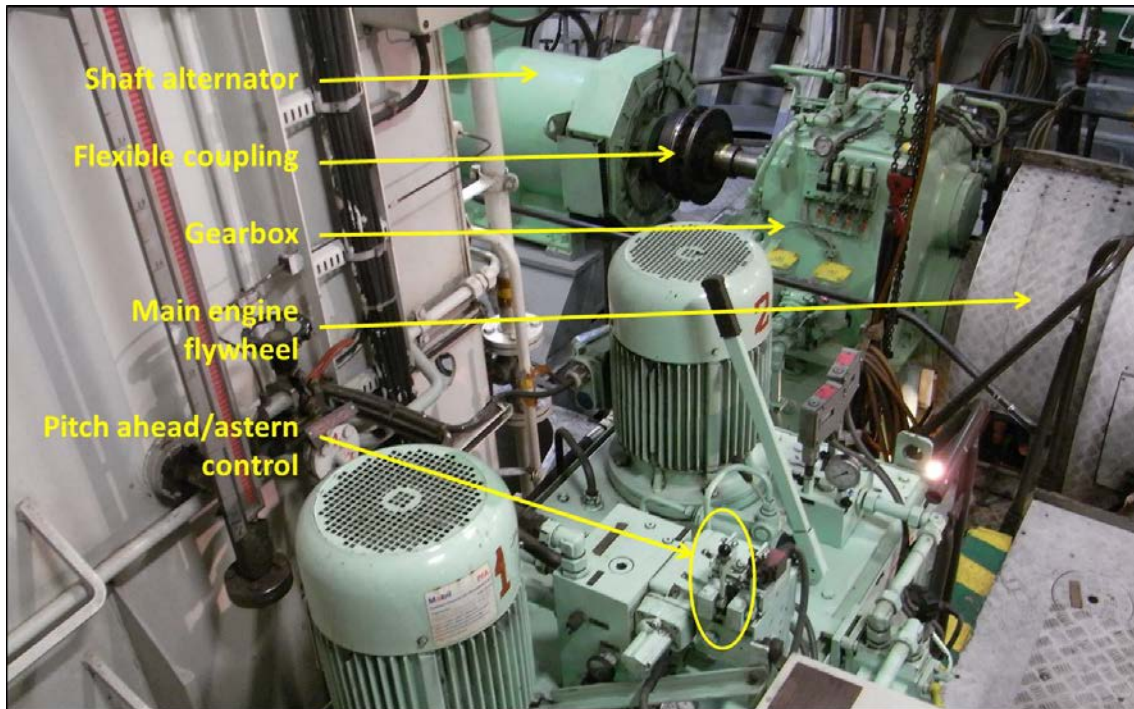
Figure 4: Photograph with the local control station and flexible coupling (guard removed)

At the time of the incident, the pitch was being operated from the local control station (Figure 4) following a complete failure of the pitch control system. The pitch order was being relayed from the bridge via telephone to the second engineer, who was manually operating the ahead and astern pitch control hydraulic valves until the required pitch was achieved.

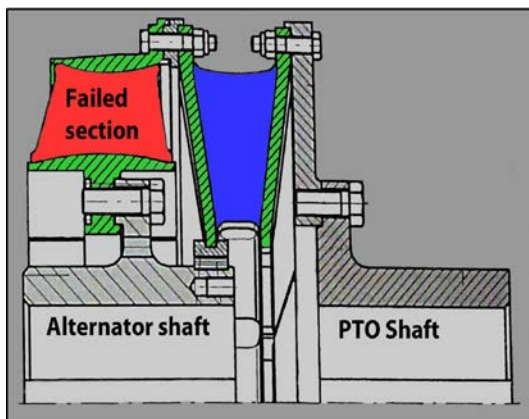
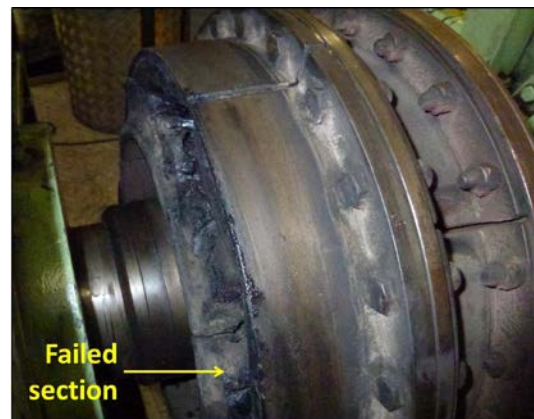
Figure 5: Shaft alternator flexible coupling

The coupling (Figure 5) transmitted the output power to the shaft alternator through an annulus rubber ring (red). The annulus ring was bonded to steel plates (green) and radial rubber segments (blue) which were also bonded to steel plates (green).

According to the manufacturer, the condition of the flexible coupling deteriorated as a result of loading and age. Therefore, they recommended it be replaced every 12 years.

At the time of this incident, *HC Rubina* was 14 years old and there were no available records to indicate that the coupling had ever been replaced. Further, no electronic job histories could be found for this task, or any task, prior to the middle of 2008. No other records were available relating to the maintenance of the coupling. Therefore, the ATSB concluded that the coupling was probably the original installed item and had exceeded its prescribed service life, being 14 years old.

While the nature of the damage sustained prevented the ATSB from specifically identifying the coupling failure mechanism, it was likely that the failure arose because it had deteriorated through age, to a point where it was no longer capable of carrying its rated load.

*HC Rubina*'s electronic planned maintenance system (PMS) did not contain any instructions relating to the shaft alternator flexible coupling. Therefore, the PMS could not produce a notification to ensure the shaft alternator flexible coupling was replaced at 12-year intervals in accordance with the manufacturer's instructions.

The Australian Transport Safety Bureau recommends that IMM Shipping takes action to address the lack of instructions in the planned maintenance systems of its managed ships, to ensure that ship equipment is maintained in accordance with manufacturers' requirements.
