Aviation Short Investigations Bulletin

Issue 37

AB-2014-176

Final – 23 December 2014

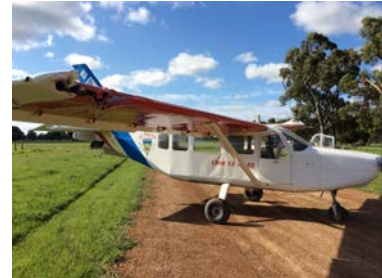
Airvan VH-XHV damage

Almost immediately the right wing of the Airvan struck the left wing of the parked WACO and the Airvan spun rapidly. The propeller struck a parked trailer, and the left wing went through the window of an unoccupied 4WD vehicle, before coming to rest. During this sequence, at least two people on the ground had to expedite themselves from the vicinity. The pilot shut down the aircraft and, still in shock, remained in the aircraft while ground personnel moved the Airvan back from the vehicle. The pilot was not injured, however two people nearby sustained minor injuries. The Airvan and the WACO were both substantially damaged.

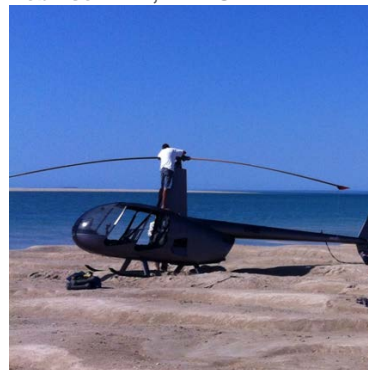
Robinson R44, VH-NUZ

The direction that the helicopter rotated could not be ascertained by the pilot or witnesses. The pilot and bystanders were not injured but the helicopter sustained substantial damage as a result of the hard landing. A subsequent inspection revealed that both tail rotor blades had broken off near the tail rotor hub, the vertical fin lower section and tail rotor guard were damaged, the tail rotor gearbox mounts had detached from the tail boom at two places and the landing gear skids were splayed (Figure 1).

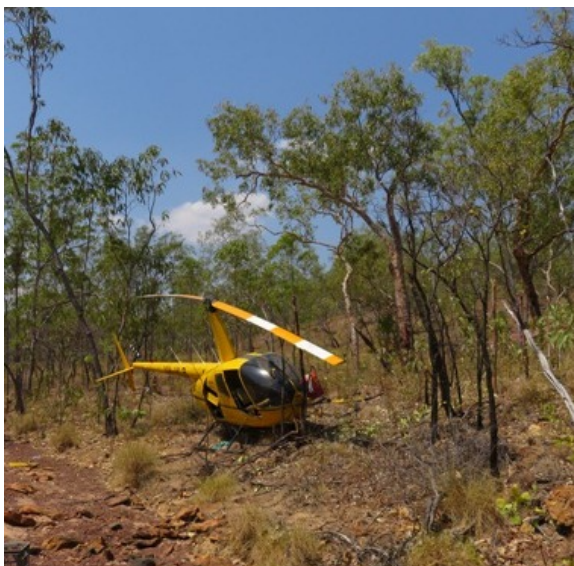
Figure 1: Accident site

The pilot then eased forward on the cyclic⁴ to increase translational lift⁵ and at about the same time, the low RRPM horn sounded. The helicopter continued to descend and the main rotor blades collided with multiple tree branches. The pilot turned the helicopter towards a small creek bed. When at about 6 ft above ground level, the helicopter rotated about 180° and landed hard with the left skid touching the ground first. The helicopter sustained substantial damage (Figure 1) and the pilot and passenger were uninjured.

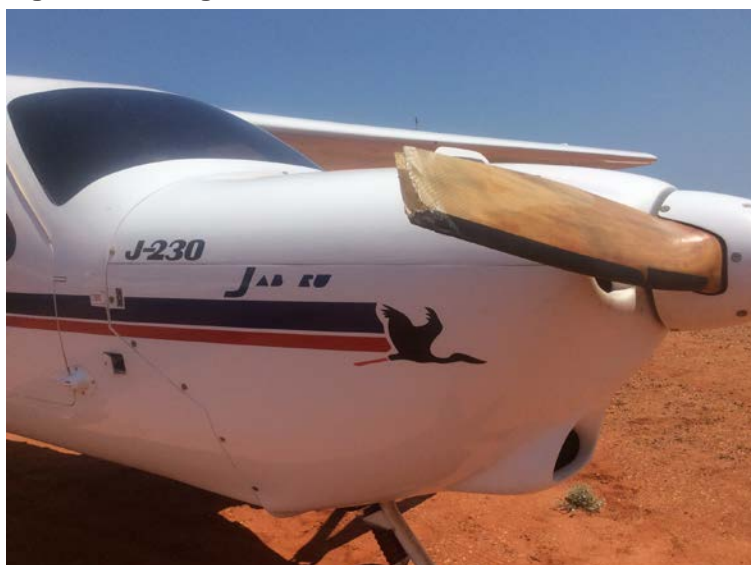
Figure 2: Damage to 24-7491

During the landing roll, the pilot was focused on looking for the correct taxiway to exit the runway for the itinerant parking bay. The aircraft was decelerating normally and the pilot did not apply brakes due to the length of runway remaining. The pilot detected the right wing rising slightly, possibly due to a crosswind. He then looked straight ahead and realised that the aircraft had veered off the runway centreline to the left. He applied right rudder in an attempt to return to the centre of the runway, but the aircraft continued towards the edge of the runway and taxiway A. He sighted a grass area and a drainage ditch ahead just off the runway which he wanted to avoid, along with a Fokker 100 aircraft that was stationary on taxiway A at the holding point for runway 28. The pilot elected to apply full left rudder to turn the aircraft around and remain on the sealed area.

- He became disoriented while looking for a taxiway to vacate the runway. He had not previously flown into Broome Airport and he felt that there were less visual cues to maintain direction, than at smaller, more confined aerodromes.
- He had to choose between veering off the runway and potentially colliding with a ditch; and ground-looping the aircraft and remaining on the runway.

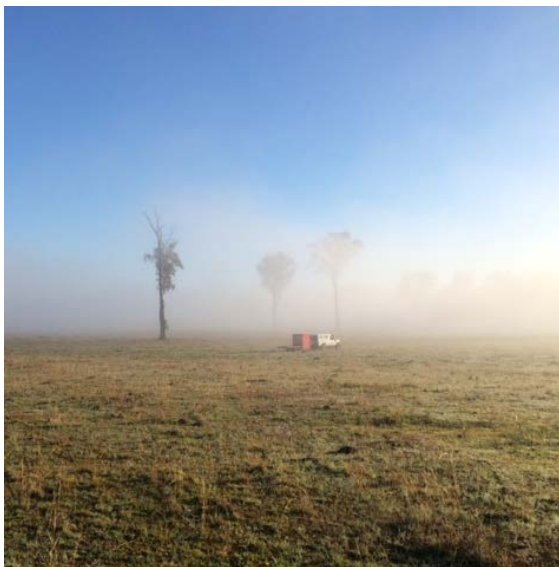
Figure 1: Landing site showing ground fog

During the approach, the pilot observed a light ground fog (Figure 1) and was heading directly into the sun, making the landing site difficult to see. The pilot attempted to obtain an accurate rate of descent from the altimeter, but it was reading erratically. When approaching treetop height, the balloon had a forward speed of about 14.5 kt. The pilot instructed the passengers to put cameras away and adopt the landing position, but not all of them complied. He repeated his instructions to the passengers, the altimeter continued to read erratically and, facing directly into the sun, made visual assessment of the approach difficult.
