# Loss of separation involving a Boeing 717, VH-NXL, and a vehicle

Perth Airport, Western Australia on 26 July 2014

**ATSB Transport Safety Report**  
Aviation Occurrence Investigation  
AO-2014-133  
Final - 26 February 2015

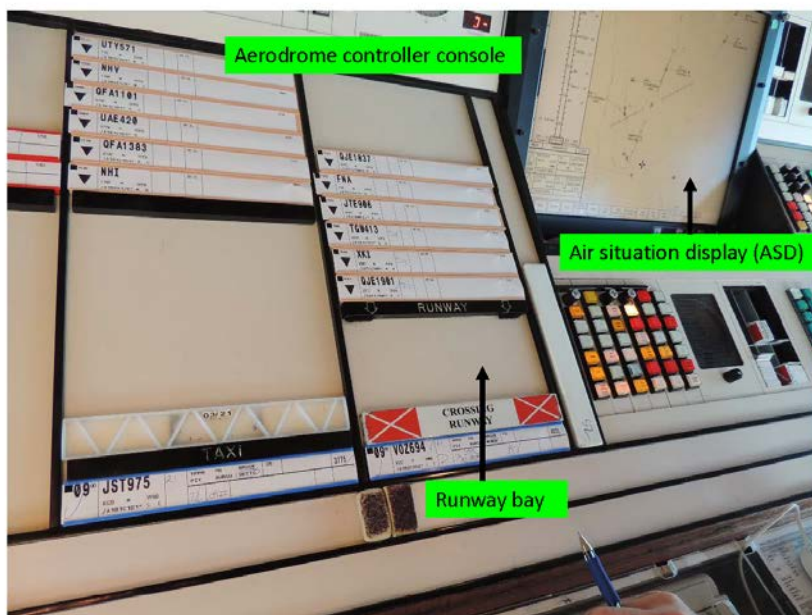
**Figure 2: Perth aerodrome controller console**

At about 1203, the ADC cleared a Fokker 100 (F100) aircraft for take-off from runway 21. After observing that aircraft pass through the intersection of runway 24, the ADC picked up the flight progress strip for NXL, scanned the runway but did not see the vehicle on it. The ADC then moved the strip into the console runway bay (Figure 2) without noticing the safety vehicle strip, while simultaneously observing the F100 become airborne.

- The controller had a single runway bay on the Tower console (Figure 2) where flight progress strips for aircraft using either of the two runways in use were placed. The runway assigned to the aircraft was written on the aircraft's strip.

- The vehicle strip (red with a white centre) was in the console runway bay at the time of the incident. There were two possible reasons the controller may have missed it: the process of placing the aircraft strip without reconciling with the vehicle strip already there was a muscle memory or automatic process rather than a conscious one; or, the combination of picking up the strip, talking and scanning all at once when issuing a landing clearance meant that the controller was looking outside at the runway, talking and moving the strip without looking at the bay to reconcile the strips.

- After many years of experience in air traffic control at Perth Airport, the controller had become efficient at the controlling duties, in particular by combining tasks together, or 'chunking'. In this incident, the controller combined the tasks of picking up the aircraft's flight progress strip in their left hand, while sighting the aircraft and checking that the landing gear was down, scanning the runway, issuing the landing clearance, and placing the strip into the console runway bay, without separating out the individual tasks. The controller reported that they now segment the tasks and complete them serially as separate actions, rather than simultaneously.

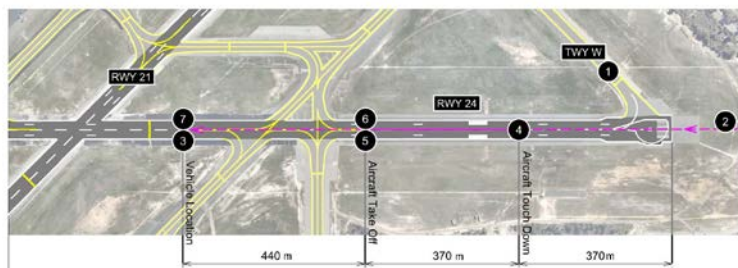
**Figure 3: Sequence of events**

At about 1204, as NXL touched down on runway 24 about 370 m from the threshold, the first officer saw the flashing lights of a vehicle ahead on the runway, immediately stated 'go-around, car on the runway' and the captain commenced a go-around. About 6 seconds later, the aircraft became airborne about 740 m from the threshold. At that time, the safety vehicle was stationary on the centreline of runway 24 about 1180 m from the threshold and facing away from the approaching aircraft. The SO did not see the aircraft, until it passed about 150 feet over the vehicle (Figure 3).

Point	Description
1	Safety vehicle held at W
2	NXL cleared to land on runway 24
3	Safety vehicle stopped short of runway 21
4	NXL touched down on runway 24
5	NXL reported going around due car on the runway
6	NXL became airborne
7	NXL passed over vehicle at a height of 150 ft

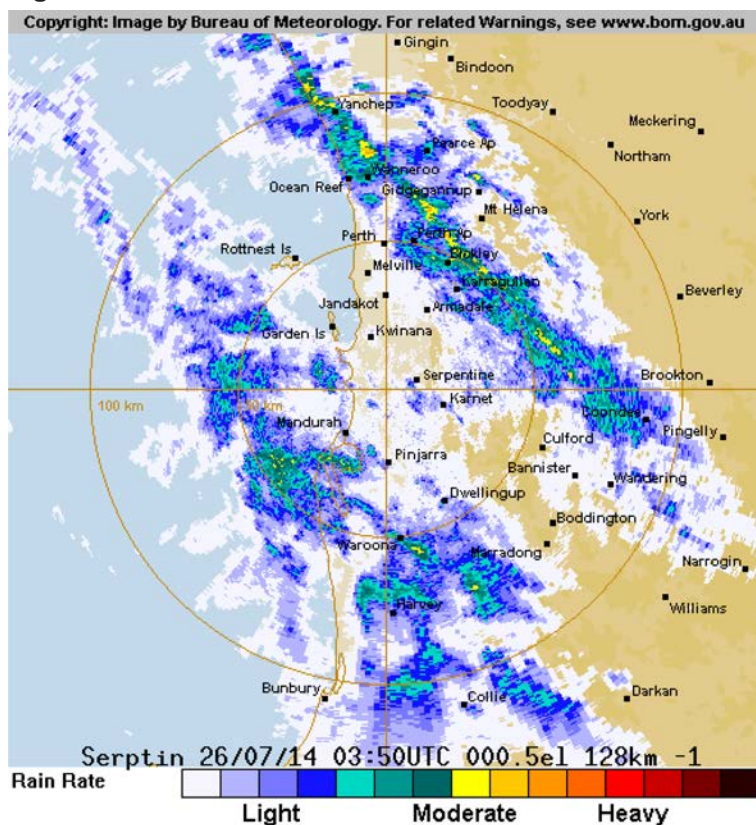
**Figure 4: Rain radar at 1150 WST**

The Bureau of Meteorology data indicated that about 10.2 mm of rain fell between 1150 and 1200 on the day of the occurrence. The weather radar showed a line of showers passed through the area about 10 minutes prior to the incident (Figure 4).
