Collision with terrain involving Cessna 182, VH-KKM

19 km WSW of Mount Hotham Airport, Victoria | 23 October 2013

ATSB Transport Safety Report
Aviation Occurrence Investigation
AO-2013-186
Final – 16 April 2015

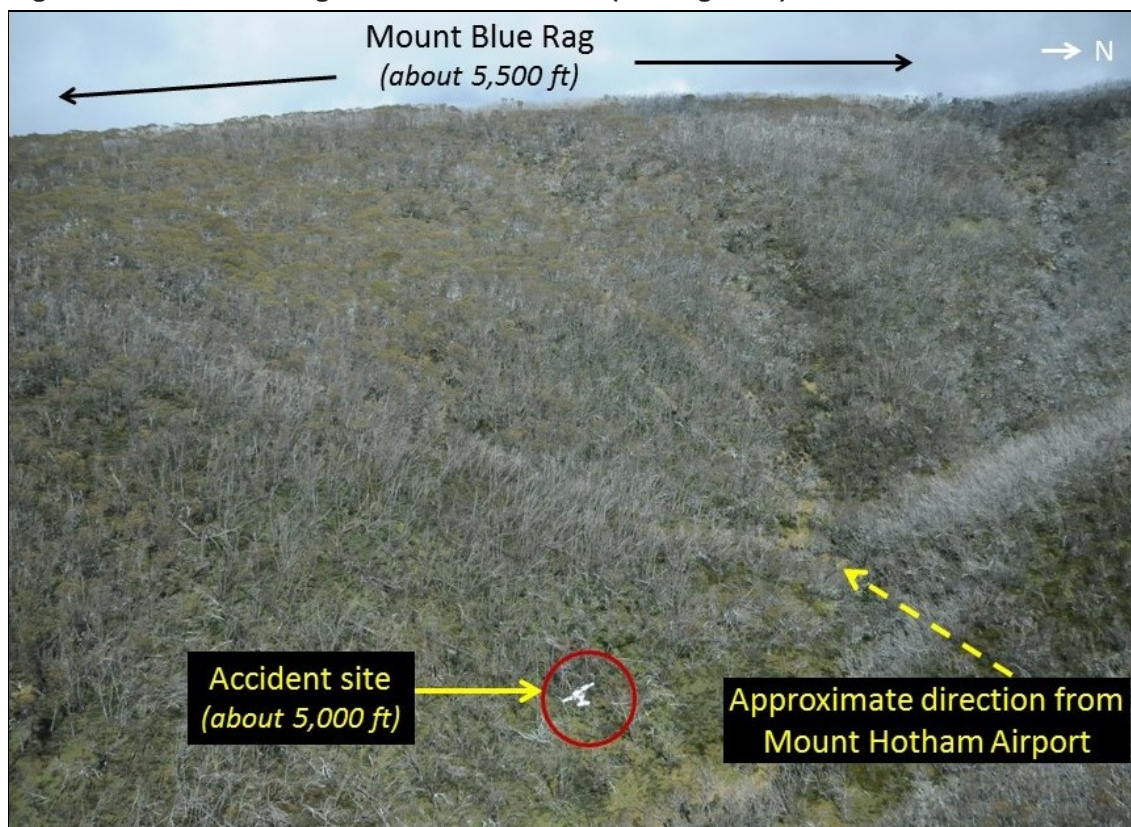
Figure 3: Mount Blue Rag and the accident site (looking west)

Examination of the wreckage found that the aircraft collided with rising terrain while travelling in a south-westerly direction, with the wings level and a nose-down attitude of about 6–10°, consistent with controlled flight into terrain (see the section titled *Controlled flight into terrain*). The impact severely compressed the wings and fuselage. The fuel tanks, located within the wings, ruptured at impact but there was no post-impact fire (Figure 4).

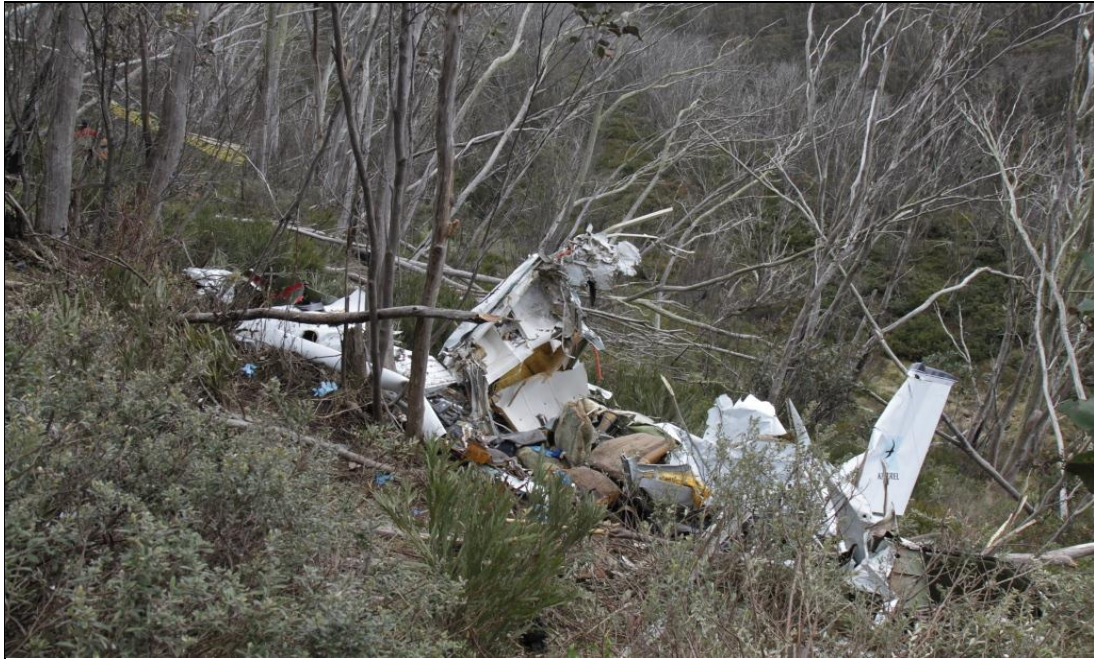
Figure 4: Aircraft wreckage

No defects were found with the aircraft or its systems that may have contributed to the accident.
