VFR flight into dark night involving Aérospatiale AS355F2 VH-NTV

145 km north of Marree, South Australia | 18 August 2011

ATSB Transport Safety Report
Aviation Occurrence Investigation
AO-2011-102
Final – 14 November 2013

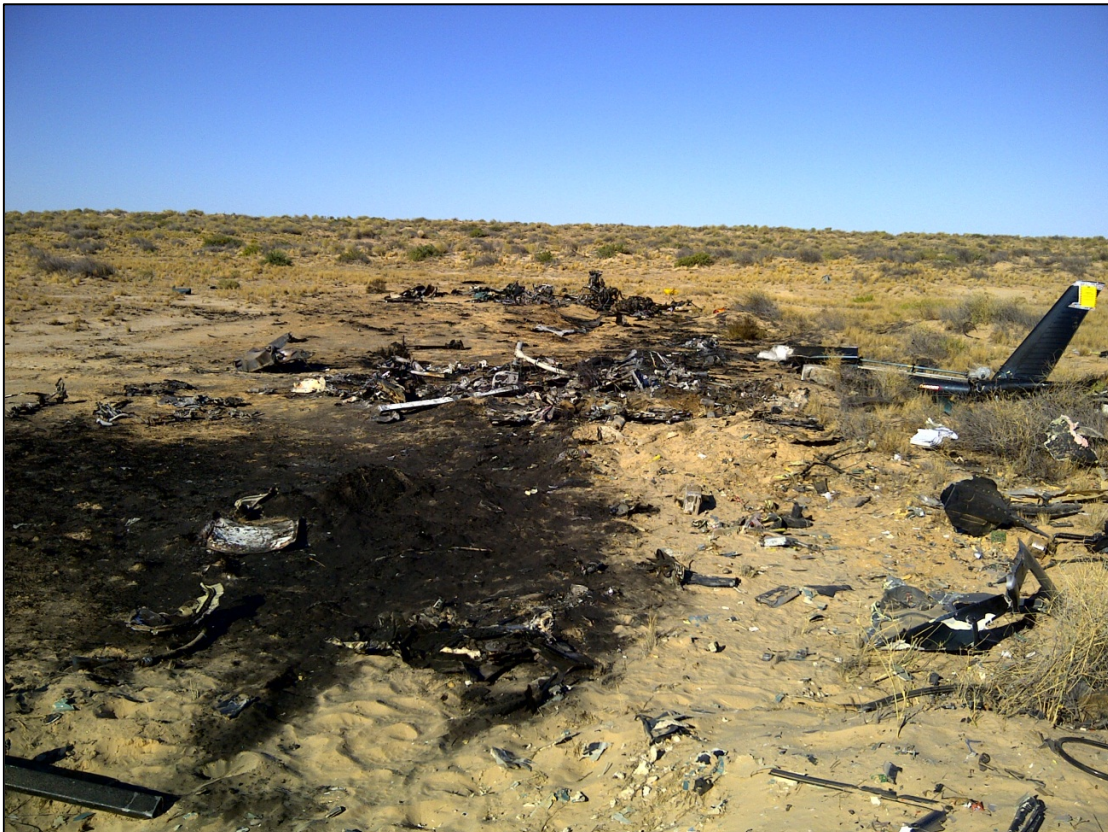
Figure 11: Helicopter wreckage

The wreckage was located on sandy, undulating terrain at about sea level (Figure 11). All of the helicopter's major components were identified at the accident site.

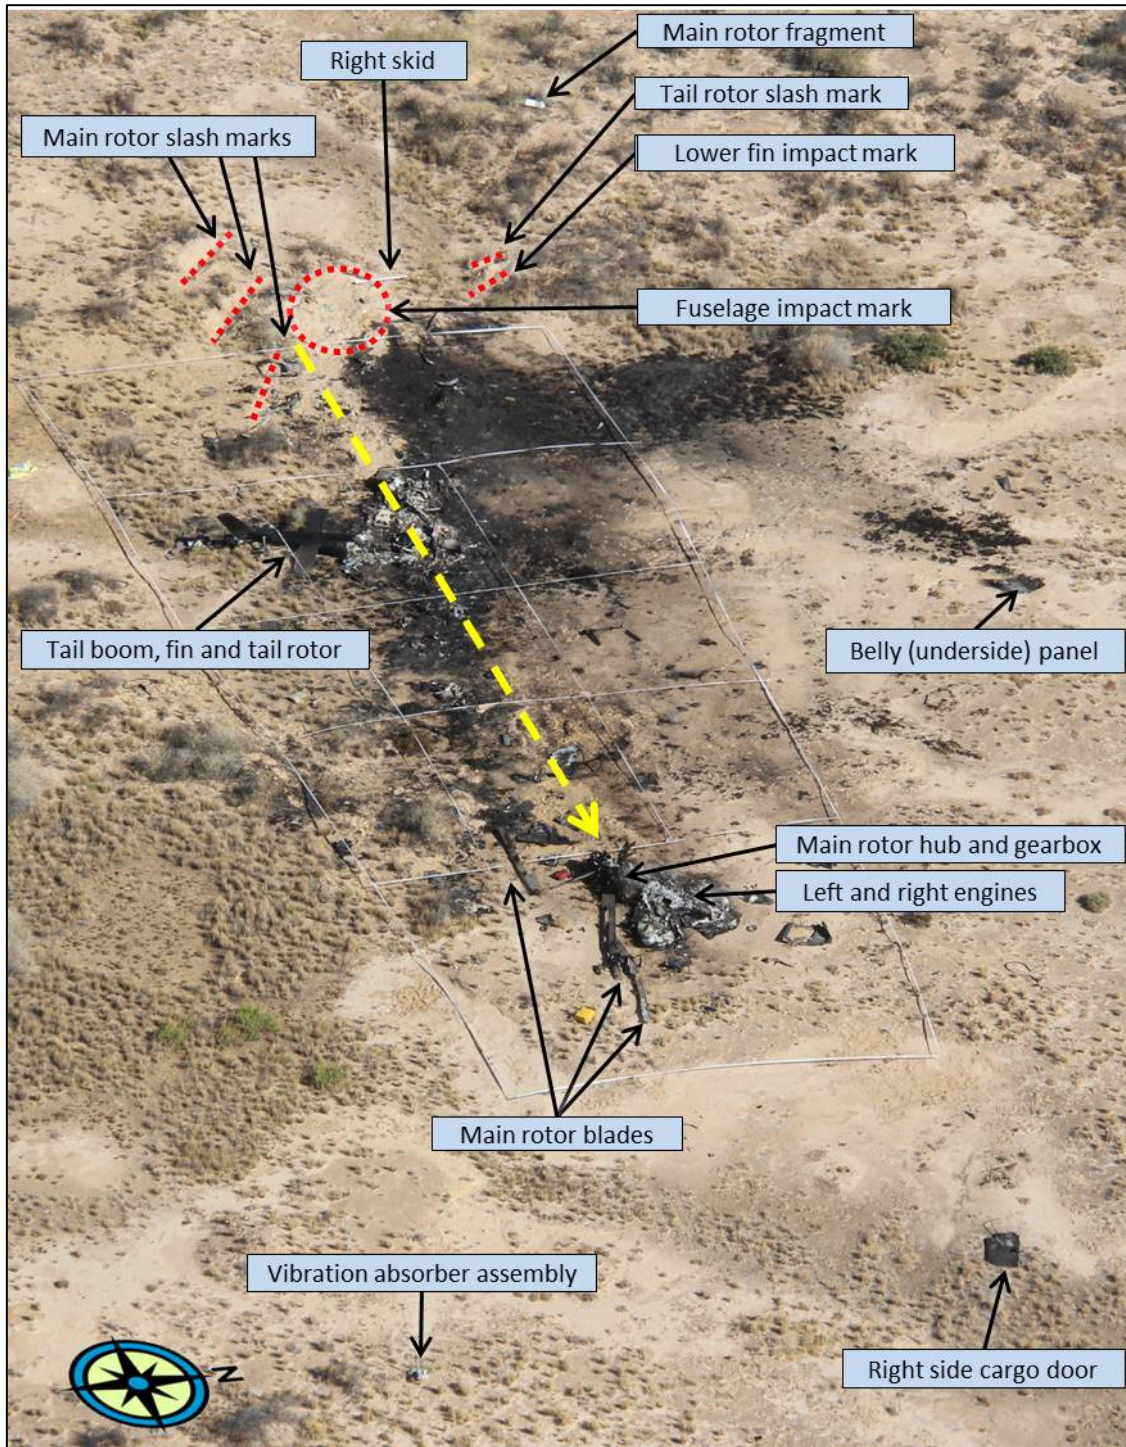
Figure 12: Wreckage trail

The wreckage trail was about 60 m long and indicated that the helicopter was travelling in an easterly direction at the time of impact (Figure 12). The majority of the cabin and tail boom were near the beginning of the wreckage trail at the western end. The heavier components, consisting primarily of the engines, main rotor gearbox, main rotor head and main rotor blades, were to the eastern end of the wreckage trail.

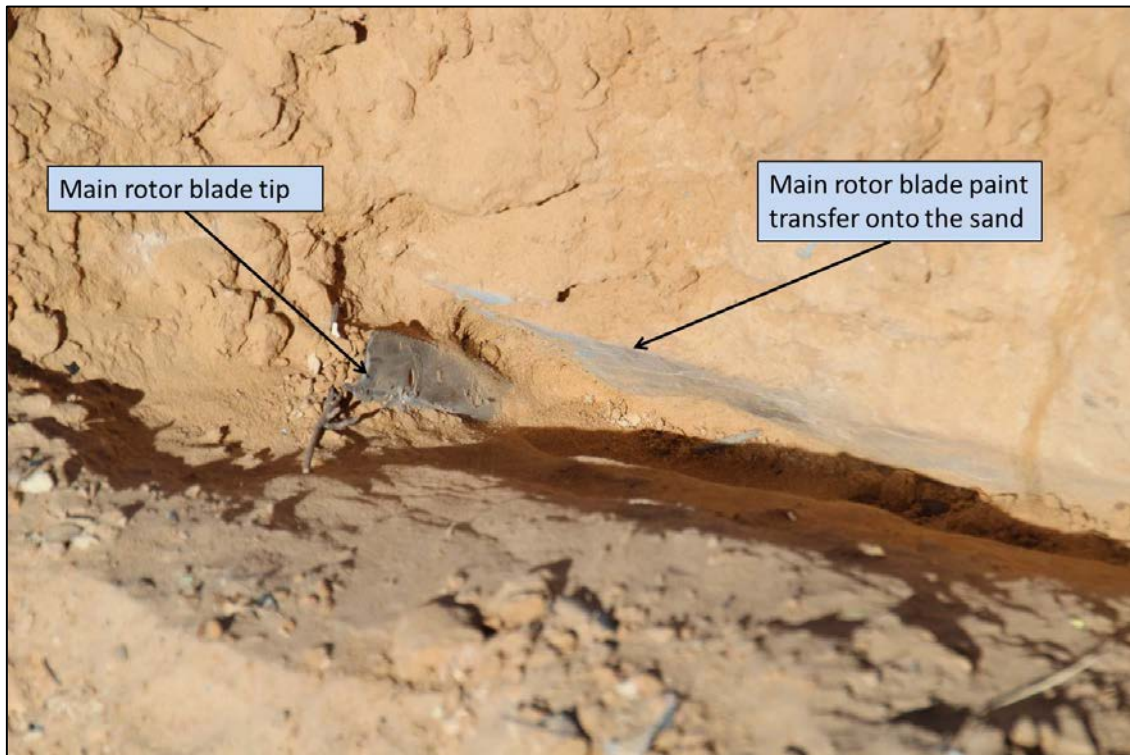
Figure 13: Main rotor blade tip

Ground strike marks from the helicopter's three main rotor blades were identified at the beginning of the wreckage trail. The marks, and the orientation of two main rotor blade tips found embedded in two of the strike marks, indicated that the helicopter impacted the ground at about a 90°, right-side-low attitude (Figure 13). The third main rotor blade tip remained attached to its blade.

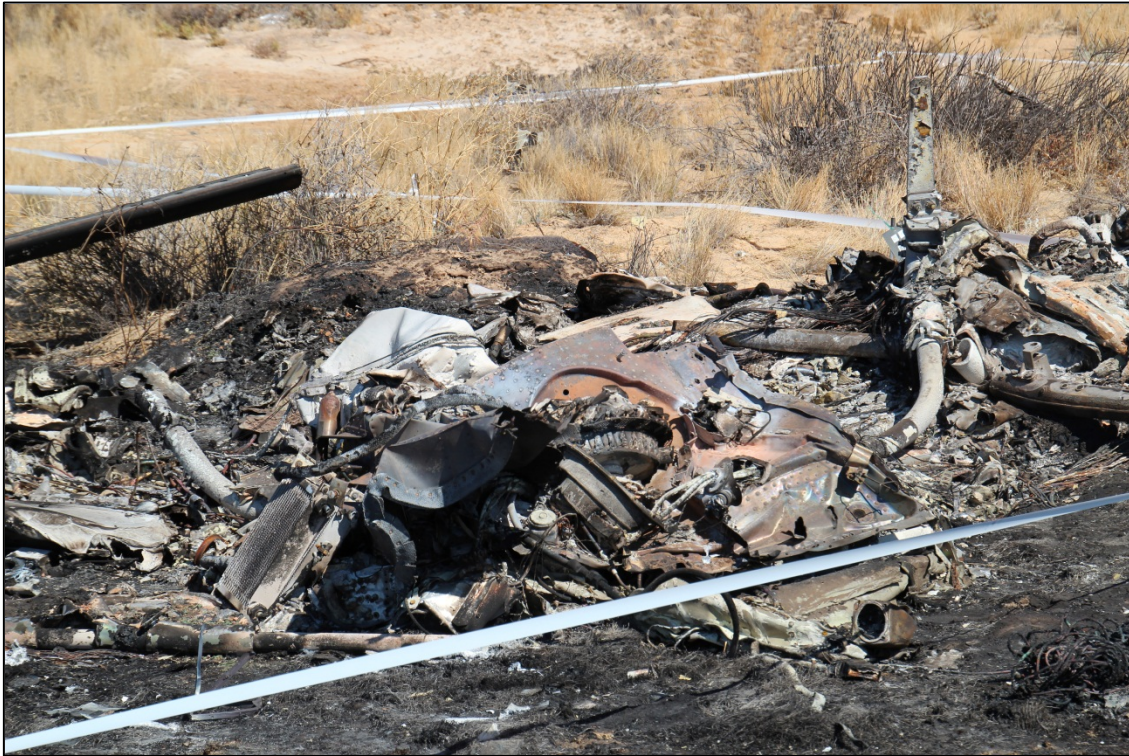
Figure 14: Main airframe

The main airframe was significantly disrupted by the initial impact, with pieces of the structure identified from the initial impact point through to the end of the wreckage trail. Almost all of the airframe had been consumed by the post-impact fire (Figure 14). Due to the level of disruption to the cabin area, the accident was not considered survivable.

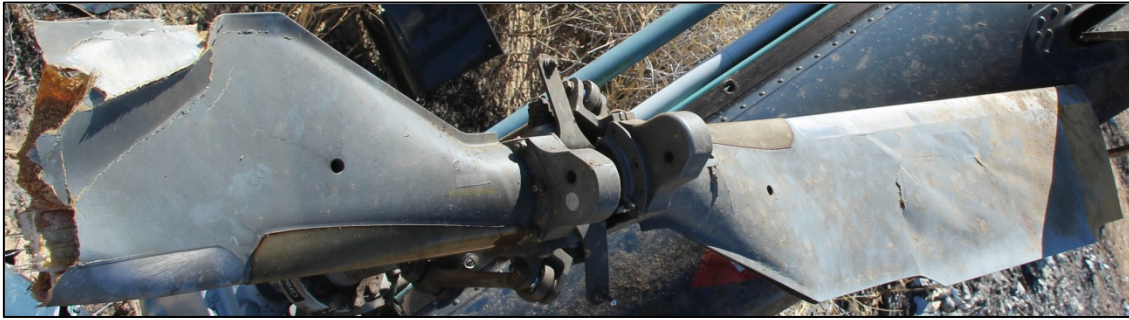
Figure 15: Tail rotor

The main rotor head was severely damaged, consistent with a main rotor strike under a level of power. All three main rotor blades had been severely disrupted, consistent with contact with the terrain. Drive continuity was confirmed from the main gearbox through to the main rotor head, then through to the tail rotor gearbox. One of the blades on the tail rotor assembly had separated at the beginning of the wreckage trail when the tail rotor contacted the ground. The other blade on the assembly had indications of rearwards bending, consistent with a ground strike under a level of power (Figure 15).

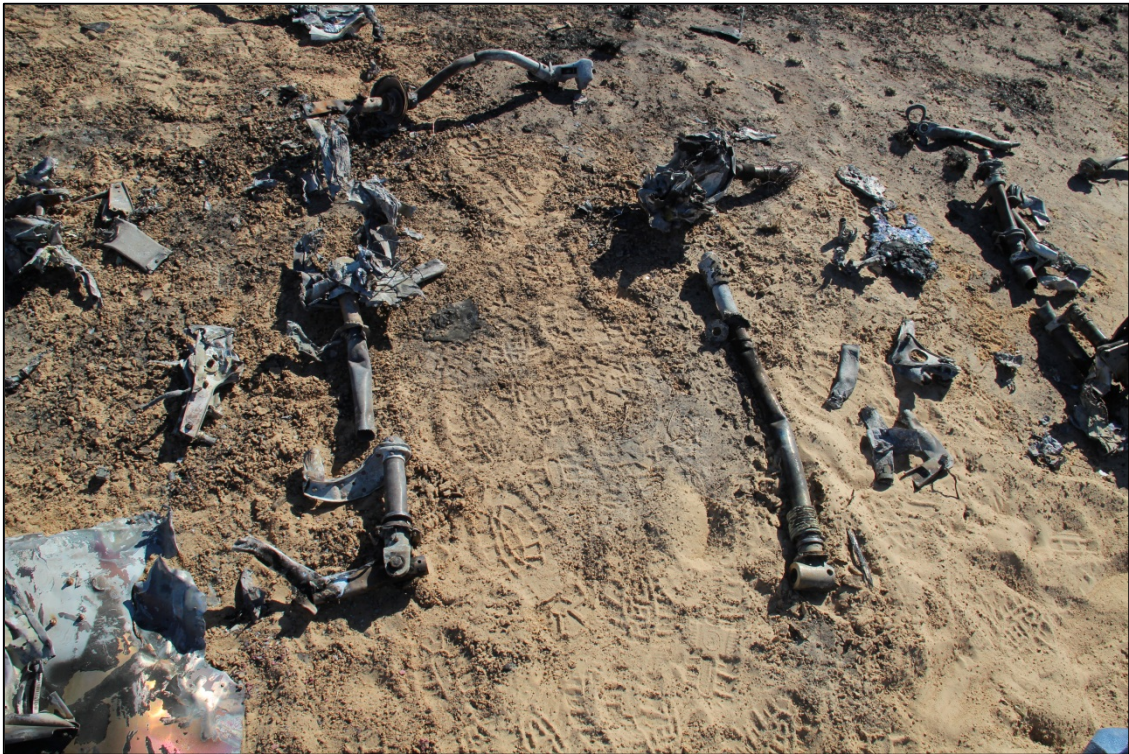
Figure 16: Flight controls set out on-site

Continuity of the tail rotor pitch control rod was confirmed along the remaining portion of the tail boom, and the rod was able to be moved. Continuity of the flight controls from the main hydraulic actuators on the main gearbox to the main rotor head was also confirmed. The majority of the flight control tubes in the cabin area had been consumed by the post-impact fire. The majority of the control tube ends and bellcranks were identified and all associated attaching hardware was intact. Unidentified flight control items were also confirmed to have attaching hardware installed (Figure 16).

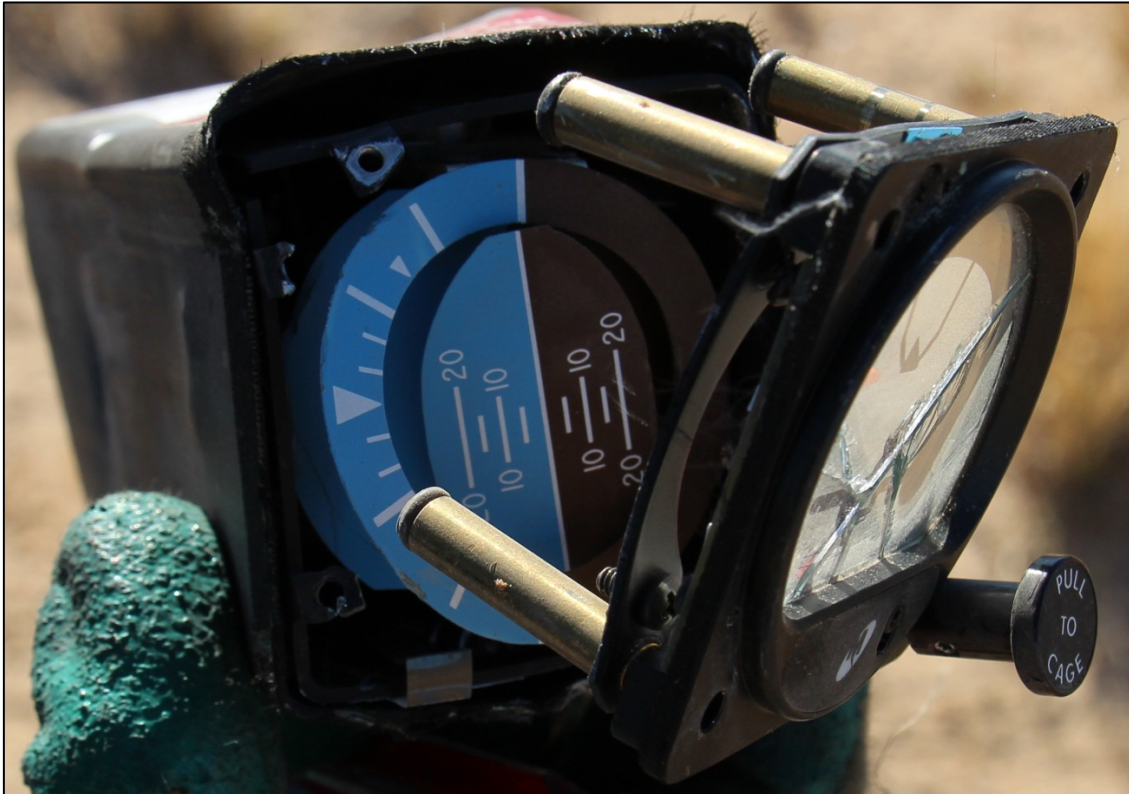
Figure 17: On-site image of the standby AH

Examination of the standby AH confirmed that the roll attitude indication on the instrument was captured at about 90° right-side low (Figure 17). The pitch attitude in the instrument had some movement, and therefore its relative position at the time of impact could not be determined. The standby AH was disassembled for a detailed examination, and it was confirmed that its internal gyro was rotating at the time of impact (Figure 18), and therefore capable of providing aircraft attitude information.

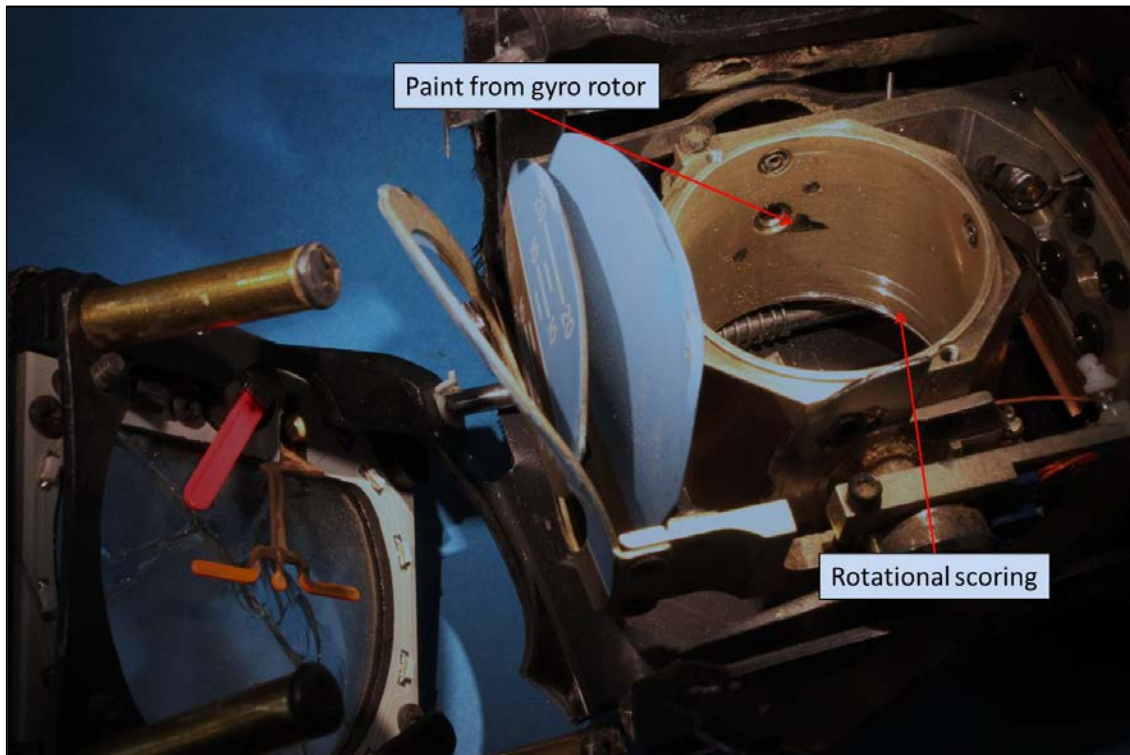
Figure 18: Standby AH displaying rotational scoring from the gyro rotor (removed)

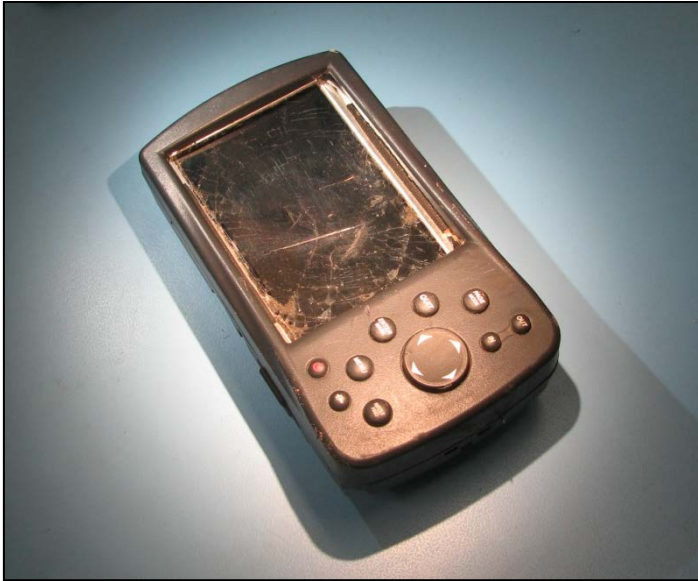
Figure A2: Recovered VH-NTV Garmin GPSMAP 495

The recovered unit was damaged (Figure A2).

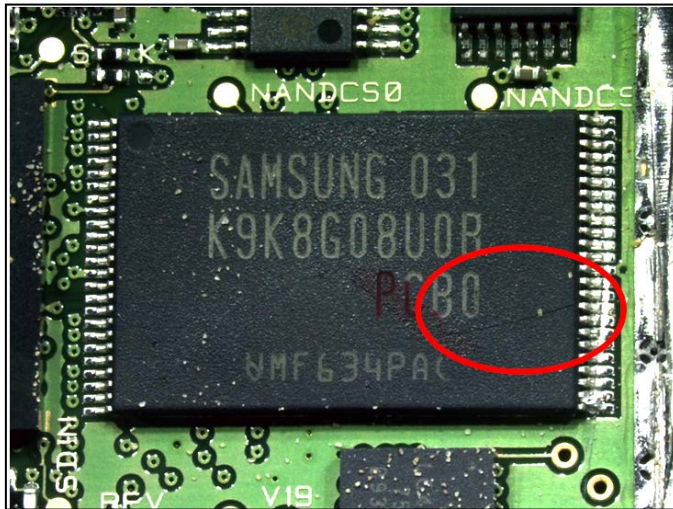
Disassembly and examination of the unit revealed that the FBGA chip was undamaged but the TSOP memory chip (Figure A3) was cracked through the outer casing (Figure A4 and Figure A5) with the pins crushed by the protective surrounding.

Figure A4: Location of damage to TSOP chip

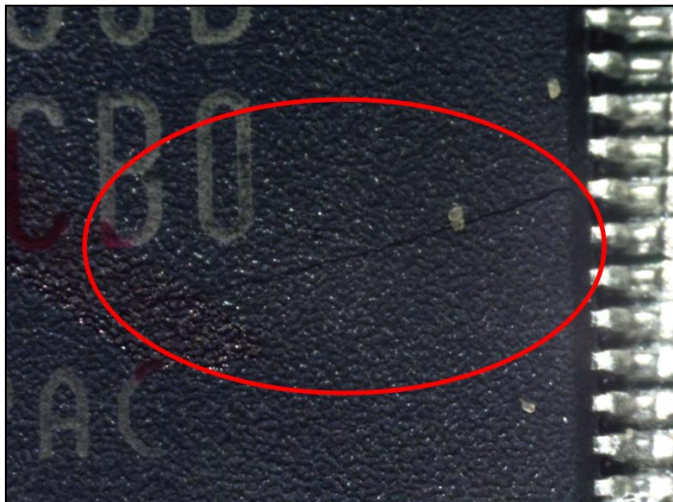
Figure A5: Damage to TSOP chip

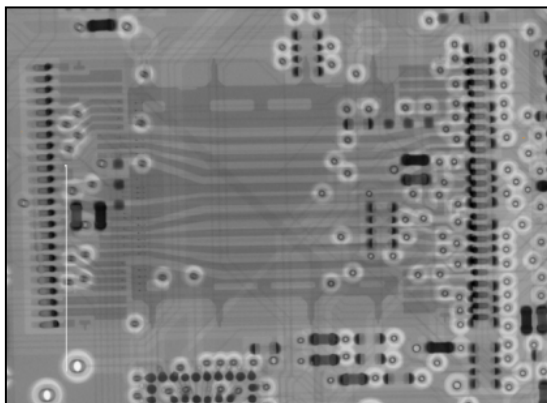
Figure A6: X-ray of the TSOP memory chip

X-ray examinations showed no damage to the metallic connections in either the TSOP or FBGA memory devices (Figure A6 and Figure A7). The examination was unable to determine the extent of damage to any silicon-based connections.

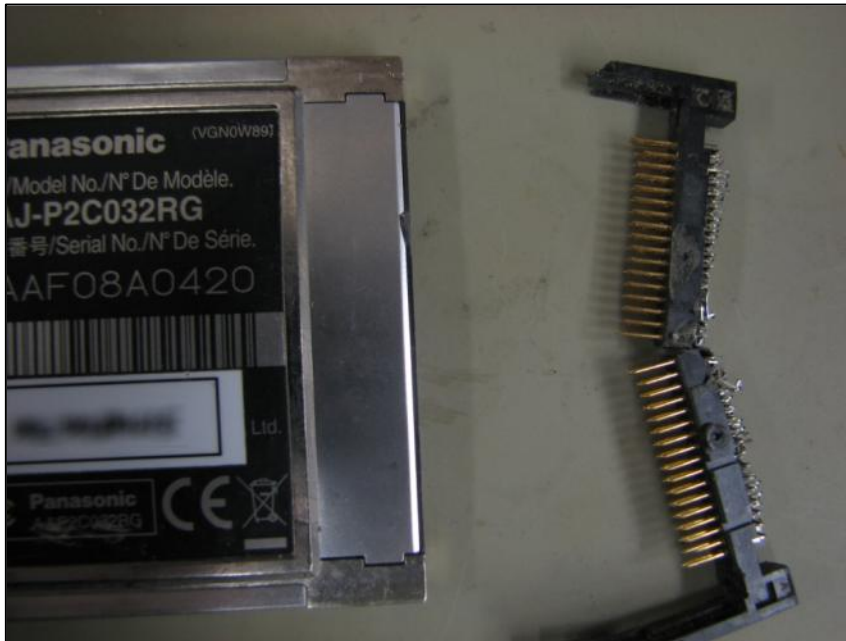
Figure B2: Header pins removed from one P2 card

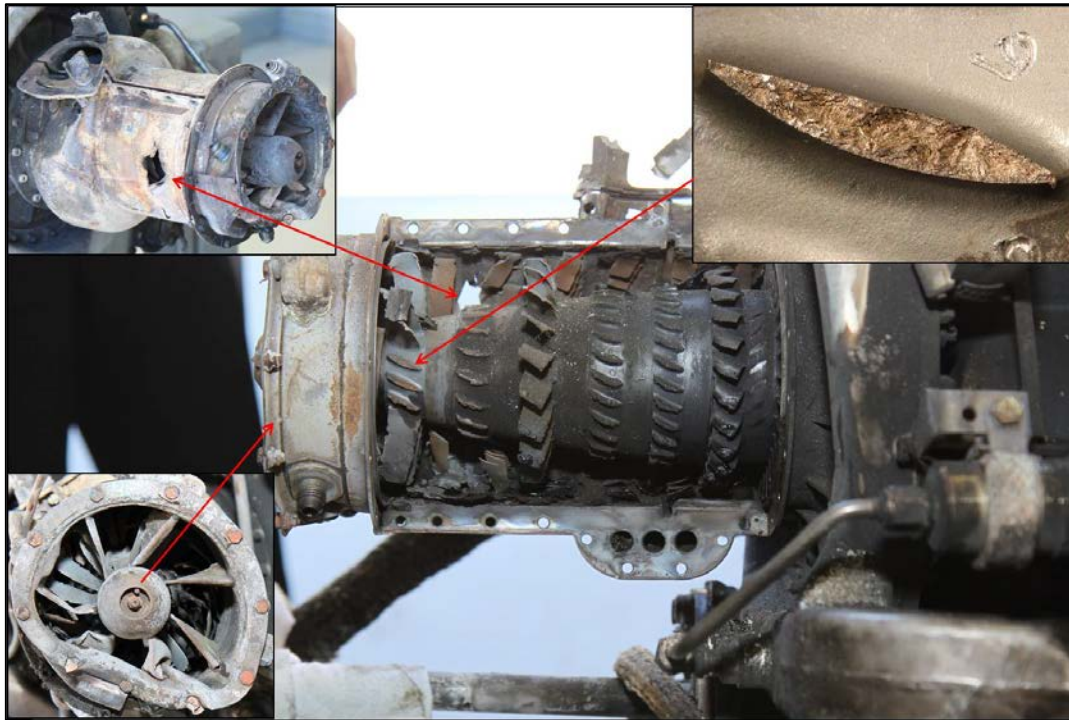
Figure C1: Left engine rotor pack with hole in casing and typical stage 1 blade overload failure

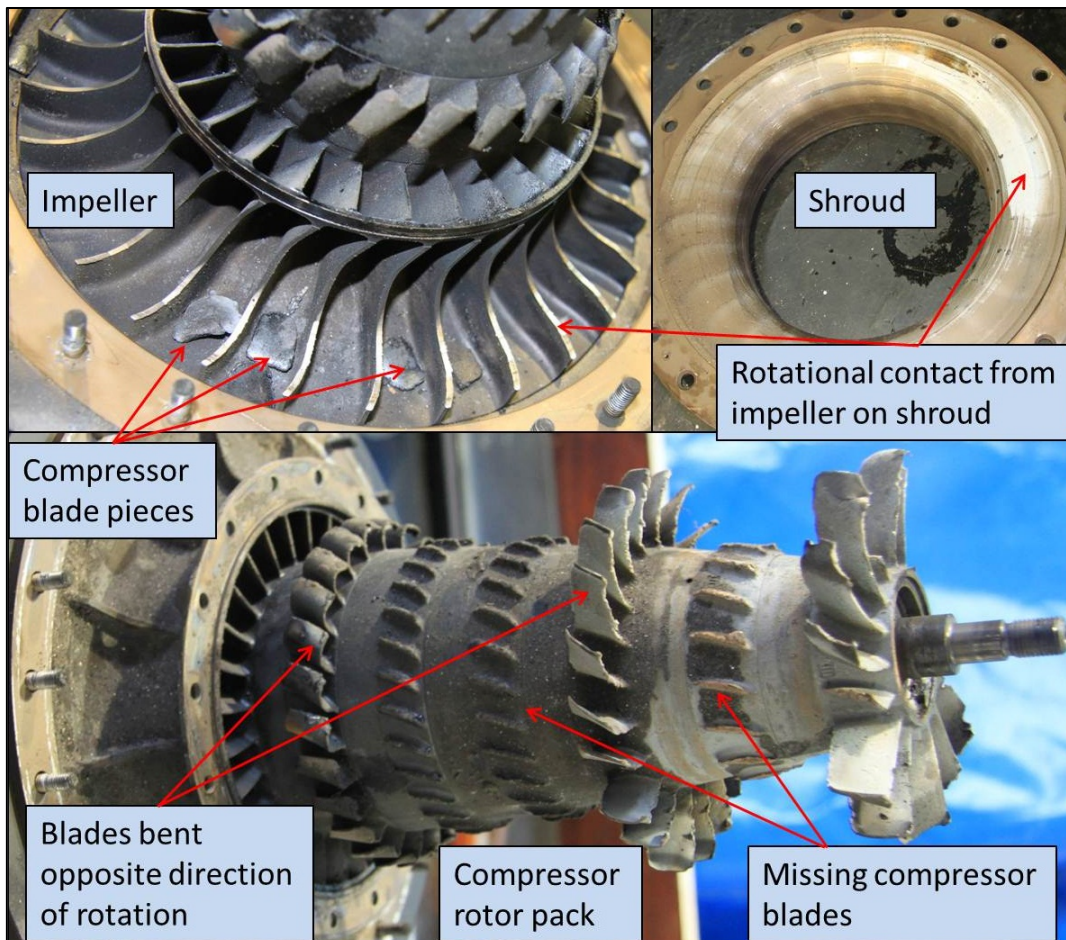
Figure C2: Left compressor displaying evidence of rotation

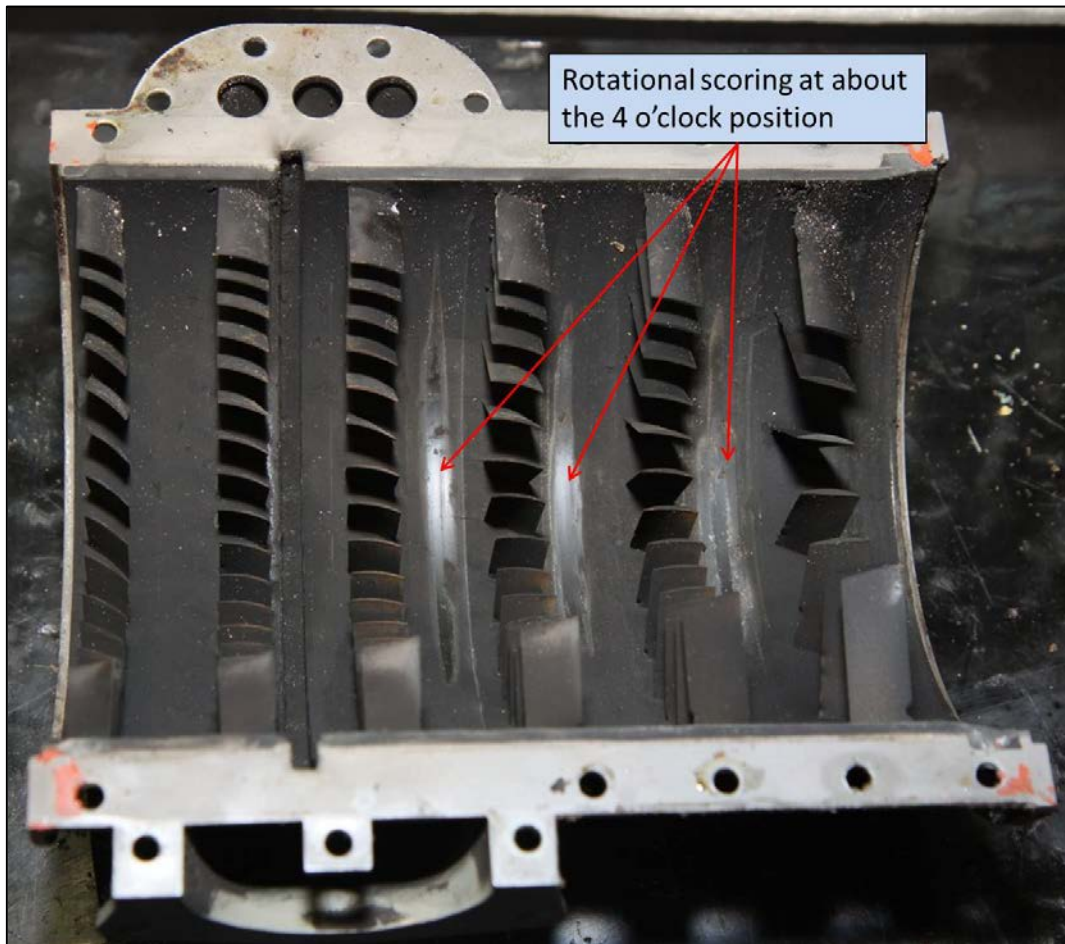
Figure C3: Right compressor case half displaying evidence of rotation

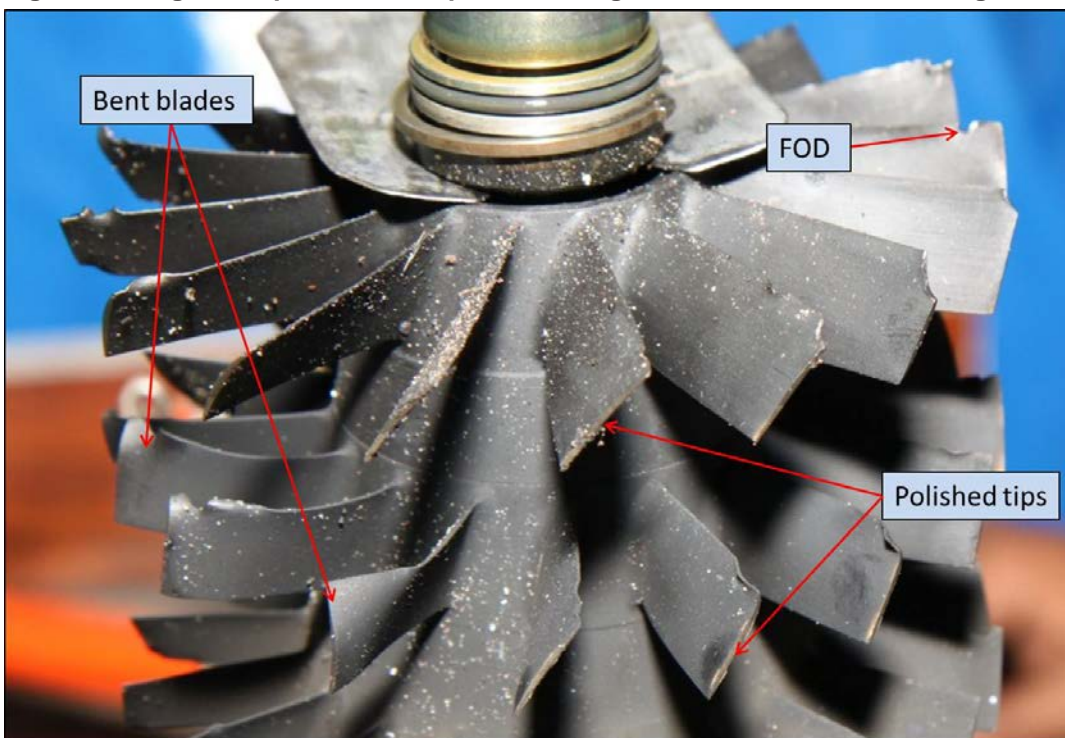
Figure C4: Right compressor rotor pack showing debris and rotational damage
