Aviation Short Investigations Bulletin

Issue 42

ATSB Transport Safety Report
Aviation Short Investigations
AB-2015-085
Final – 27 August 2015

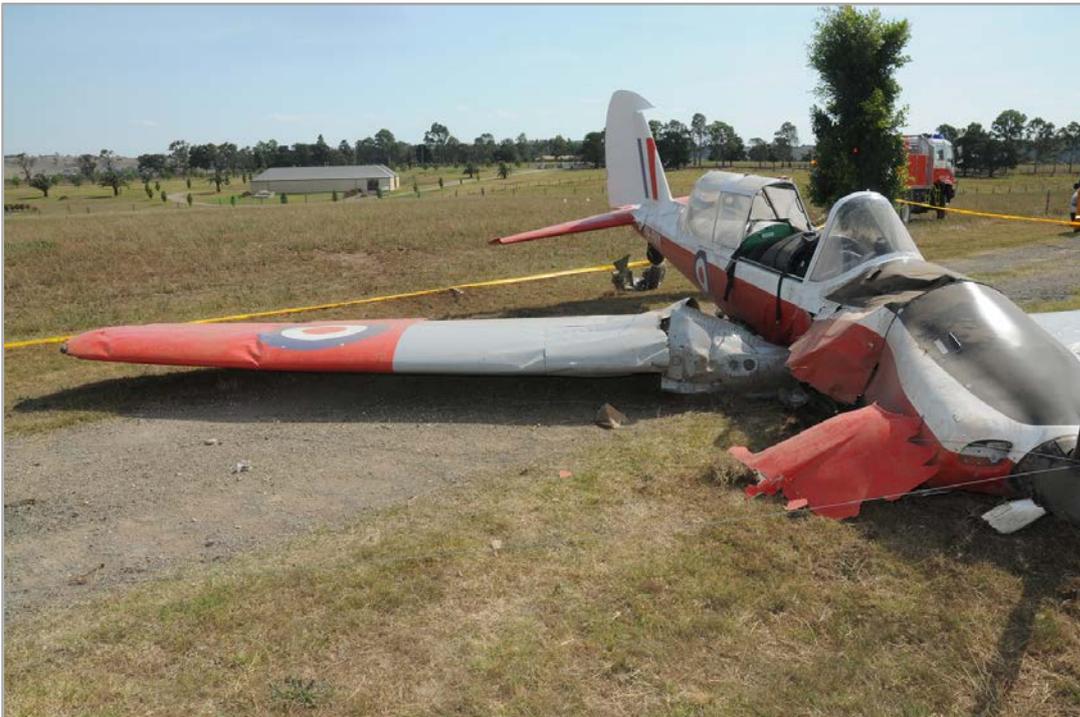
Figure 2: VH-RVY

he was unable to provide any physical assistance. After a short time, the passenger exited the aircraft. The pilot and passenger sustained serious injuries and the aircraft was substantially damaged (Figure 2).

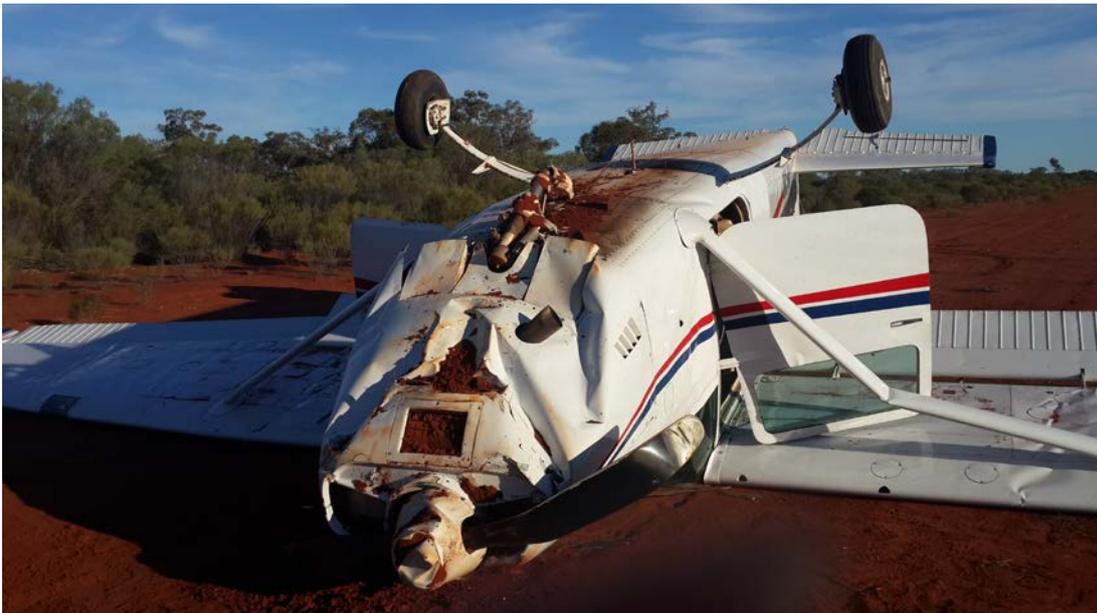
Figure 1: Accident site of Cessna 182, VH-AHC

When on final approach to land, at about 5 ft above ground level, the aircraft sank rapidly. The aircraft landed heavily and the nose wheel detached from the aircraft. The aircraft then bounced into the air, touched down for a second time, and dug into soft ground. The aircraft flipped over and came to rest inverted, resulting in substantial damage (Figure 1). The pilot and two passengers sustained minor injuries.

The pilot was unsure what caused the aircraft to sink faster than usual. The wind was light and variable. The additional sink and high rate of descent combined with the soft surface led to the aircraft landing gear digging in and flipping the aircraft over.

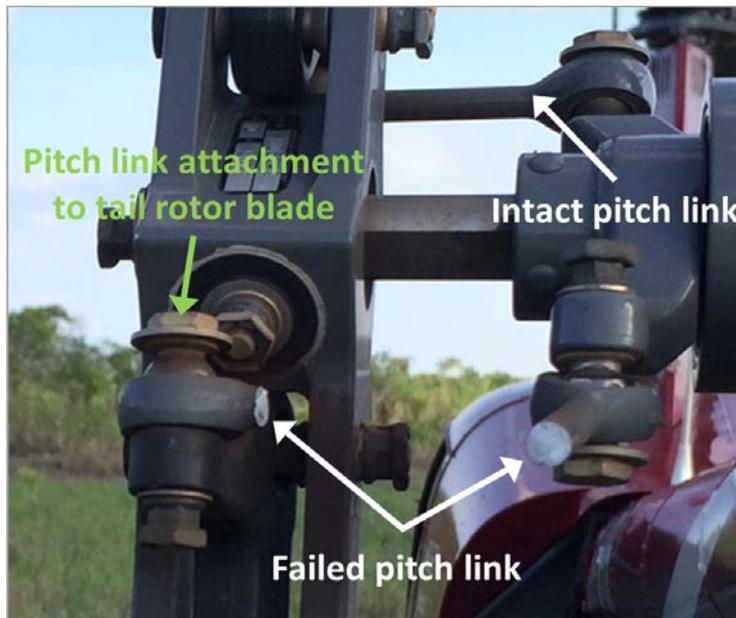
Figure 1: Failed tail rotor pitch link

After landing, the pilot observed that the tail rotor pitch link¹ had failed (Figure 1).

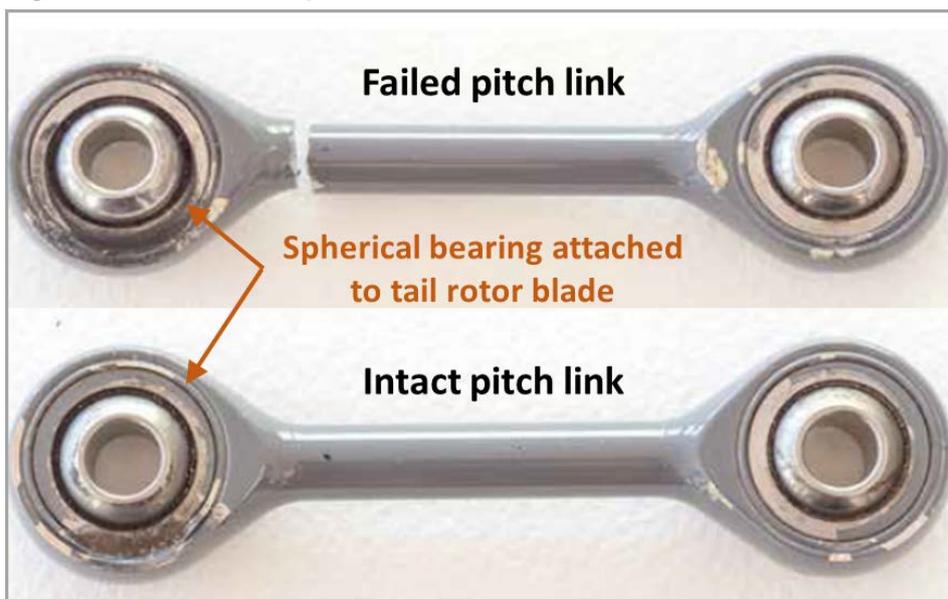
Figure 2: HPH tail rotor pitch links

An examination of the tail rotor pitch links was conducted on behalf of the helicopter operator by a consultant in engineered-system failure analysis and the following was found (Figure 2):

- Alternating stress in the failed pitch link resulted in the initiation and propagation of a fatigue crack.
- The alternating stress in the pitch link resulted from failure of the spherical bearing to provide a low friction connection between the end of the tail rotor blade and the pitch link.

- No physical explanation was found as to why the specified inspection procedures (*R22 Maintenance Manual*, Chapter 2 Inspection, section 2.410) failed to detect bearing wear. Possible explanations beyond what could be ascertained by the examination were that the helicopter was operated in an exceptionally abrasive environment or the Teflon bearing lining was affected by some cleaning action.

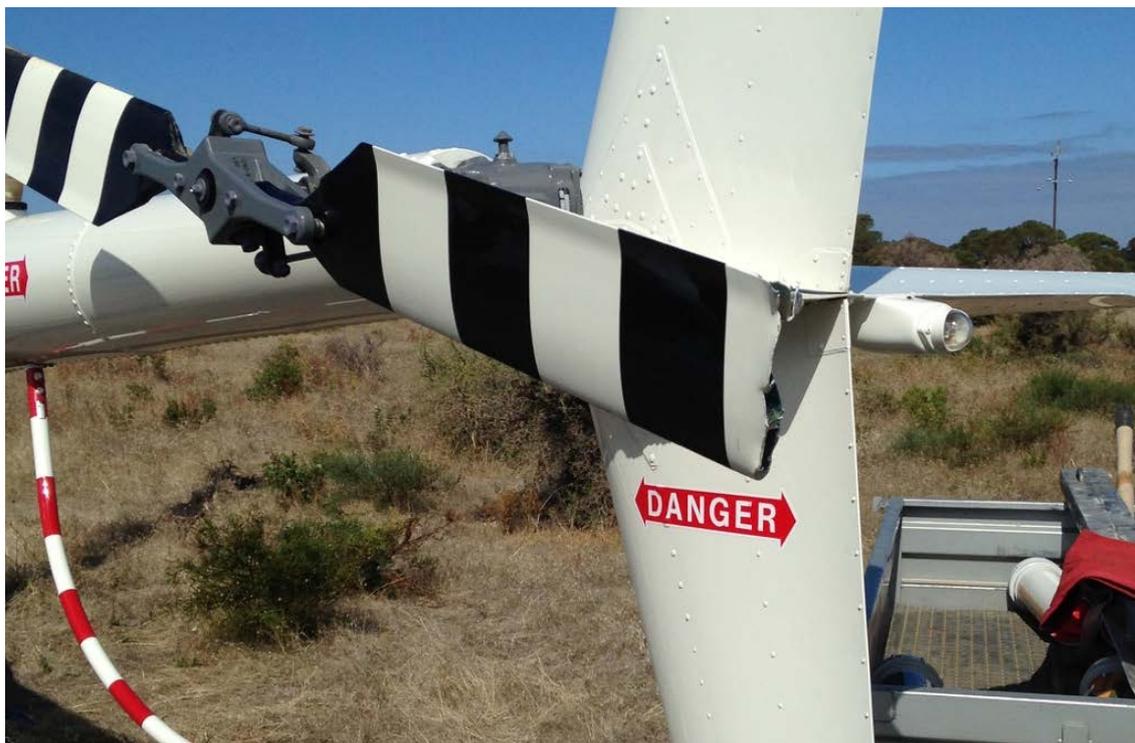
Figure 1: Tail rotor blade damage to VH-LOL

Also on board were client representatives who were directing the noxious weed management operation and manually dispensing the chemical into each bush. In the course of traversing the field at low level in search of the weed, the helicopter struck a previously unidentified power line. The helicopter's main rotor blade made initial contact with the power line and during the avoidance manoeuvre, the tail rotor blades also made contact, severing the blade tips (Figure 1). The pilot landed the helicopter safely. The helicopter was substantially damaged but the occupants were uninjured.
