# Air Safety Investigations

# Safety briefs

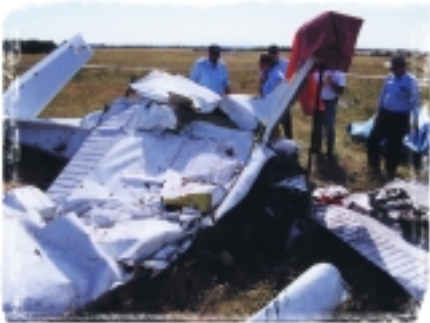
Four young people on a private flight were fatally injured on 1 December 1999 when the pilot apparently lost control of the aircraft following a stall during unbalanced flight.

Witnesses reported that the aircraft had conducted steep turns at different stages of the flight. Radar information showed that between the times 1432 and 1435 the aircraft was flown in a sequence of left turns through 360 degrees between 1,900 feet and 2,300 feet above mean sea level near the accident site. The elevation of the accident site was 1,350 feet.

Shortly after the aircraft was reported to head north and adopt a nose high attitude before entering a steep turn to the left. The bank angle steepened as it passed through a westerly heading and the nose dropped. The aircraft was heading approximately south in a near vertical, nose-down attitude when it impacted the ground.

An analysis of the prevailing weather conditions and surrounding terrain suggested that the aircraft was probably operating in turbulent conditions. This would have made it very difficult for the pilot to maintain balanced flight. The manoeuvre described by witnesses was consistent with the aircraft stalling during the steep turn with insufficient height to effect recovery. ■

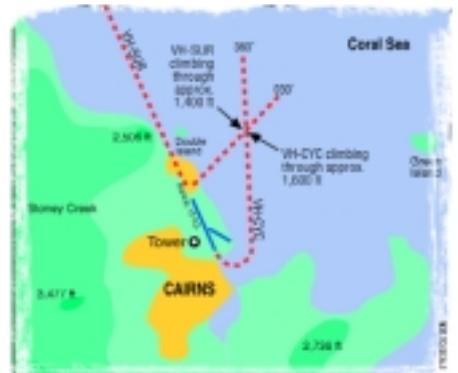
A Shorts SD360-300 and a Cessna 208 came within 100-200 feet vertically and about 70 metres horizontally at Cairns airport on 12 March 1999 following intense flying activity in cloud, heavy rain and severe turbulence.

The Cessna had been cleared to execute a standard instrument departure and the Shorts commenced a missed approach. The missed approach and departure tracks at Cairns were within a 40 degree sector to the north east due to terrain constraints. The two aircraft crossed tracks at approximately 2 nm north east and were only able to avoid further conflict when they entered a clear area at the same time and the crews sighted each aircraft.

Other factors that contributed to the incident included air traffic control instructions that placed the departing Cessna in direct conflict with the runway 15 missed approach path; lack of positive separation techniques between the aerodrome and the approach controllers; and a lack of ongoing refresher training for tower controllers in emergency and unusual situations.

On 17 June 1999 Airservices Australia introduced a new missed approach procedure that changed the outbound heading from 030 to 015 degrees, and a restriction to the heading for departure to 030 degrees when missed approaches are likely. Regular emergency training sessions for controllers have also been implemented. ■

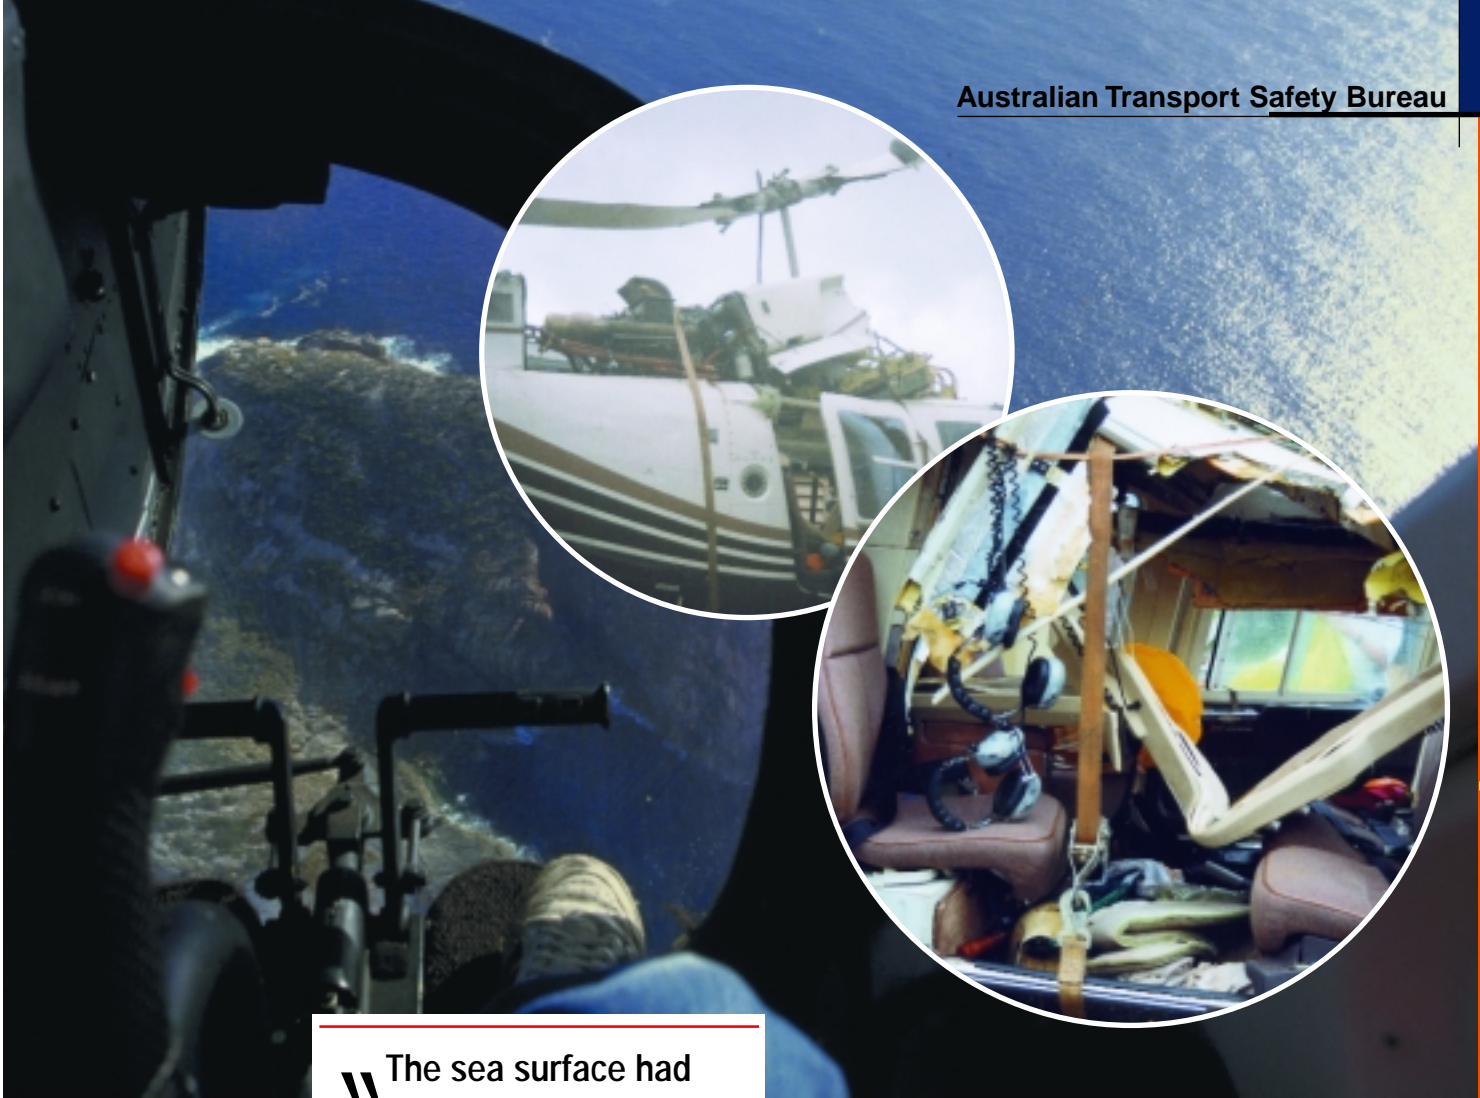
\\ The sea surface had

become completely flat and  
featureless and had  
blended entirely with  
the rain //

The pilot reported that the visibility during the return flight from Green Island was the worst that he had ever experienced. The sea surface had become completely flat and featureless and had blended entirely with the rain. By that time it was too late to turn around.
