# Data entry error and tailstrike involving Boeing 737-838, VH-VZR

Sydney Airport, New South Wales | 1 August 2014

**ATSB Transport Safety Report**  
Aviation Occurrence Investigation  
AO-2014-162  
Final – 16 November 2015

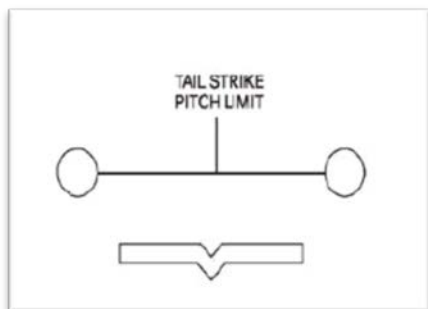
During rotation, the aircraft tail strike pitch limit symbol will appear when the aircraft is approaching the tail strike angle. As well as the tail strike pitch limit indication, the aircraft reference symbol is also displayed and if the two symbols come in contact, a tailstrike has probably occurred (Figure 1).

**Figure 1: Tail strike pitch limit symbol (dumb bell) and aircraft reference symbol as displayed on the HGS**
