Loss of control following partial engine failure involving amateur-built Rand Robinson KR-2 VH-CTE

12 km west of Tumut | 5 October 2013

ATSB Transport Safety Report
Aviation Occurrence Investigation
AO-2013-174
Final – 17 November 2015

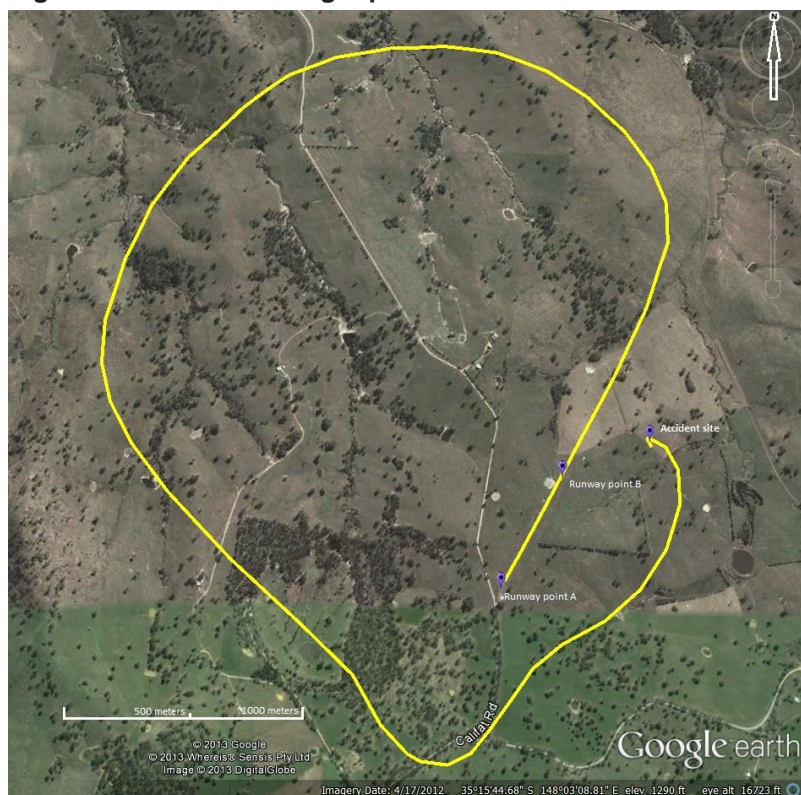
Figure 1: GPS-derived flight path of VH-CTE

A portable Garmin Pilot III global positioning system (GPS) satellite navigation receiver was found in the wreckage. The GPS held recorded data for a number of flights, including flight path data for the day of the accident (Figure 1). The accident data started at 0853:21. It recorded the aircraft departing the airstrip towards the north-east before turning left onto a south-westerly heading. At a point adjacent to the downwind threshold of the airstrip the aircraft turned left 90° and tracked south-east. The aircraft then turned left again to make what appeared to be a close-in left downwind leg. This appears consistent with positioning to land toward the south-west, the opposite direction to that used for the take-off. The data showed that in the last 20 seconds of the flight, the aircraft's groundspeed was steady at about 63 kt before rapidly decreasing during the final left turn. The recorded data indicated that the aircraft impacted terrain at about 0900.

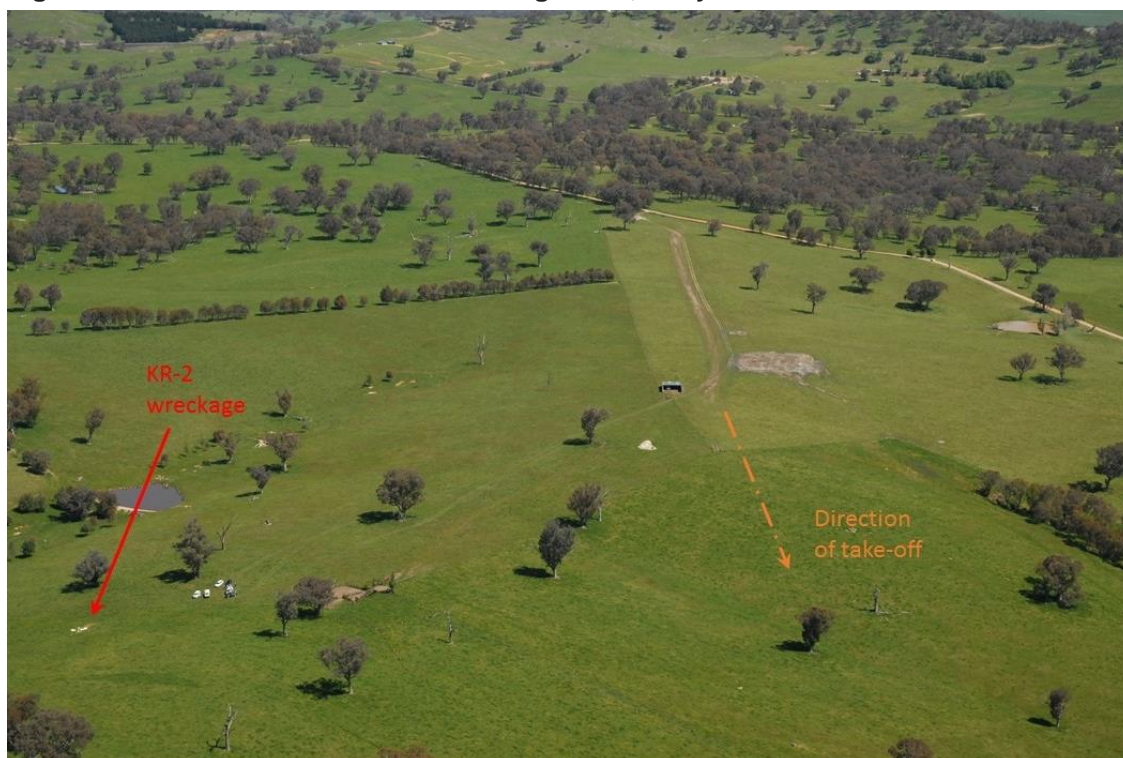
Figure 2: Overview of accident site looking south, away from the direction of take-off

The aircraft, a Rand Robinson KR-2 (KR-2), impacted terrain about 450 m to the east-north-east of the northern end of the Adelong airstrip (Figure 2).

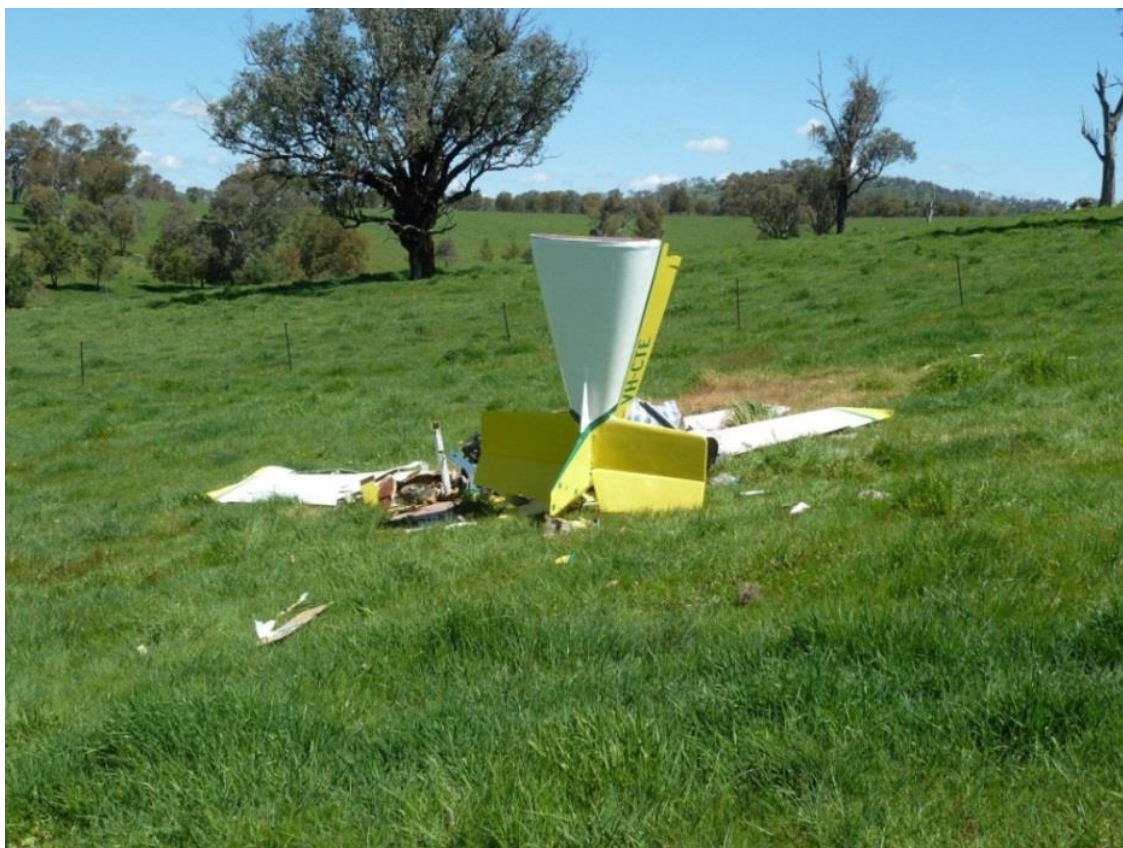
Figure 3: Aircraft wreckage

Examination of the aircraft wreckage (Figure 3) determined the following:

- All components of the aircraft were located at the impact site.
- The aircraft was in a left wing-low, steep nose-down attitude and heading in a south-westerly direction on impact.

- Damage to the landing gear was consistent with the landing gear being extended at impact.
- The position of the flap could not be determined.
- All flight controls appeared to be intact and securely connected at impact. The position of the aircraft's electrical elevator trim at impact could not be determined.

- The engine was producing low or no power at impact.
- The engine controls were disrupted by the impact and their position at impact was uncertain.
- There appeared to be sufficient fuel remaining on board the aircraft at impact.

- The number three cylinder upper spark plug (No.3 upper) was dislodged from its cylinder head hole. The spark plug remained attached to the engine through the spark plug lead and the engine cylinder head temperature gauge wiring. The dislodgment was not a result of impact forces.

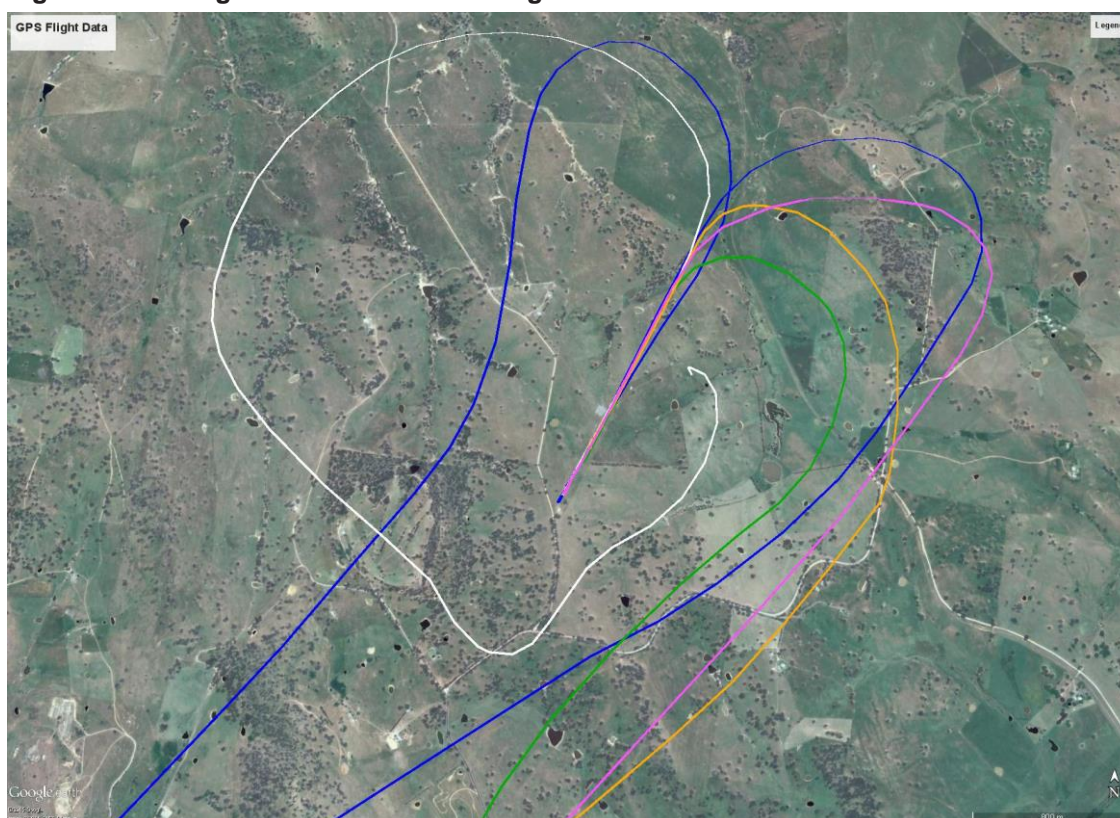
Figure 4: GPS flight data with accident flight shown as the white track

The GPS unit found in the wreckage contained data for a number of flights. These recorded flights were consistent with reports and observations of flights that the pilot conducted in CTE. The data included the accident flight. The flight recordings identified that the pilot would depart the Adelong airstrip to the north-east before turning left and setting heading for Holbrook. For the return legs, the pilot would position the aircraft for a left hand circuit to land to the south-west. A comparison of the recorded circuits for landing at the Adelong airstrip is at Figure 4. The flight profiles are for flights that departed Holbrook and landed at Adelong, with the following exceptions:

- the accident flight (white)
- a flight that departed Adelong and then turned back to the Adelong airstrip from a position near Holbrook (blue).

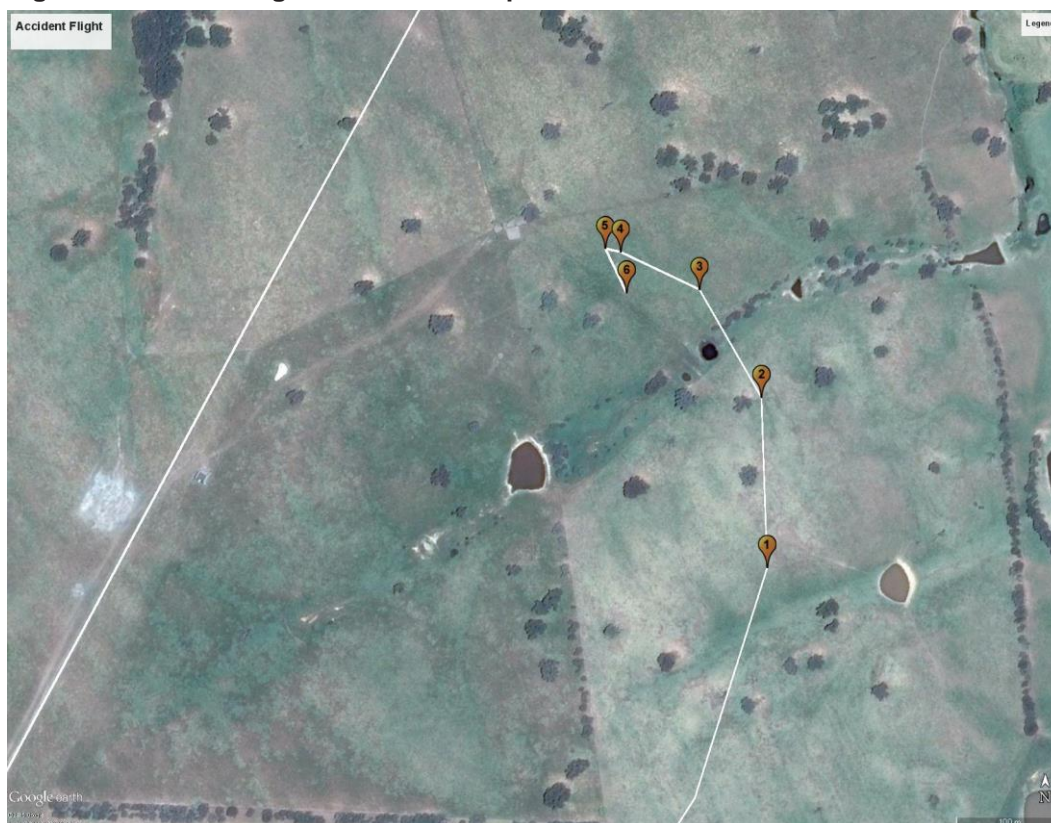
Figure 5: Accident flight with final data points from Table 1

The data for the accident flight was analysed to determine the aircraft's flight profile. The data is presented at Table 1 and graphically presented in Figure 5. The following conditions and limitations apply to this data:

- There was no vertical component (altitude) in the GPS data.
- The positional data with associated time enables ground speed to be determined. The actual airspeed may be greater or lesser due to wind as well as any vertical component of the aircraft's velocity vector.
- The wind component is unknown, however, the meteorological data and local reports identify that the wind was probably calm.
- The track, groundspeed and bank angle values are derived values based on the latitude/longitude and time data provided by the GPS.
- Based on the GPS data, the estimated time of impact was at 0859:55.

The following observations in relation to the accident flight are also of note. The ground speed for the majority of the flight was between 58 kt and 70 kt, except for the last 8 seconds of flight. The average angle of bank remained below 10°, except:

- when the pilot turned towards the north-east onto a downwind heading, where the bank angle increased to just under 25°
- during the last 13 seconds of flight.
