Derailment of freight train 2AD1

Near Hugh River, Northern Territory | 23 December 2014

ATSB Transport Safety Report

RO-2014-025

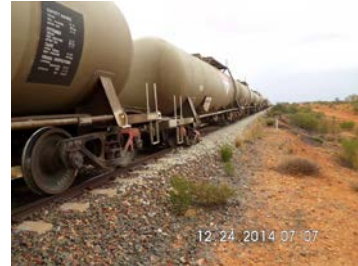
Train 2AD1 near Hugh River, NT

At about 1925 CDT¹ on 23 December 2014, GWA train 2AD1 derailed near Hugh River, Northern Territory. The derailment resulted from an axle bearing failure on wagon PTMY 6-T. The wagon, carrying distillate fuel, remained upright and there was some minor damage to the track (sleepers and rail clips). There were no injuries.

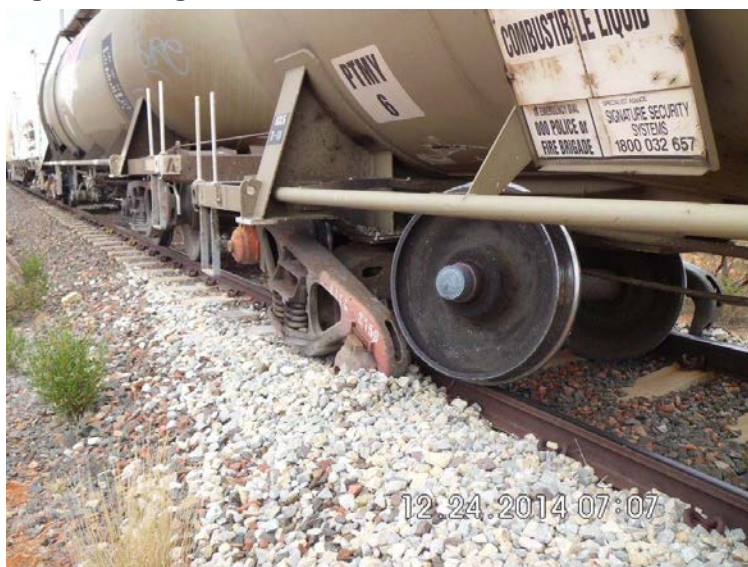
Figure 1: Wagon PTMY 6-T derailed at 1201km

The crew found that wagon PTMY 6-T (distillate tank wagon) had derailed, with the leading axle of the trailing bogie completely separated from the right hand side axle box in a manner commonly known as a screwed journal (Figure 1). The bogie had collapsed and some minor damage had occurred to the body of the wagon. The derailment caused about 1,800 m of track damage – mostly cracked concrete sleepers and damage to rail fastenings. There was no spillage of distillate from the wagon.

It was evident that a bearing on the wagon had failed and completely seized, causing the inner raceway to loose interference fit and spin on the axle journal. This generated and transferred sufficient heat into the journal to reduce its strength, make it 'plastic' and cause it to torsionally separate from the axle (an event commonly referred to as a *screwed journal*).

Post-derailment observations found that the axle box lubrication plug was missing. Neither the plug, rear seal nor the stub end of the journal were found.

- A grease nipple will be added to all axle boxes. This would ensure both the inner and outer bearings receive a more even distribution of grease when axle boxes are regreased during scheduled servicing.
- Bearings incorporating bronze cages will be progressively withdrawn from service and replaced with new steel-cage bearings.
- The GWA Work Instructions associated with bearing overhaul and preventative maintenance/inspection have been reviewed and updated to reflect the process changes.
- The updated Work Instructions have been disseminated to all affected GWA rolling stock maintenance staff, and contracted bearing suppliers and maintainers.
