In-flight engine shut down involving Airbus A330-302 B-18358

887 km ENE of Darwin | 3 October 2013

ATSB Transport Safety Report
Aviation Occurrence Investigation
AO-2013-172
Final – 10 December 2015

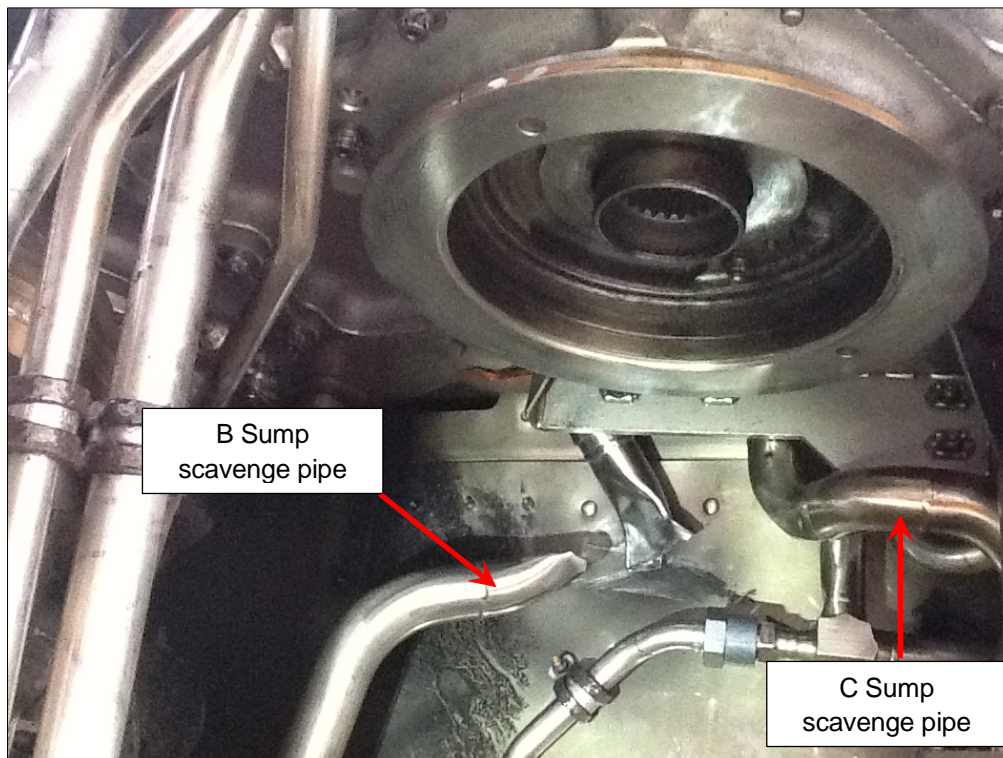
Figure 1: Damage to oil pipes visible after removal of the starter

Preliminary examination of the No. 1 engine by maintenance personnel at Cairns found that the air turbine starter had sustained an uncontained failure. Debris released from the starter had severed the adjacent B-sump engine oil scavenge pipe and damaged (without rupturing) the C-sump oil scavenge pipe (Figure 1). This resulted in the complete loss of oil from the No. 1 engine, necessitating the engine shut down.

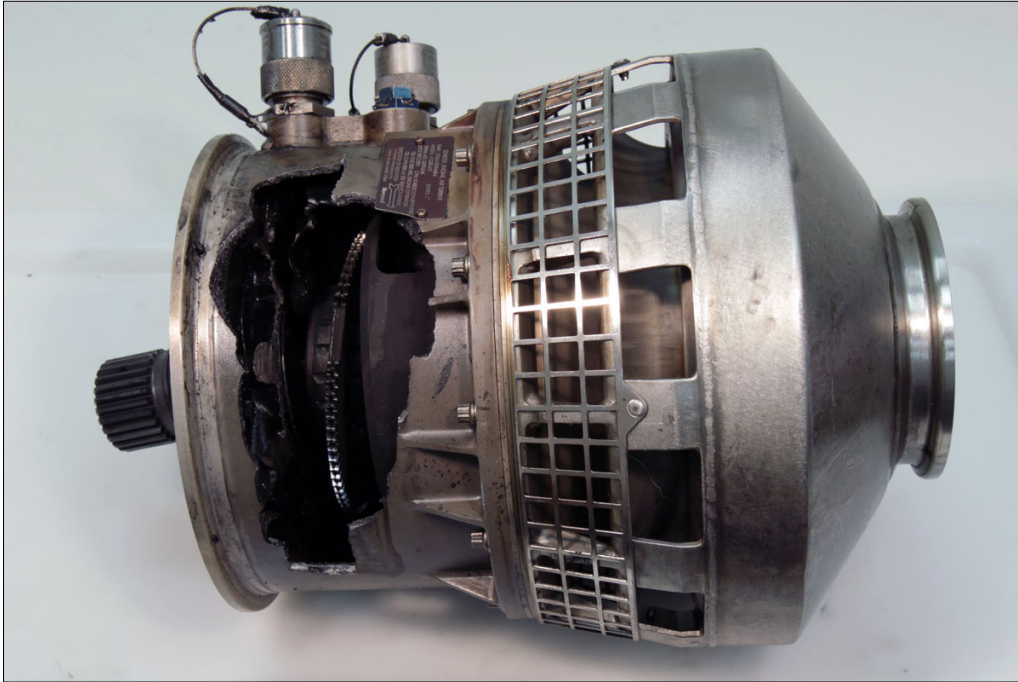
Figure 2: The air turbine starter removed from B-18358, as-recovered

Disassembly and examination of the starter was conducted by the starter manufacturer at their investigation facility and a detailed report was provided to the ATSB. The report concluded that the failure sequence was initiated by failure of the output shaft support bearing. This allowed contact between the rotating pawl carrier and ratchet, which subsequently failed, along with the hub gear. Failure of these components resulted in the fracture of the starter casing and release of debris with enough energy to sever the adjacent B-sump scavenge pipe on the engine.

Recovered output shaft bearing components were limited to fragments of the bearing cage, one fractured ball and one ball with significantly reduced diameter. The inner and outer bearing races were extensively damaged, but intact. It was likely that the output shaft continued to run for some time after the loss of oil, which caused additional damage to the bearing. It was therefore difficult to accurately assess the bearing failure mechanism. Nevertheless, the report indicated that based on analysis of the starter components, the most probable factor contributing to failure of the output shaft bearing was damage caused by a prior crash-engagement³ of the clutch.

The single pawl and ratchet clutch design has also been superseded, with the replacement design being much less susceptible to this type of failure.
