Wire strike and impact with terrain involving a Cessna 182L VH-TRS

Burrumbuttock, New South Wales | 20 July 2014

ATSB Transport Safety Report
Aviation Occurrence Investigation
AO-2014-131
Final – 14 December 2015

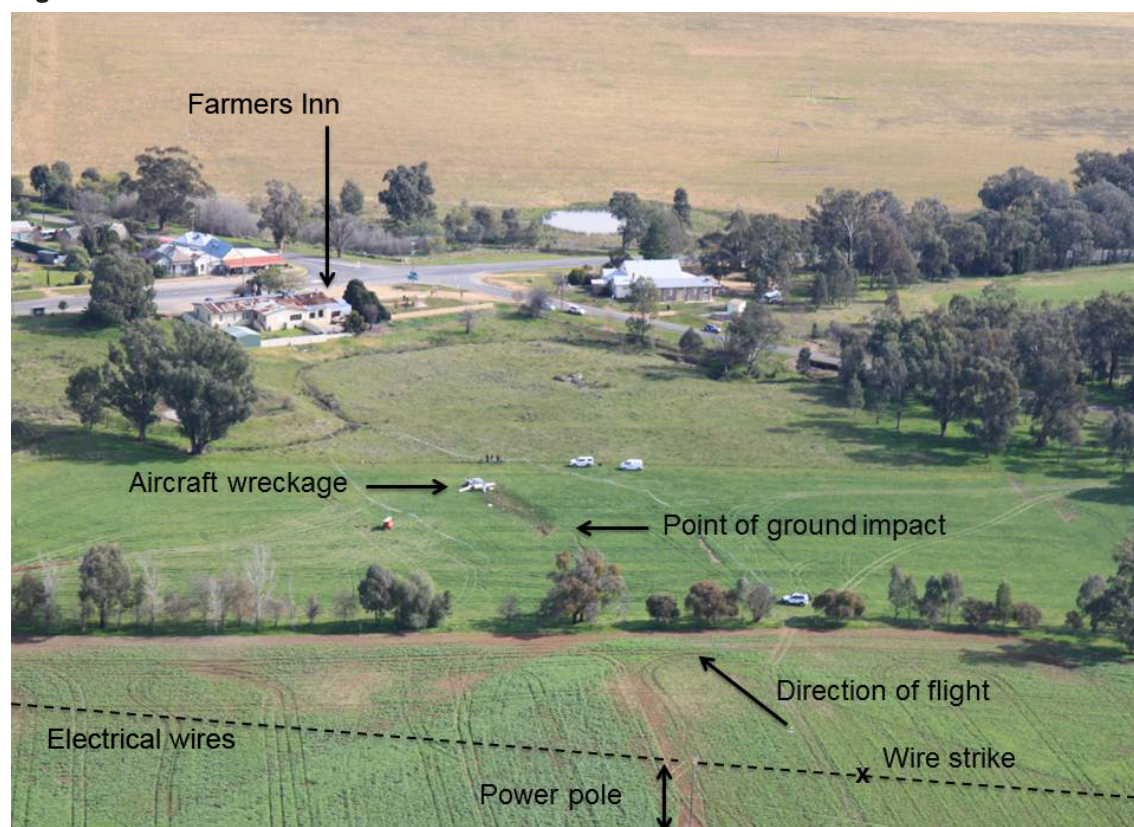
About 30 minutes into the flight the aircraft was observed to be flying at a low altitude above the ground in a westerly direction toward Burrumbuttock. At 1733, the aircraft struck two energised electrical wires from a powerline in a paddock that bordered the town. The aircraft continued on for a short distance before it impacted terrain in a steep nose-down inverted attitude, stopping short of the Burrumbuttock 'Farmers Inn' hotel (Figure 1).

Figure 1: The accident site at Burrumbuttock

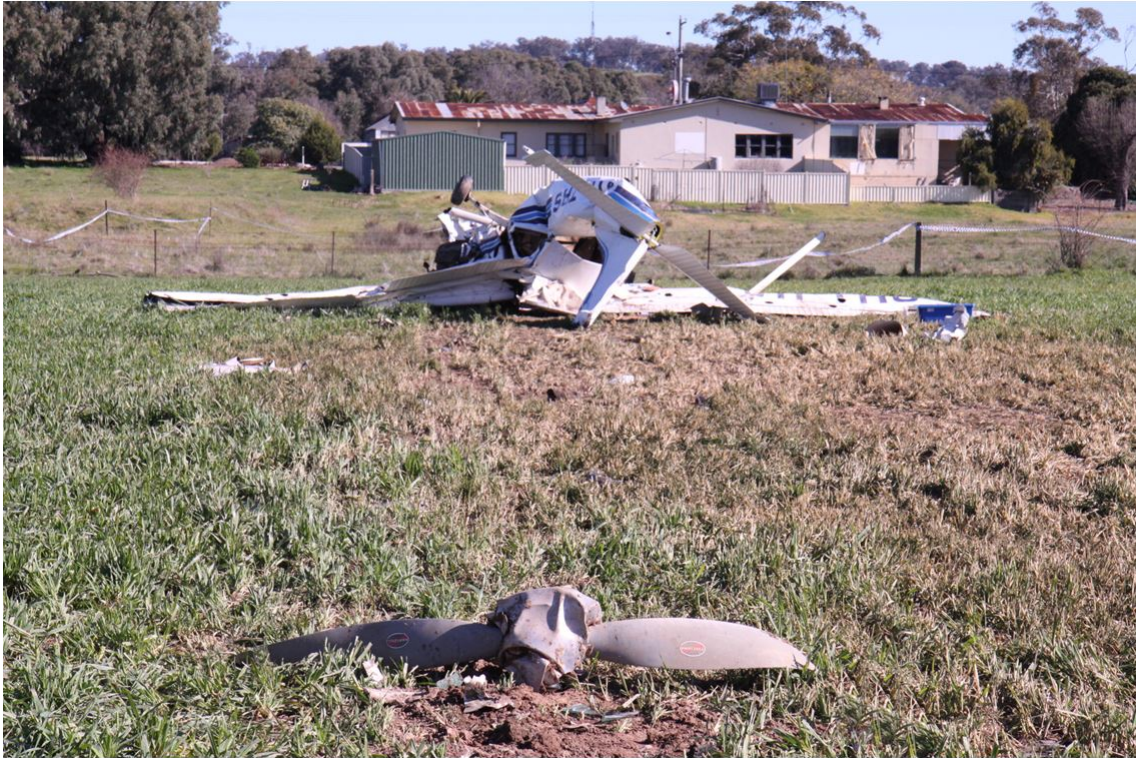
The aircraft structure had sustained severe damage from ground impact forces (Figure 2). Both wings were compressed and the tail section had buckled midway along its length. Upon contact with the ground, the nose and front section of the aircraft took the majority of the impact loads, breaking the engine mounts and compromising the survivable cockpit space. The pilot's seatbelt assembly was locked and secure.

Figure 2: The aircraft impacted terrain near the Farmers Inn hotel. The aircraft was inverted at impact and the propeller separated from the engine

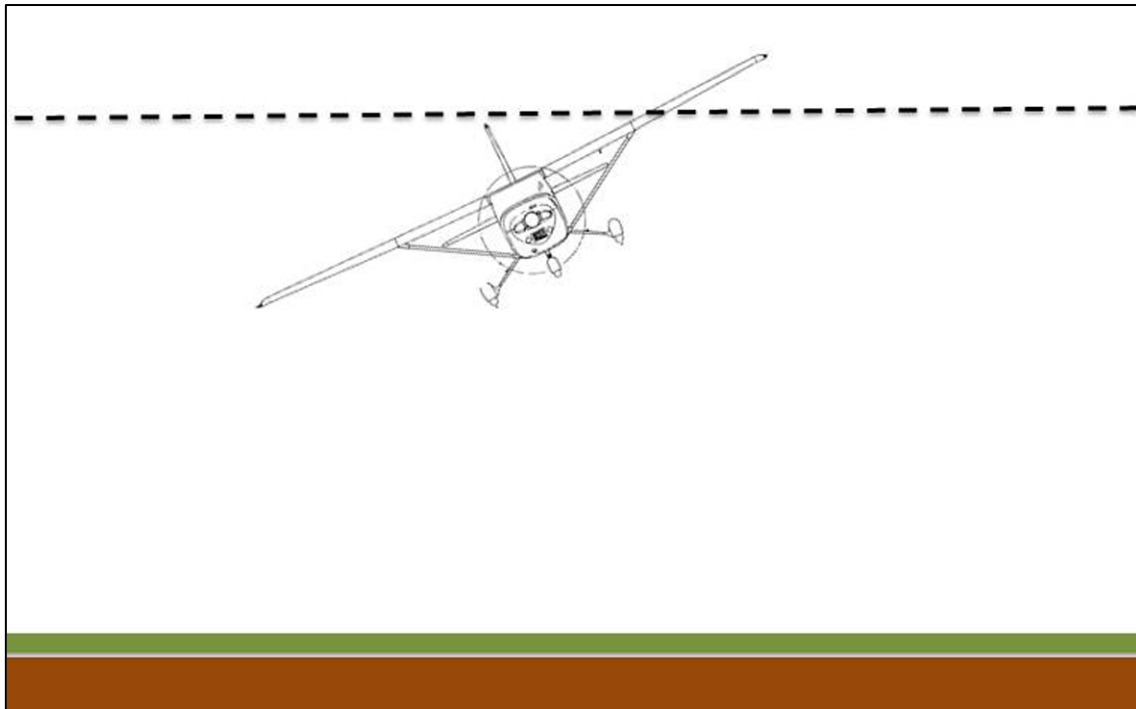
A significant quantity of fuel had leaked from the damaged wing fuel tanks. The front spar from the left wing displayed saw marks and tearing that was consistent with striking the powerline. The marks commenced at the strut-to-spar connection and their general orientation indicated that the aircraft was probably right-wing low at the time of the wire strike (Figure 3).

Figure 3: Illustration showing the likely aircraft orientation at the time of striking the powerline

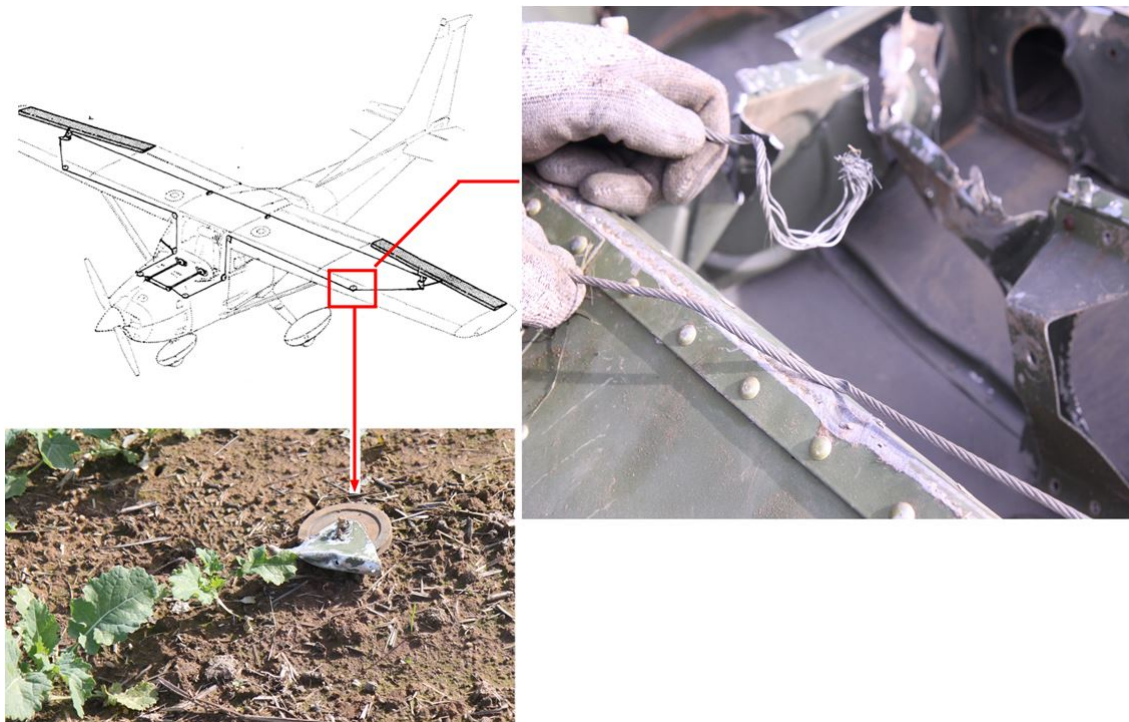
All of the primary structures and controls were accounted at the accident site. With the exception of the left aileron cable, flight control continuity was established and no pre-impact defects were identified. The left wing aileron cable had fractured in overstress coincident with the strut-to-front spar connection (Figure 4).

Figure 4: The aircraft's left wing leading edge structure including the aileron guide pulley and cable, was damaged from contact with the powerline

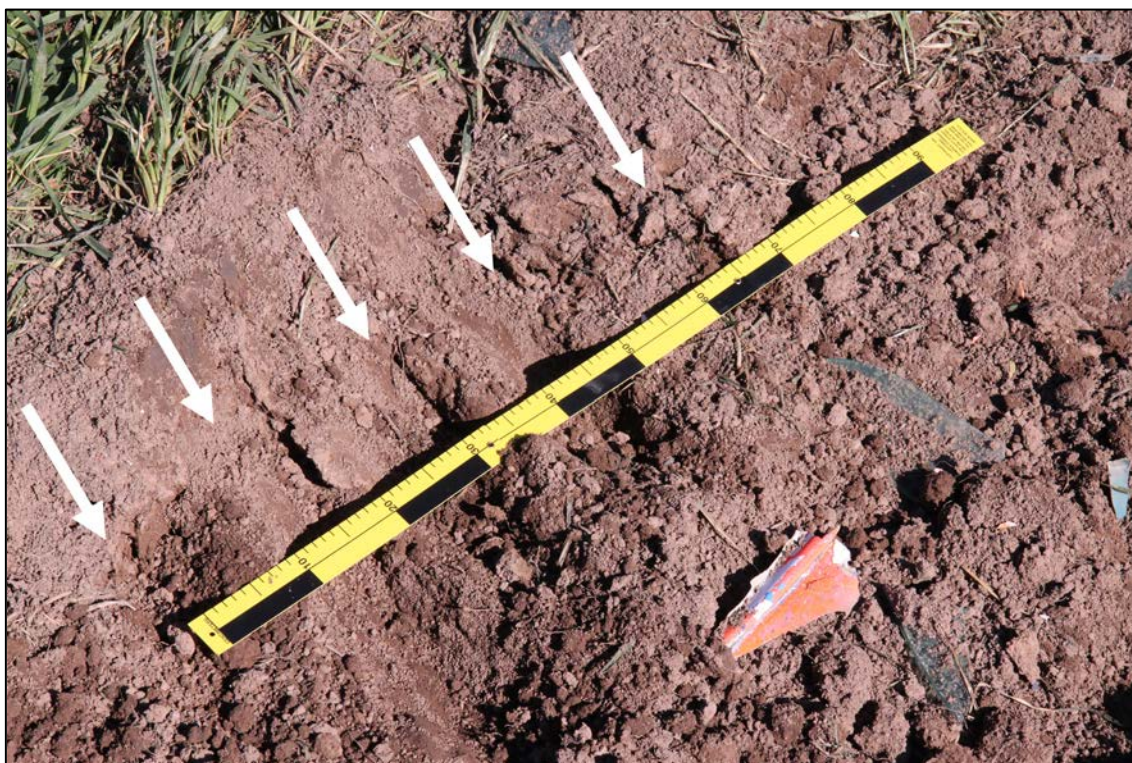
Analysis of propeller damage can provide evidence of the operational state of an aircraft's engine at the time of any collision with terrain. In this instance, the engine was severely disrupted during the accident sequence and the propeller had separated from the crankshaft and was embedded in soil a few metres forward of the initial point of ground impact. Both blades from the propeller exhibited chordwise scoring and a degree of bending and twist that was consistent with being operated under significant torque at the time of the accident (Figure 5).

Figure 5: Propeller slash marks (arrowed)

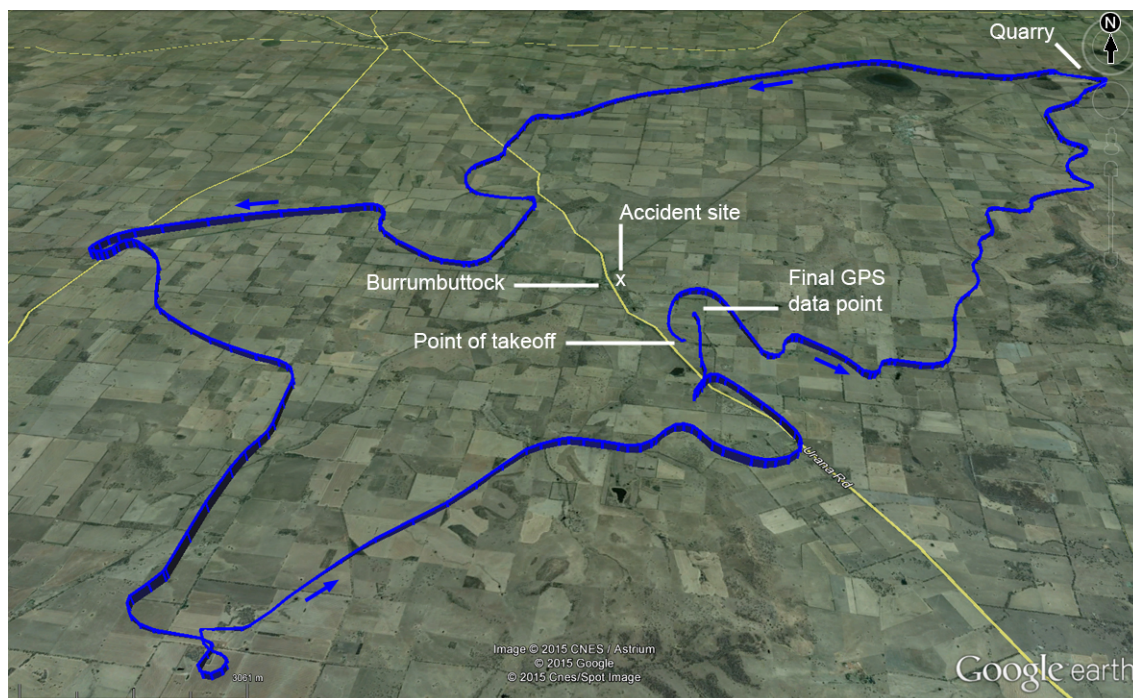
- The accident flight data (Figure 6) captured a number of low-altitude and aerobatic manoeuvres, including an extremely low-level pass into a quarry, located north-east of Burrumbuttock. Previous flight data showed that the pilot had conducted that manoeuvre previously.

- The final recorded GPS track point for the accident flight was written at 1731, approximately 2 minutes prior to the accident. The aircraft altitude at that time was approximately 420 ft above ground level. The ATSB was unable to determine why the GPS ceased recording data at that point.

Figure 6: Accident flight path noting that the final 2 minutes of data was unable to be recovered

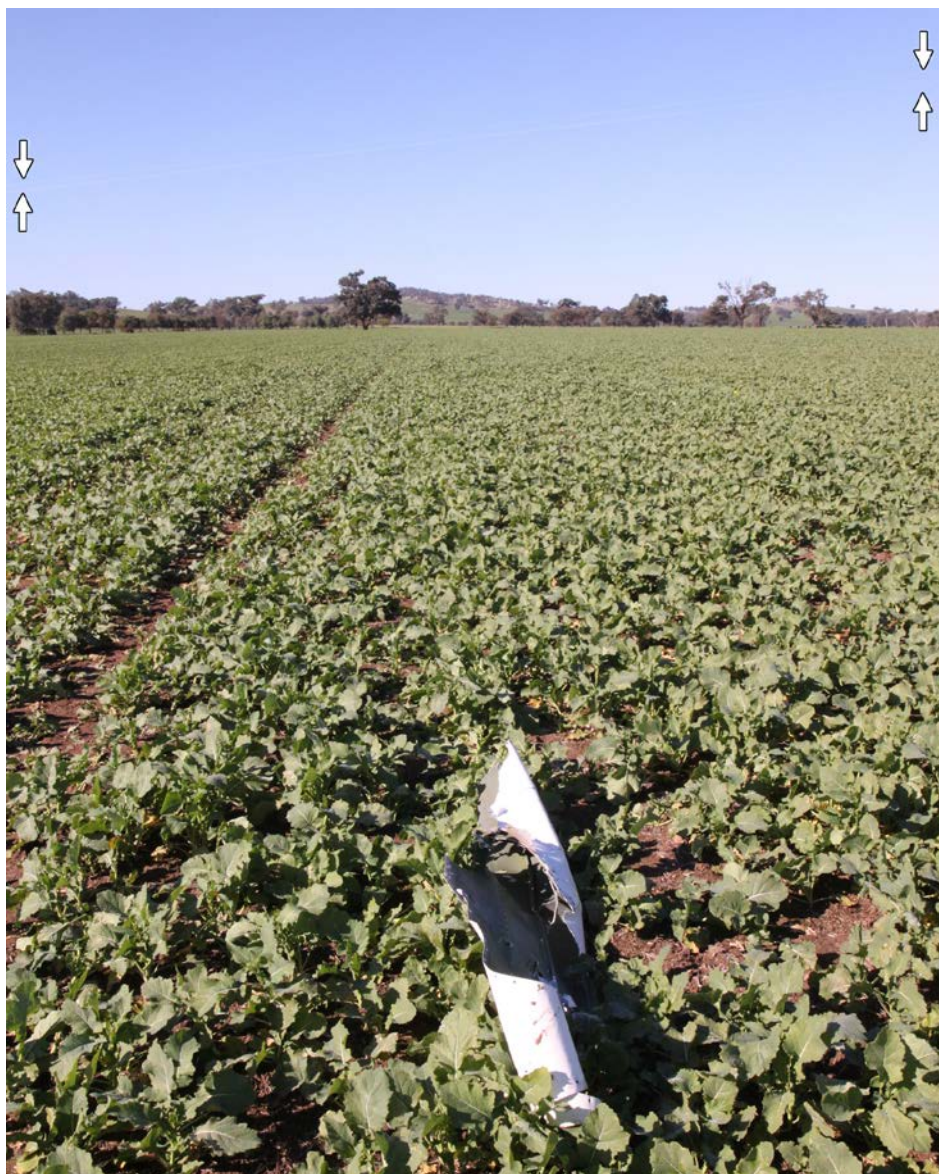
The aircraft's impact with the powerline dislodged both electrical wire conductors from their insulated tie-off points atop the cross-arm of one of the poles. One of the wires was severed from the impact and a large current fault was recorded at 1733:08 by the company's electrical system. On-site measurements showed the point of impact to be 30 m to the nearest wooden pole and the wire height at the point of impact was estimated to be 9.5 m above the ground.

Figure 7: The powerline (electrical wires arrowed) looking back along the flight path. A piece of the leading edge skin from the left wing is also shown
