Near collision between an Extra 300L, VH-KCF and a Robinson 44, VH-OLG

Bankstown Airport, New South Wales, 15 July 2015

ATSB Transport Safety Report
Aviation Occurrence Investigation
AO-2015-080
Final – 22 December 2015

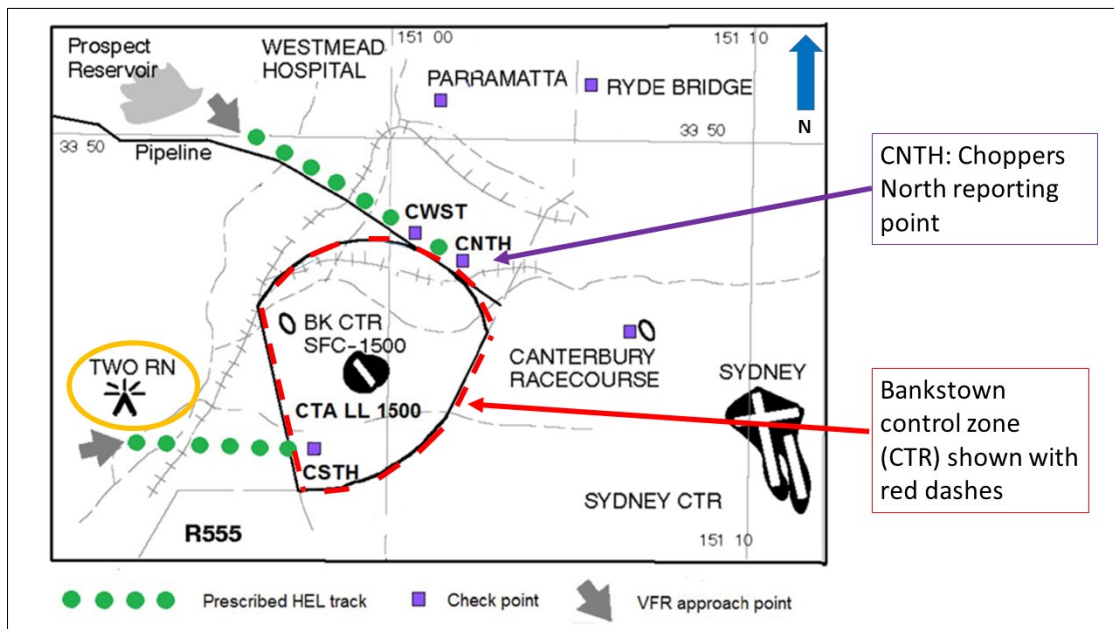
Figure 1: Helicopter inbound procedures diagram for Bankstown Airport. Note the Choppers North inbound reporting point as used by VH-OLG (purple arrow). On this occasion, VH-OLG was inbound from the northeast. TWO RN, the inbound reporting point for VH-KCF is also marked (yellow circle)

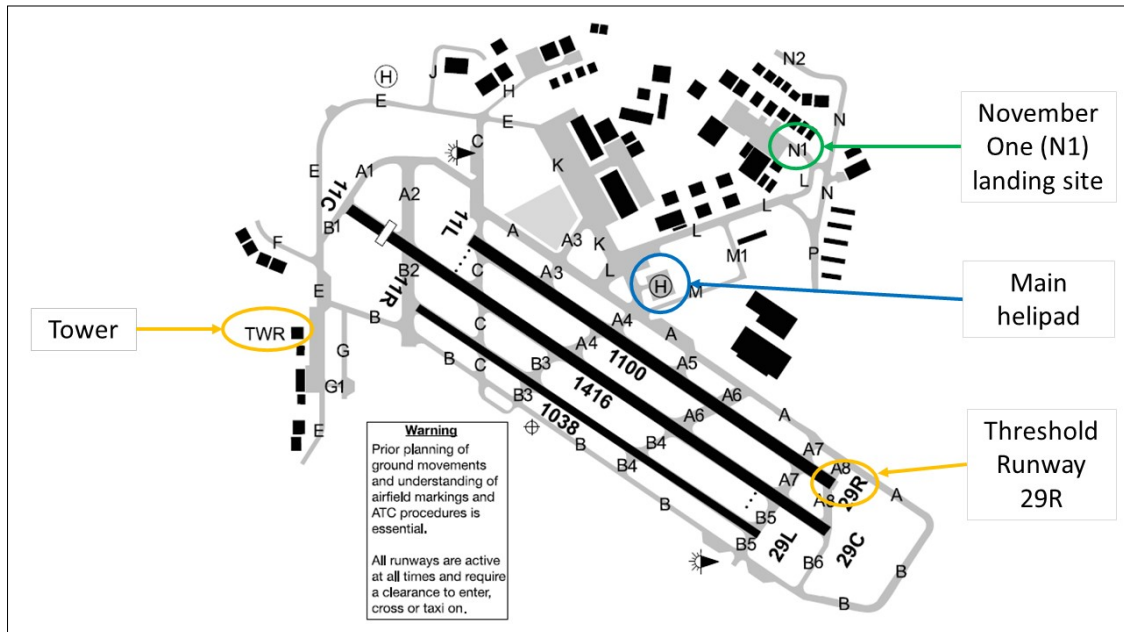
An N1 arrival could only be conducted by appropriately trained and qualified pilots (such as the pilot of the R44). The arrival allowed a visual approach from the helicopter circuit altitude of 700 ft via an oblique approach to taxiway N1 (Figure 2). In an N1 arrival, the Tower were unable to see a helicopter during the latter part of the approach. So the pilot was required to advise the Tower when they had landed.

Figure 2: Bankstown Airport showing the N1 taxiway used as a landing site for a November One arrival (green)

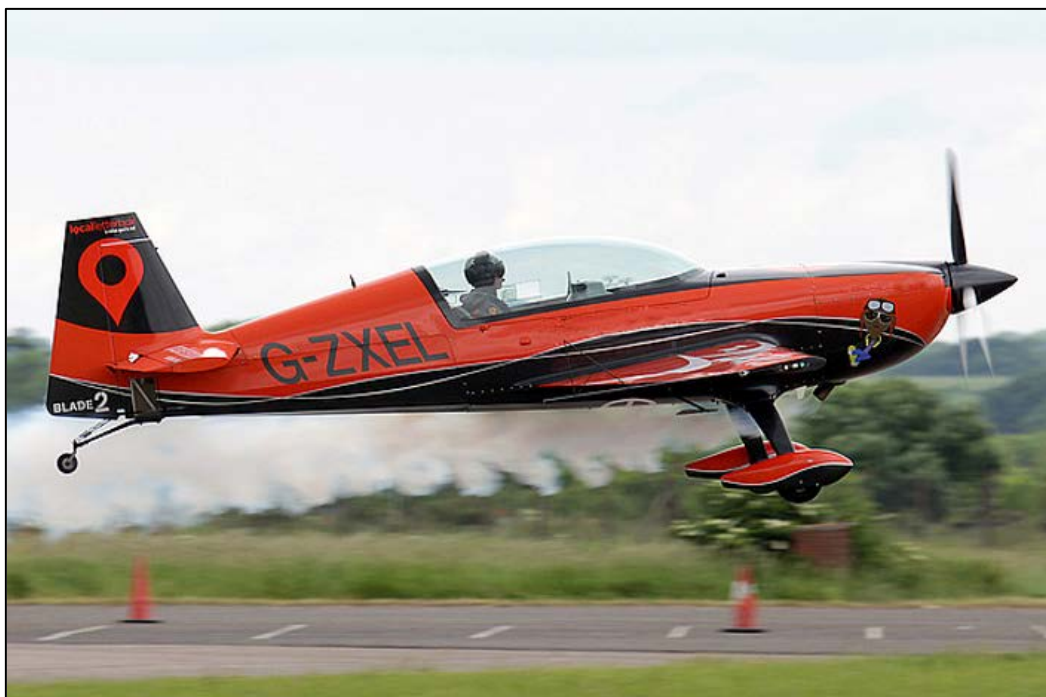
Figure 3: An example of an Extra 300 L aircraft showing the seating position of the pilot. This gives an indication of the reduced visibility with the aircraft nose slightly raised, which occurs when the aircraft is at a slower speed

When flying the Extra, as on this day, the pilot completed a continuous descent once cleared for a visual approach on downwind. As per normal in the Extra, the pilot side-slipped the aircraft down final approach. Side-slipping allowed the pilot better forward visibility at the slower approach speed, while also keeping the runway threshold continuously in sight.

The pilot commented that they thought that the pilot of the Extra would not have been able to see the helicopter during the sideslip.

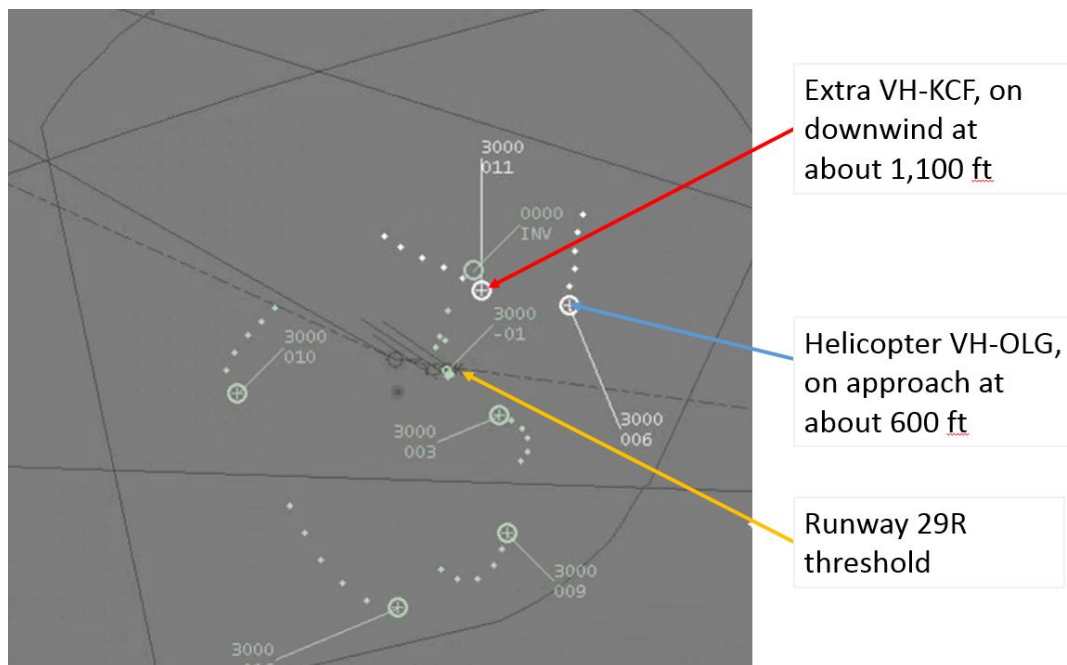
During the descent and sideslip of the Extra, the pilot of the R44 continued their descent at about 100-150 fpm toward N1. While descending through about 350-300 ft, the passengers and pilot on the R44 saw the underside of the Extra pass from right to left in front of the helicopter. They estimated it was within 100 ft of the R44's altitude and about 70-100 m in front of them (Figure 5).

Figure 5: Radar plot showing both aircraft approaching their relative landing areas

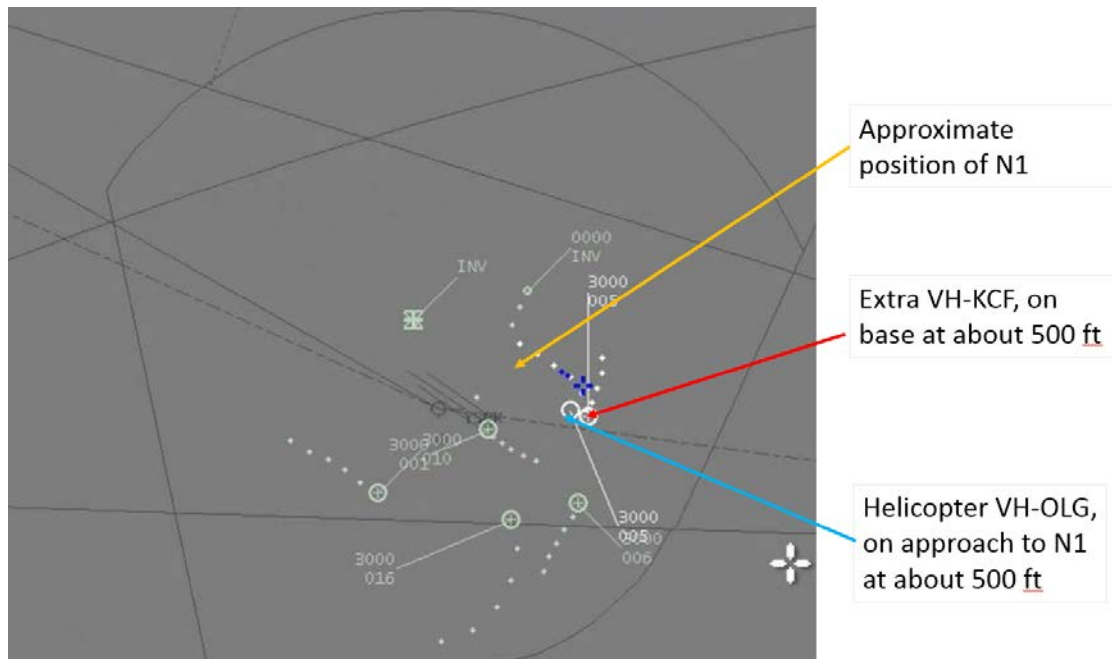
Figure 6: Radar plot showing the R44 VH-OLG (light blue) at about 500 ft tracking toward N1 and VH-KCF (red) on a continuous descending approach to runway 29R
