Australian Transport Safety Bureau

Loss of control involving a Robinson R44 helicopter, VH-ZWA

Darwin Airport on 7 October 2015

ATSB Transport Safety Report
Aviation Occurrence Investigation
AO-2015-117
Final – 22 December 2015

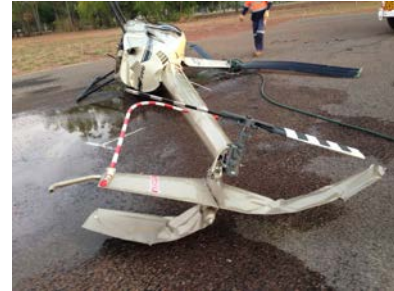
VH-ZWA on right side

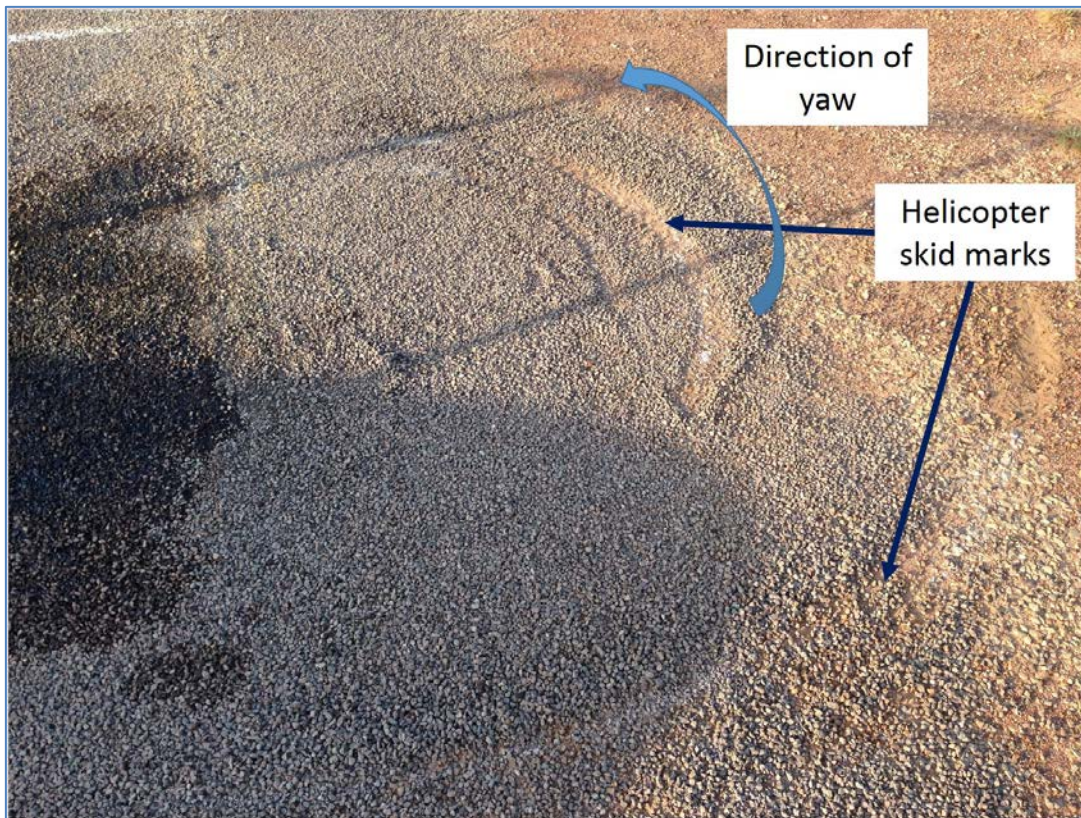
Figure 1: Skid marks made by VH-ZWA yawing to the left

However, the helicopter continued to yaw left rapidly, through about 90° (Figure 1). The pilot applied full right pedal but the helicopter did not respond and continued the yaw, through about 180°, before falling onto its right side. The pilot, who sustained minor injuries, quickly exited the helicopter and the helicopter was substantially damaged (Figure 2).

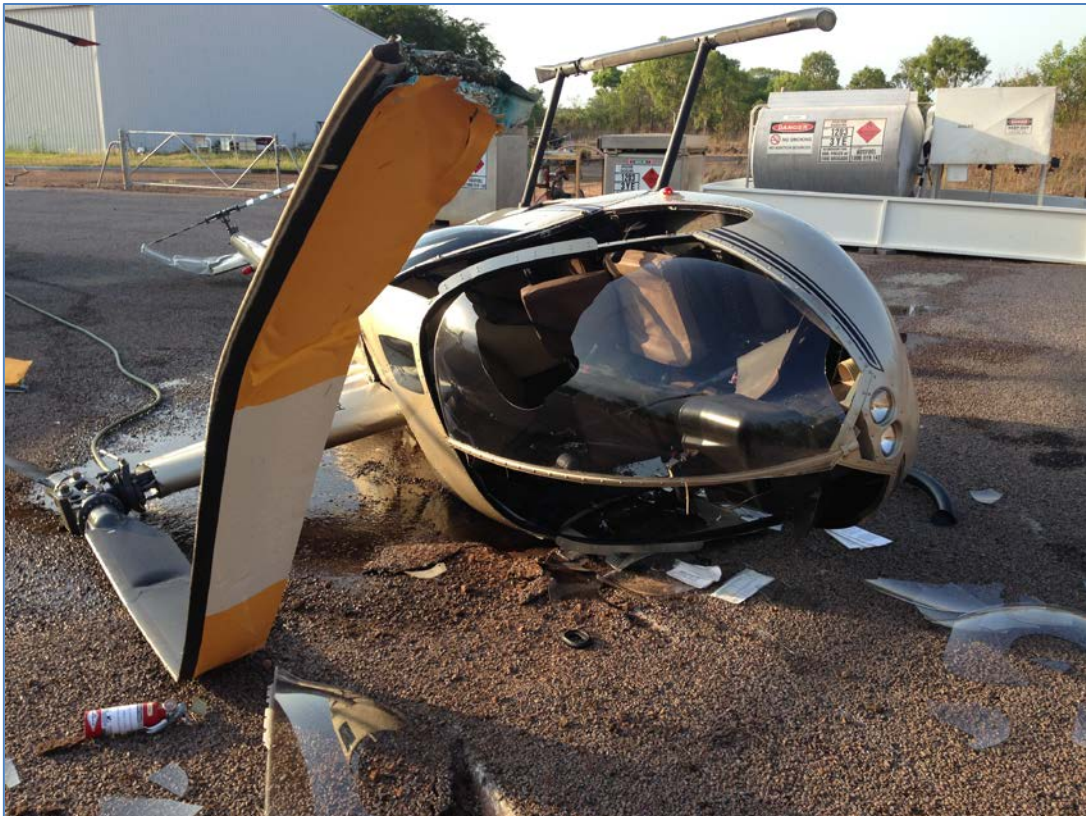
Figure 2: VH-ZWA on right side showing damage to main rotor and cabin

- at the time of the accident, not understanding why the helicopter turned to the left, or yawed so rapidly, particularly after full right pedal had been applied. The pilot later reflected that the pedals must not have been as neutral, as first thought and that this had allowed the yaw leading to the resultant loss of control
- suggesting the left yaw may have been from the collective lock being jammed under the collective just enough for the control to feel fully down, but actually have sufficient play to allow the yawing movement.
- felt that the helicopter falling onto the right side was consistent with dynamic rollover

All pilots recruited with under 500 hours total time and / or 30 hours in the previous 90 days, must fly with a Grade 1 instructor. This flight is to assess the pilot's practical and mental status. The Grade 1 instructor is to provide a report on the flight to the Chief Pilot prior to the new pilot undergoing company induction.
