Derailment of track maintenance vehicles

Singleton, NSW | 11 June 2015

ATSB Transport Safety Report
Rail Occurrence Investigation
RO-2015-010
Final – 6 January 2016

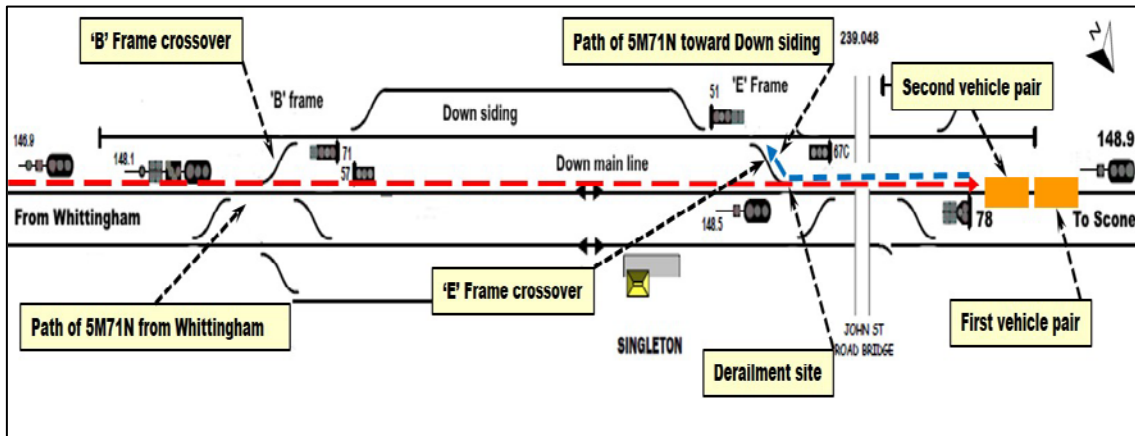
Figure 2: Singleton yard simplified track and signal layout

Simplified track layout of Singleton yard showing path of 5M71N. The two pairs of vehicles entered from Whittingham and stopped between signals 78 and 148.9. Once the points in the E Frame crossover were set, the vehicles reversed direction of travel to enter the Down siding via the crossover. Source: Graham Vincent, Track and Signal, annotations by ATSB

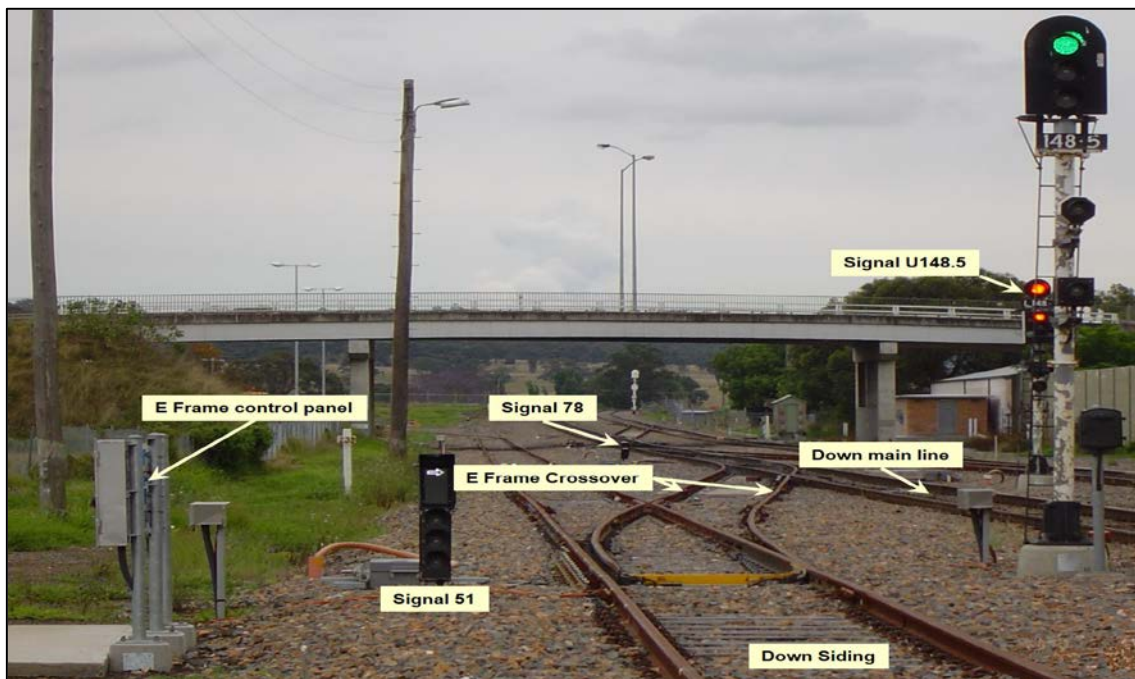
Figure 3: Location E Frame control panel

View looking North along the Down Siding toward signal 78 showing position of the E Frame control panel relative to the E Frame crossover. Source: Australian Rail Track Corporation, annotations by ATSB

Responding to the absence of the REV indication, the RRA Traffic Officer visually inspected the orientation of the points from a location adjacent the E Frame control panel (Figure 3).

The RRA Traffic Officer did not inspect the lie of each point on the crossover to confirm whether the corresponding machine had operated to the required position and the locking mechanism had engaged correctly.

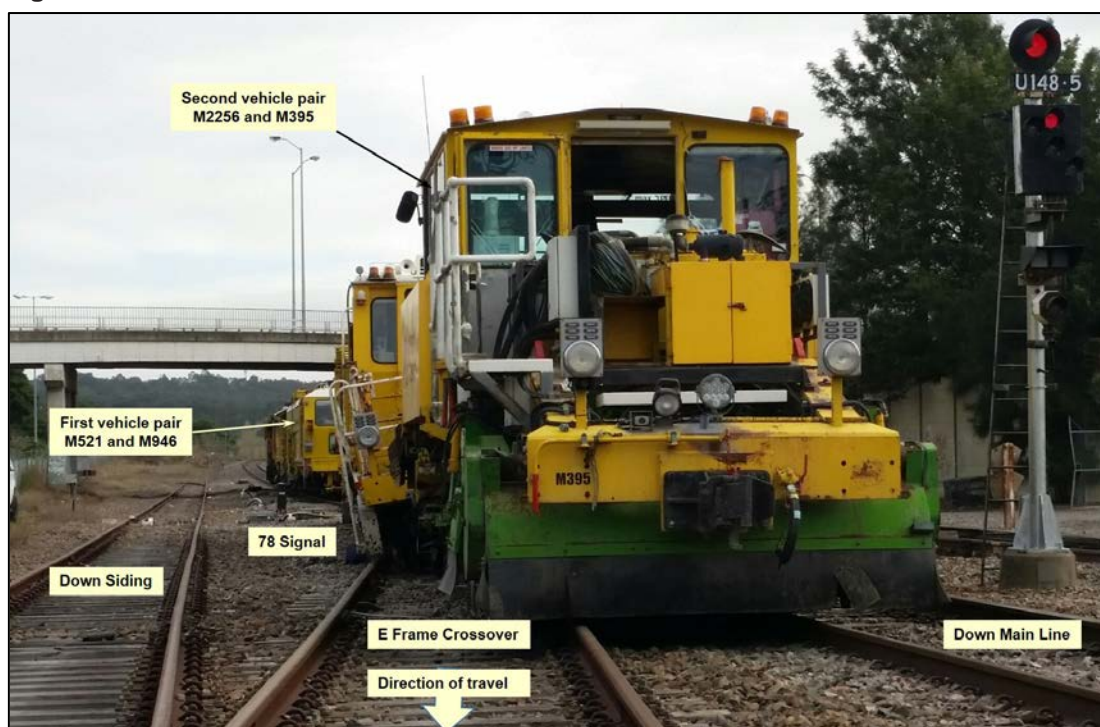
Figure 4: Derailed track vehicles M2256 and M395

The leading vehicle (M395) and the leading axle of the trailing vehicle (M2256) derailed as they passed over the swing-nose crossing that had failed to operate in conjunction with the other machines in the crossover (Figure 4). The lurching of the vehicles following the derailment impeded the ability of M395's driver to operate the brake or other controls until the vehicles had stopped. The derailment obstructed the Down main line and resulted in minor damage to the track vehicles. There were no injuries.

View from the Down Siding of the derailed vehicles on the crossover. The vehicles M2256 and M395 (in foreground) were the first to pass signal 78 for entry into the Down Siding. The vehicles derailed at the swing-nose crossing that is located at the junction of the E Frame Crossover and Down Main Line rails. Source: Australian Rail Track Corporation, annotations by ATSB

Post-incident, ARTC representatives inspected the crossover; finding that it was likely that the motorised machine that was part of the swing-nose crossing in the turnout on the Down main line had failed to properly operate – rendering the points unsafe. At about 1900 that day, the recovery of the derailed track vehicles and repair to the E Frame points was completed.

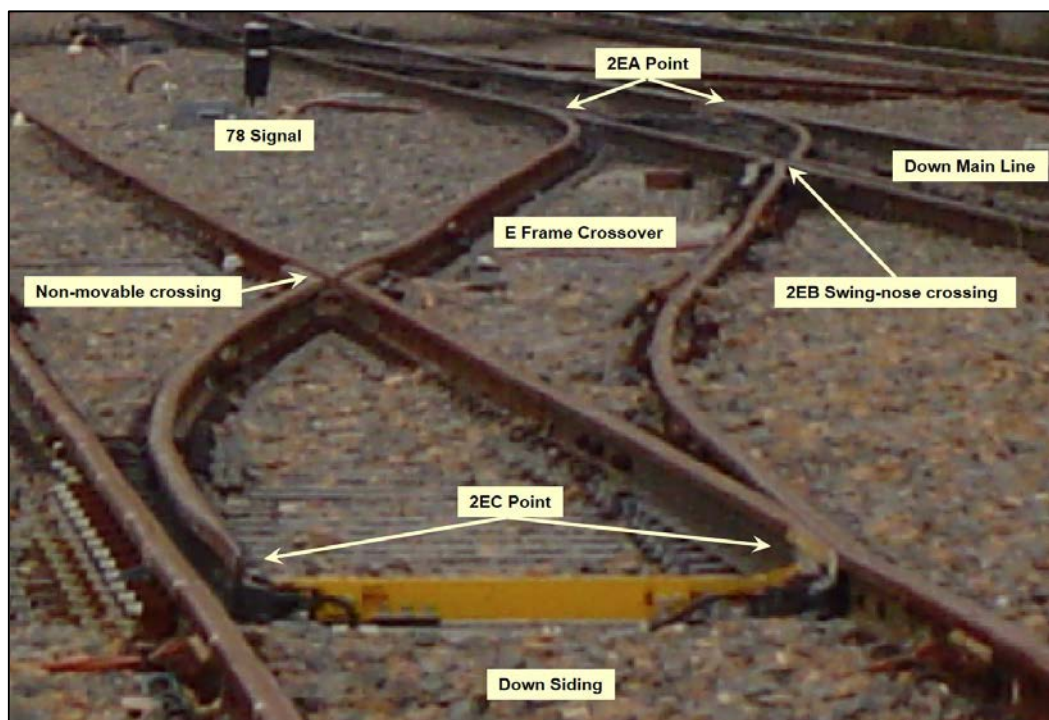
Figure 5: Singleton yard E Frame Crossover

The crossover from the Down main to the Down siding comprised motorised point machines at each end and a motorised swing-nose at the “V” crossing of the turnout on the Down main line. The “V” crossing of the turnout on the Down siding was of a non-movable compound type (Figure 5).

The E Frame Crossover showing 2EA and 2EC points at each end of the crossover and the 2EB swing-nose crossing at the junction of the Down main line and crossover rail. The points illustrated are set for the normal (straight through direction). The vehicle pair (M395 and M2256) derailed at the 2EB swing-nose crossing that did not operate to reverse. Source: Australian Rail Track Corporation, annotations by ATSB

In this instance, after the Traffic Officer commanded the points to move for access to the Down siding, the reverse light did not illuminate to indicate all motorised machines were in the correct position for safe access the siding. Post-incident, ARTC engineering staff inspected the E Frame and points machines; finding that the E Frame control panel operated correctly but the swing-nose machine did not operate. A motor start capacitor terminal had disconnected in the machine due to a broken mounting plate. While this would have prevented the motor from operating, it could not be conclusively determined if this damage was pre-existing or a consequence of the derailment.

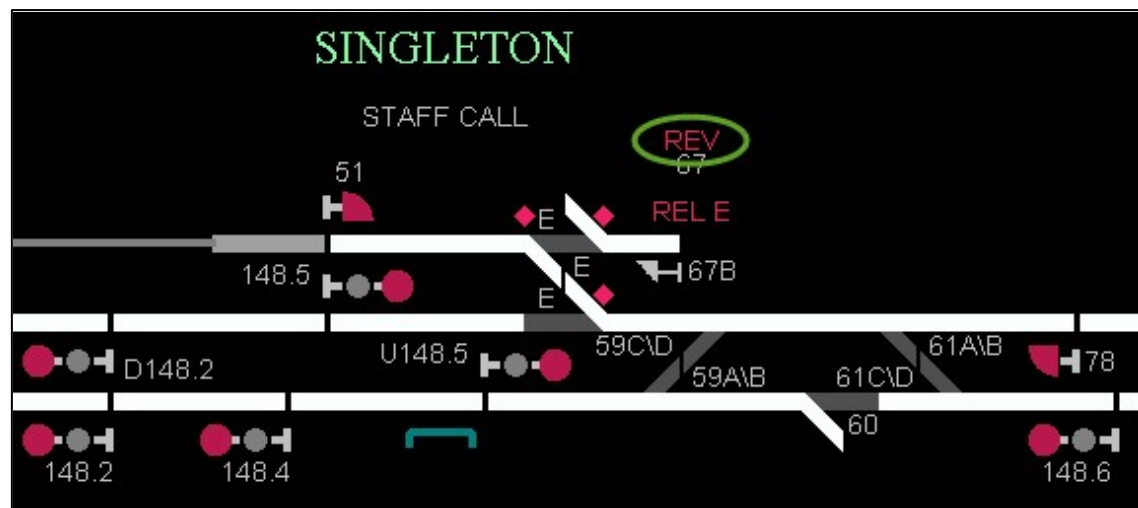
Figure 8: Phoenix screen extract showing E Frame points detected reverse

The REV indication (circled) seen by the NCO after detection of E Frame points in reverse following the operation by the qualified worker at Singleton. The E Frame points are set for the crossover. Source: Australian Rail Track Corporation

The indications provided to display to the NCO the orientation of the E Frame points are not consistent with those typically displayed for other points within the Phoenix system. This variability in the representation of point positions may result in the NCO misinterpreting the information presented; increasing the risk of a verbal movement authority being provided before it was safe to do so.

The ARTC published, post-incident, an *Incident Advice Notice* (Appendix A – ARTC Incident Advice) to the NCO's at Broadmeadow – clarifying the 'REV' indication on the Phoenix display for the Singleton E Frame, and procedures for authorising of a movement to pass a signal at stop.

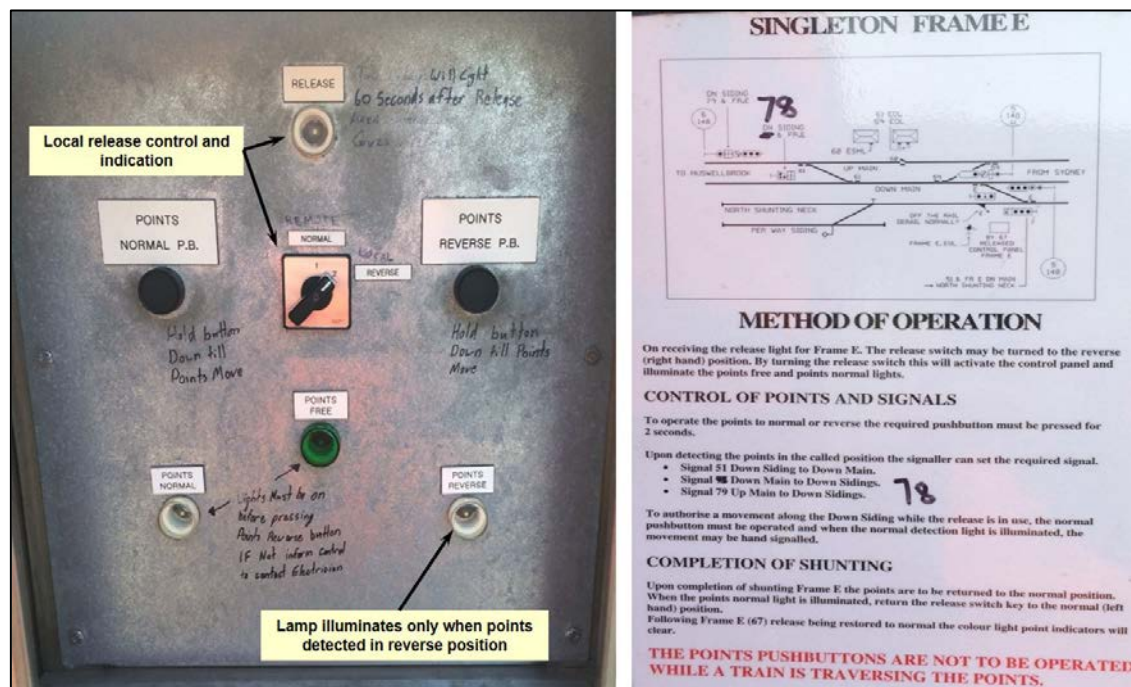
Figure 9: E Frame local panel faceplate and instruction sheet

The switches and lamps on the E Frame panel used to set and indicate the position of the E Frame points. Each switch and lamp had a permanent label to identify its function. Users had added additional handwritten instructions to clarify the operation and meaning of the various labels and contents of the instruction sheet. Source: Australian Rail Track Corporation, annotations by ATSB

None of the instructions referred to the unique arrangement for the Points Normal or Points Reverse lamps displaying only a steady indication when the points were set in the required position. The absence of a flashing indication during the transition of the points to the reverse position likely contributed to the Traffic Officers perception that the lack of the Points Reverse indication was due to a lamp fault.

It was evident that, at the time of the derailment, the ARTC had not updated all relevant operating procedures/local appendix units to reflect the unique arrangements for the E Frame local control panel. This departure of the equipment arrangements and operational behaviours from documented procedures, may result in a qualified worker misinterpreting the information presented by the indicator panel lights.
