Australian Government
Australian Transport Safety Bureau

Flight preparation event involving Kavanagh E-260 balloon, VH-FSR

near Alice Springs, Northern Territory | 13 July 2013

ATSB Transport Safety Report
Aviation Occurrence Investigation
AO-2013-116
Final – 9 December 2015

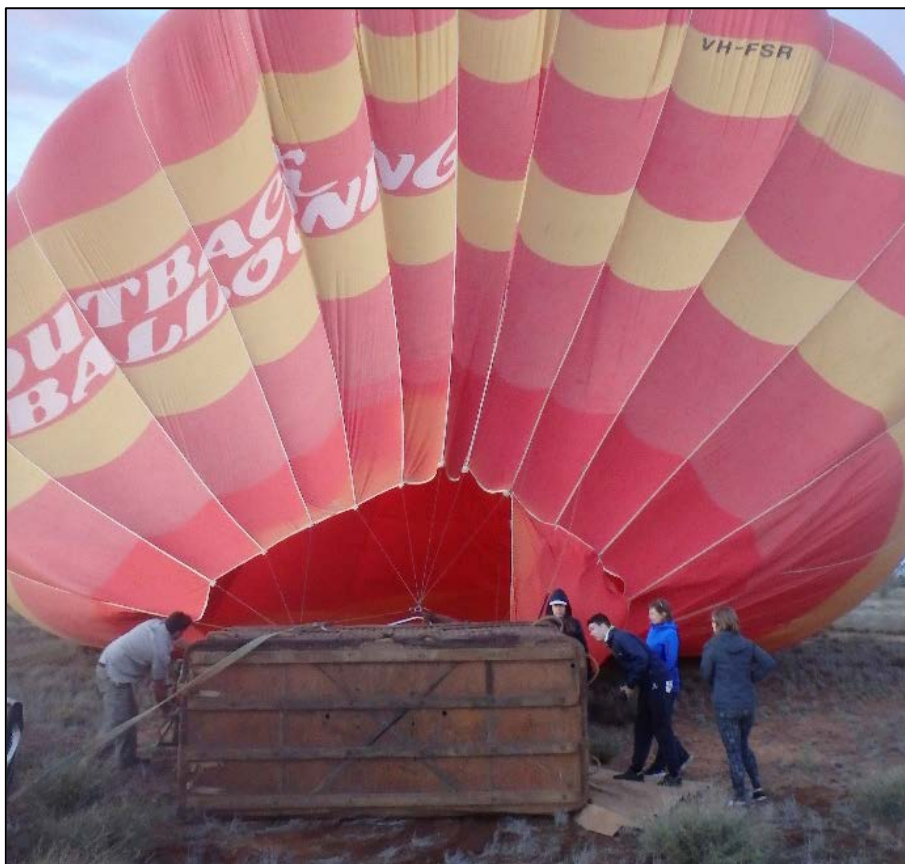
Figure 7: Passengers pre-loading into the side of the basket furthest from the inflation fan (Note: the pilot on the left side adjusting the fan's position)

At around 0715, the pilot instructed the passengers allocated basket positions furthest from the inflation fan to commence pre-loading (Figure 7). After several of the passengers had entered the basket, the pilot directed the passengers assigned locations closest to the fan to begin pre-loading. The pilot reported that he monitored the passengers as they entered both ends of the basket. During the loading process he remained on the fan-side of the basket near to the balloon's burner frame, about 1.5 m to 2 m away from the fan. The passenger's recollection of the distance between the basket and the fan varied between 1 and 2.5 m.

Pre-loading of the passengers during the inflation process, although appropriate in the wind conditions, resulted in the passengers entering the fan-side of the basket coming into close proximity to the operating inflation fan. The effectiveness of the following measures that were in place on the day to prevent fan entanglement will be examined:

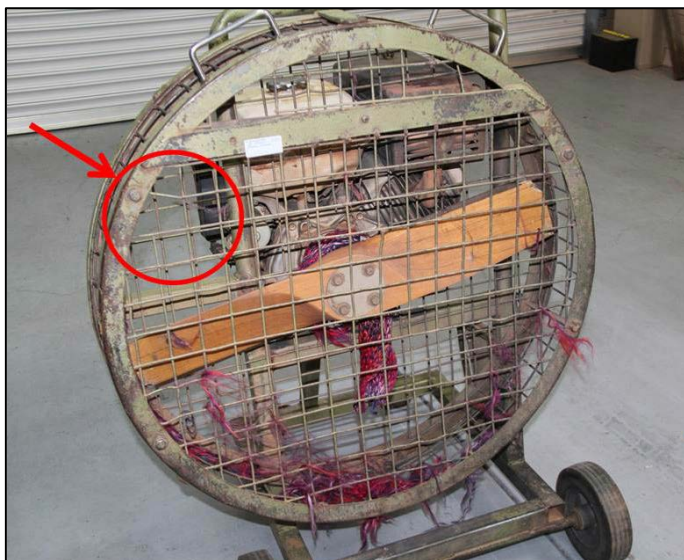
Figure 8: The cold-air inflation fan with remnants of the scarf (pre-existing minor cage damage highlighted)

Examination of the fan identified remnants of the woollen scarf caught around the blades and driveshaft. Both wooden blades had tip damage that also contained small strands of wool. The upper front part of the guard had minor damage that increased the size of the mesh opening (Figure 8). That damage appeared to pre-date the accident.

The mesh and steel tubing guard positioned around the fan did not prevent the scarf tassels being drawn in to the fan blades as the passenger walked towards the basket. A review of the safeguarding of similar fans identified that the occurrence fan had a relatively large mesh size and no peripheral cowl. The mesh size on the occurrence fan was also larger than that recommended in the United States (US) Department of Labor Occupational Safety and Health Standard. Given the lightweight nature of the scarf tassels, it could not be concluded that a smaller mesh would have prevented the scarf from reaching the fan blades on this occasion. More generally however, safeguarding forms an important part of managing the risk associated with hazardous equipment such as fans. Therefore the ATSB recommends that balloon operators review the adequacy of fan guards, including the mesh size, in the context of the international and US standards for industrial fans.

The mesh size on the operator's cold-air inflation fan guards have been reduced in size to impede the ingress of items such as scarves and other items of loose clothing (Figure 14). Changes to the mesh size can be identified by comparison with the occurrence fan (Figure 8).

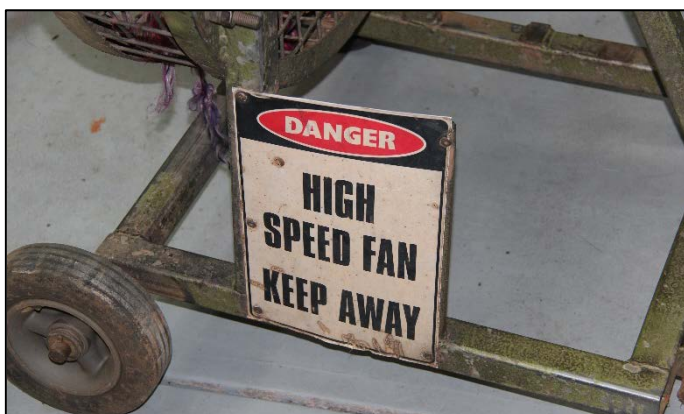
Figure 9: Installed fan warning sign

Although there was no specific standard identified relating to inflation fans, the occurrence fan did have two of the safeguards recommended for industrial fans: a warning sign and a fixed guard. The warning sign had been identified during the passenger briefing. However, as the sign was only on one side of the fan assembly, and accounts varied as to the path taken by the passenger to the basket, it may not have been visible to them. In that regard, and despite the warning sign having been identified by the pilot during the passenger briefing, the salience of the warning to the passenger as they approached the fan could not be determined.

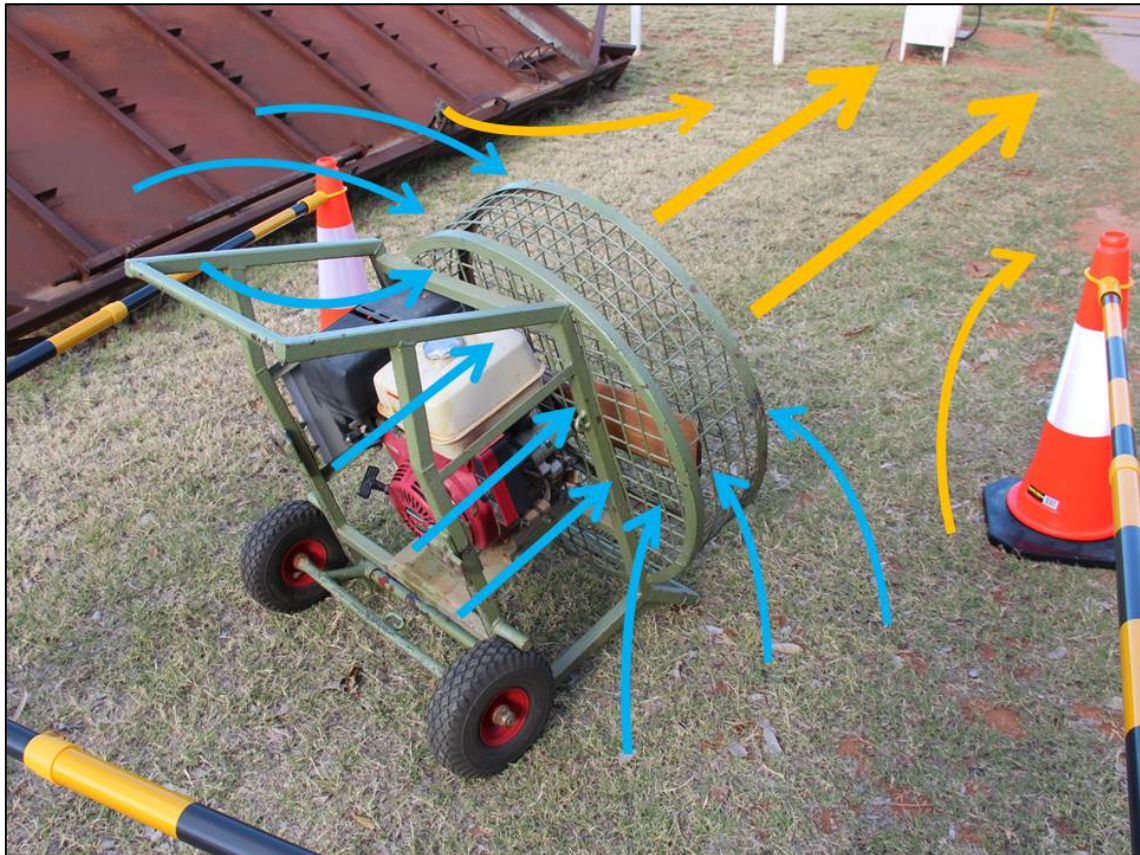
Figure 10: Cold-air inflation fan airflow (blue arrows show air being drawn in, yellow arrows show outflow)

It was identified that air was drawn from the rear of the fan at a distance of 40 cm behind the guard, with significantly more suction within 15 cm of the guard. The fan also drew air in from the circular section of the guard from about 20 cm and from a region in front of the guard.

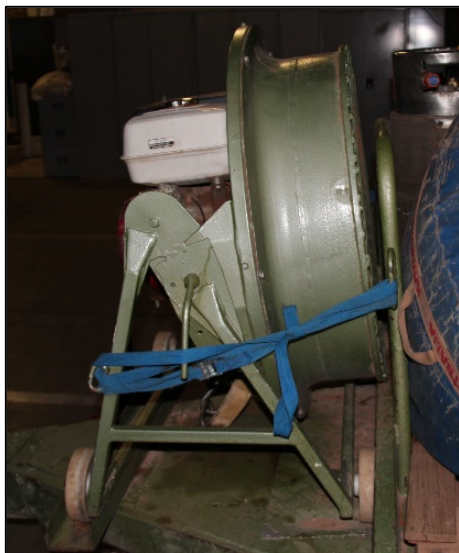
Figure 12: Shrouded fan design

The balloon operator advised that one of their inflation fans had a metal cowl around the periphery of the cage as recommended in the FAA handbook (Figure 12). The operator reported that the presence of the cowl significantly reduced the inflation airflow.
