Collision with terrain involving a Beech A36, VH-PAK

near Southport Airport, Queensland, on 16 August 2015

ATSB Transport Safety Report
Aviation Occurrence Investigation
AO-2015-098
Final – 28 January 2016

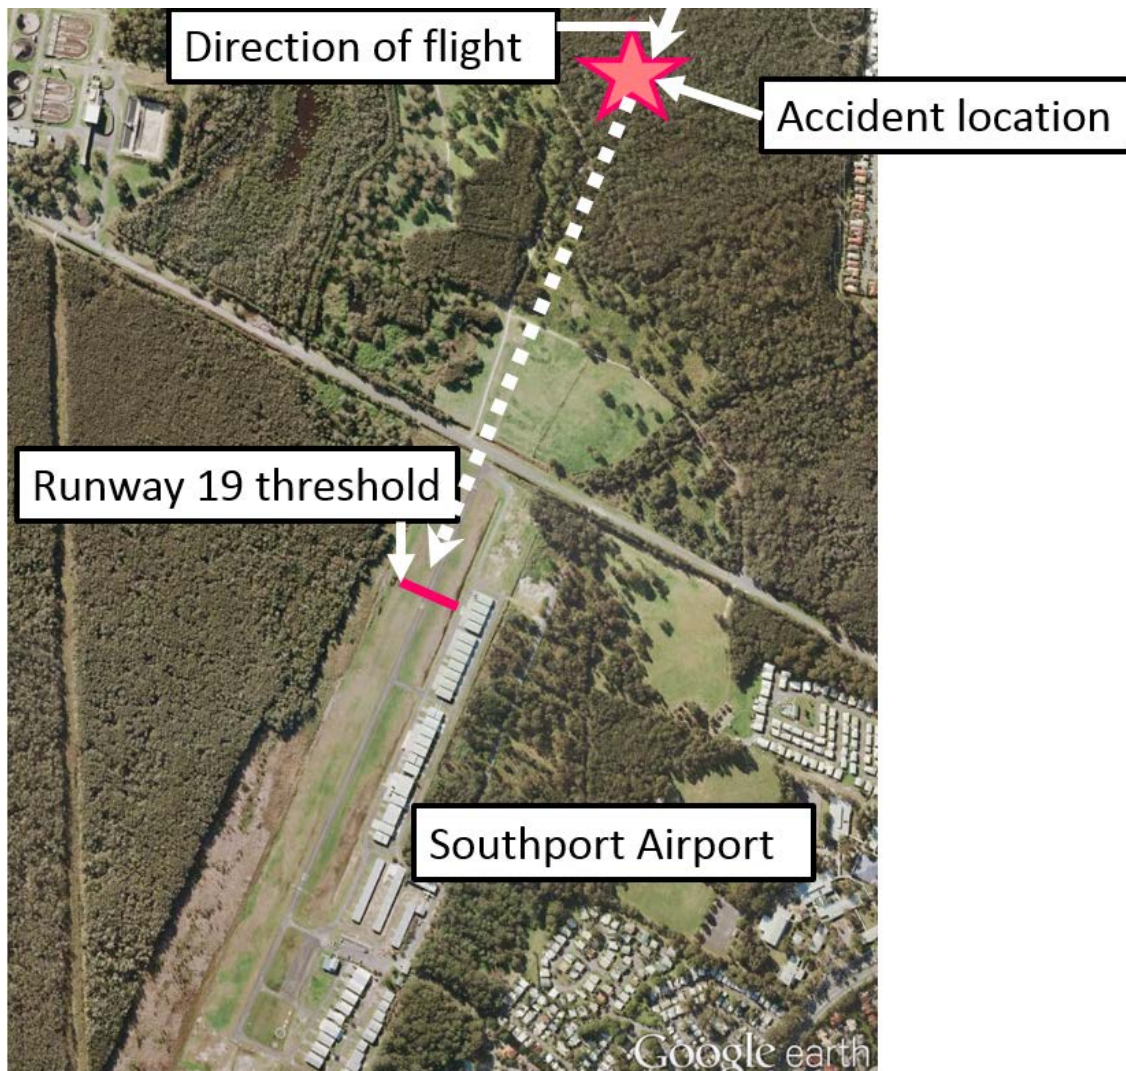
Figure 1: Southport Airport and accident location

About 800 m from the runway threshold, at about 150 ft above ground level, the aircraft's engine stopped. The pilot broadcast a Mayday¹ and conducted a forced landing (Figure 1). The aircraft collided with trees, resulting in substantial damage and the pilot was not injured (Figure 2).

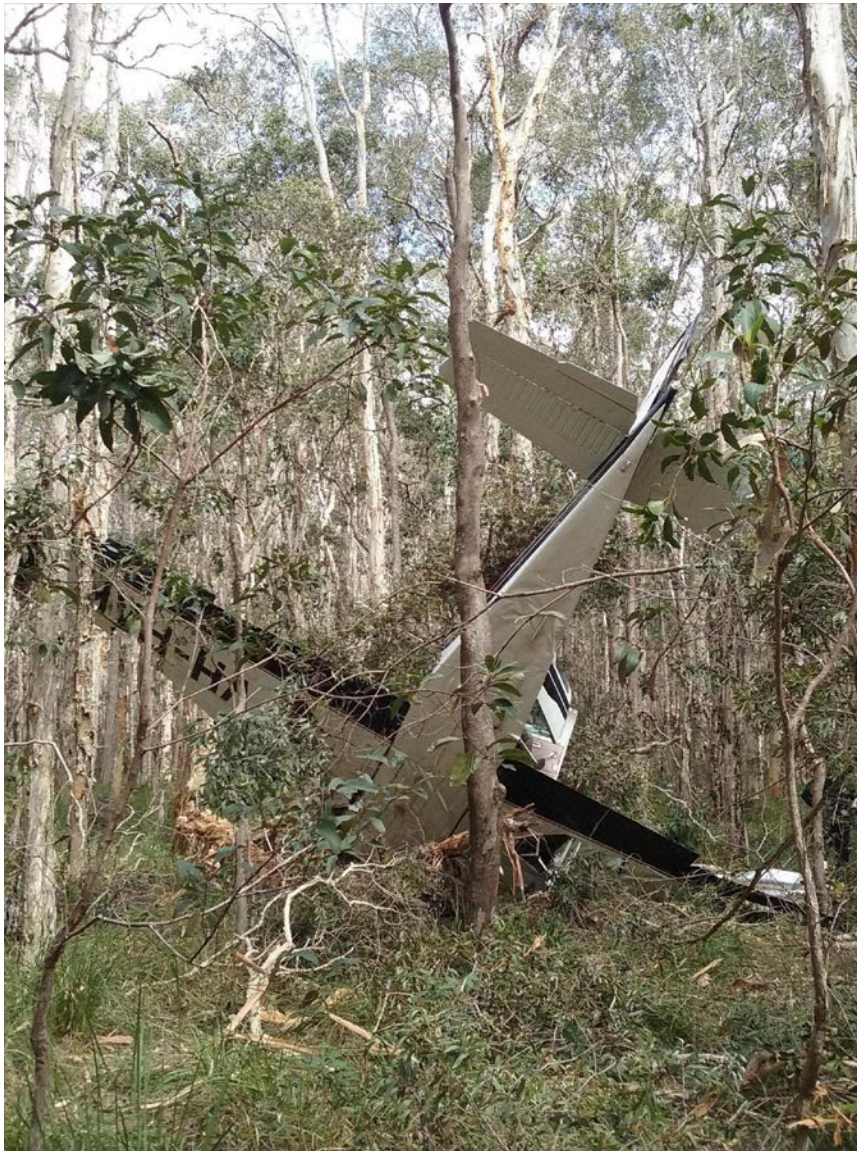
Figure 2: VH-PAK at accident site

The engine appeared intact, with all connections also intact. There was no evidence of oil loss from the engine.

During the post-accident inspection, the engineer found that only a few drops of fuel remained in the fuel control unit. The engineer drained the right main fuel tank and airframe fuel filter bowl. Less than 2 L of fuel drained from the right fuel tank, and less than 20 ml from the fuel filter bowl. The right main fuel tank was selected in the cockpit at the time of the accident.

The tip tanks and left main fuel tank were ruptured as a result of the collision, and no fuel remained in them. However, there was no evidence of fuel contamination at the accident site, and only a slight smell of fuel.

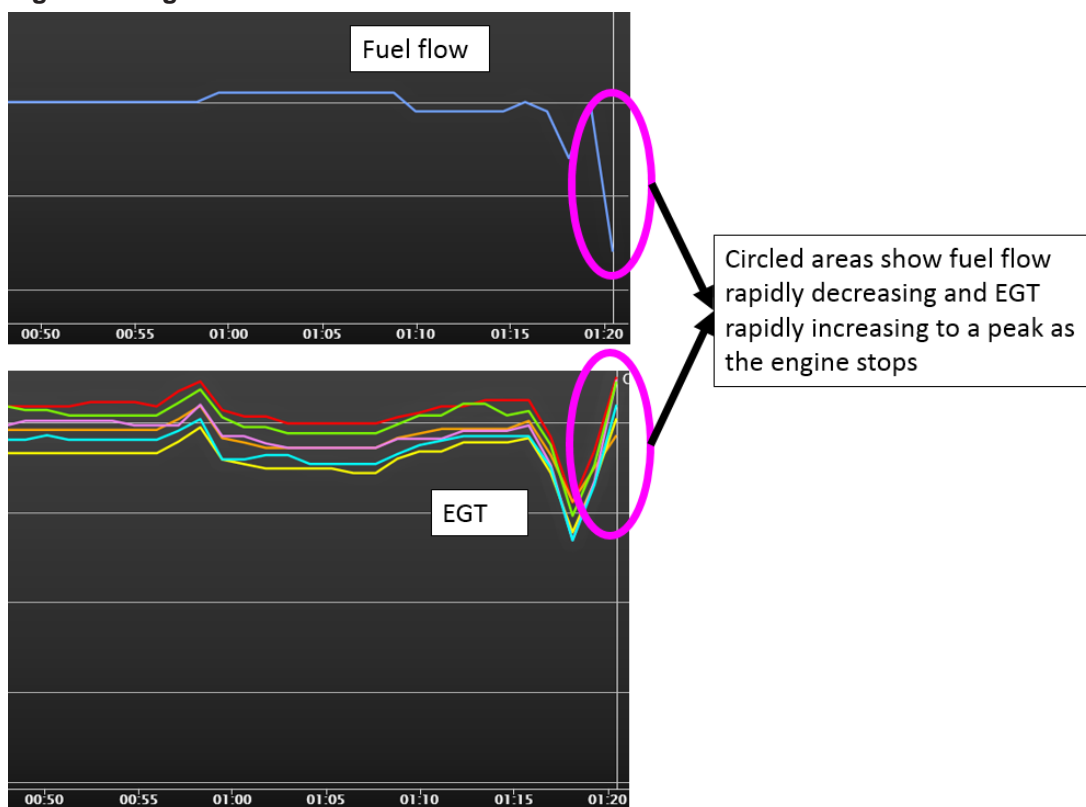
Figure 3: Engine data

The aircraft's engine data was reviewed for the flight. Figure 3 shows the recorded exhaust gas temperatures (EGT) and fuel flow for the flight. During the cruise, the fuel/air mixture was leaned to achieve a fairly constant EGT around 1,500 ° Fahrenheit (816 °C). Towards the end of the flight, as the aircraft descended, the EGT decreased. About 2 minutes before the engine stopped, the EGT climbed rapidly. The peak EGT, of about 1,552 °F (844 °C), occurred as the engine stopped (Figure 3). Simultaneously, the fuel flow dropped to zero and the engine rpm increased rapidly. This is indicative of an overly lean fuel/air mixture, and is consistent with fuel starvation.

The pilot reported that about half of the aircraft's fuel capacity remained at the time of the accident. However, the subsequent inspection found a total of about 2 L of fuel remained in the intact (and selected) right main fuel tank. The recovered engine data indicated that fuel starvation occurred at the time the engine stopped. The ATSB could not resolve the difference between the pilot's account and the fuel state found after the accident.
