# Wheels-up landing involving a Cessna 172RG, VH-HTP

Elcho Island Aerodrome, Northern Territory, on 14 October 2015

**ATSB Transport Safety Report**  
Aviation Occurrence Investigation  
AO-2015-121  
Final – 28 January 2016

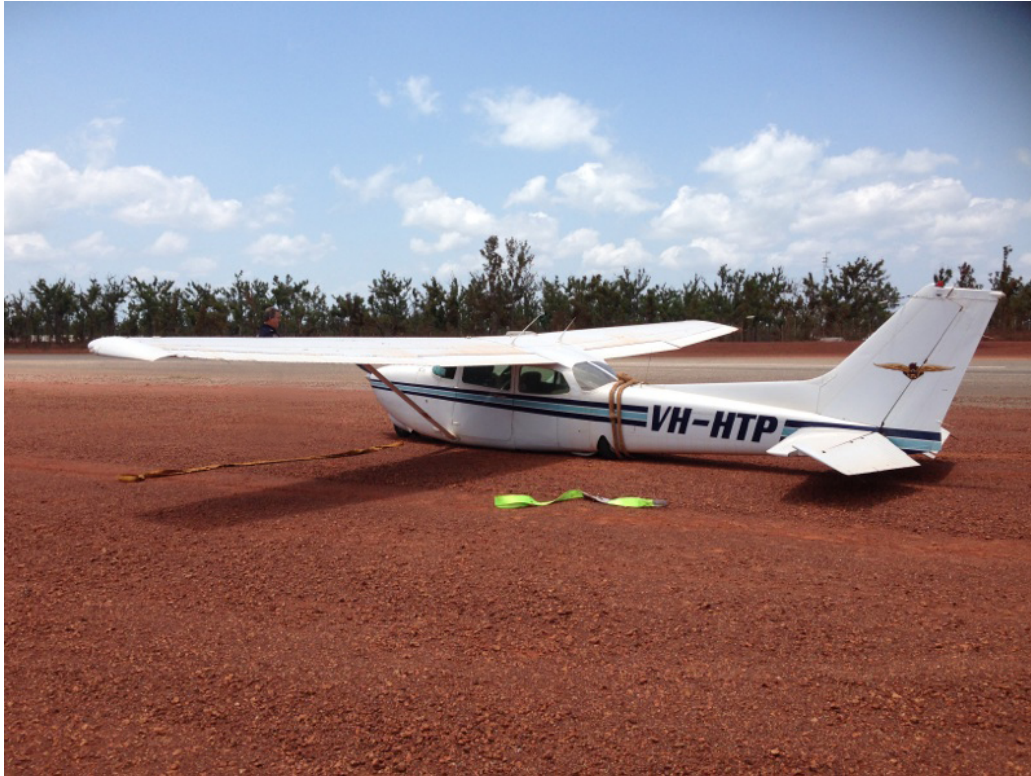
**Figure 2: VH-HTP at the accident site**

As the aircraft ahead taxied clear of the runway, the pilot continued the approach, and selected 10° of flap. However, the pilot omitted to extend the landing gear. The pilot reported the approach was normal, and the conditions were smooth with a light breeze and no turbulence. As the pilot flared the aircraft for landing, the belly of the aircraft contacted the tarmac and the aircraft skidded along the runway. On hearing the scraping sound, the pilot initially applied full power, but the aircraft remained on the ground and came to rest on the gravel beside the runway. The pilot did not hear the stall or landing gear warning horn at any time.

The pilot and passengers were uninjured, and the aircraft sustained substantial damage (Figure 2).

Initially assessing that an orbit was required led to a break in the pilot's normal pre-landing checks. The pilot was then distracted monitoring the aircraft on the ground, and the approach. When the pilot assessed that the other aircraft would be clear of the runway and elected to continue the approach, the pilot did not complete the pre-landing checks, and omitted to extend the landing gear.
