Collision with terrain involving a Robinson R22, VH-NCL

at Newman Airport, Western Australia, on 6 November 2015

ATSB Transport Safety Report
Aviation Occurrence Investigation
AO-2015-128
Final – 28 January 2016

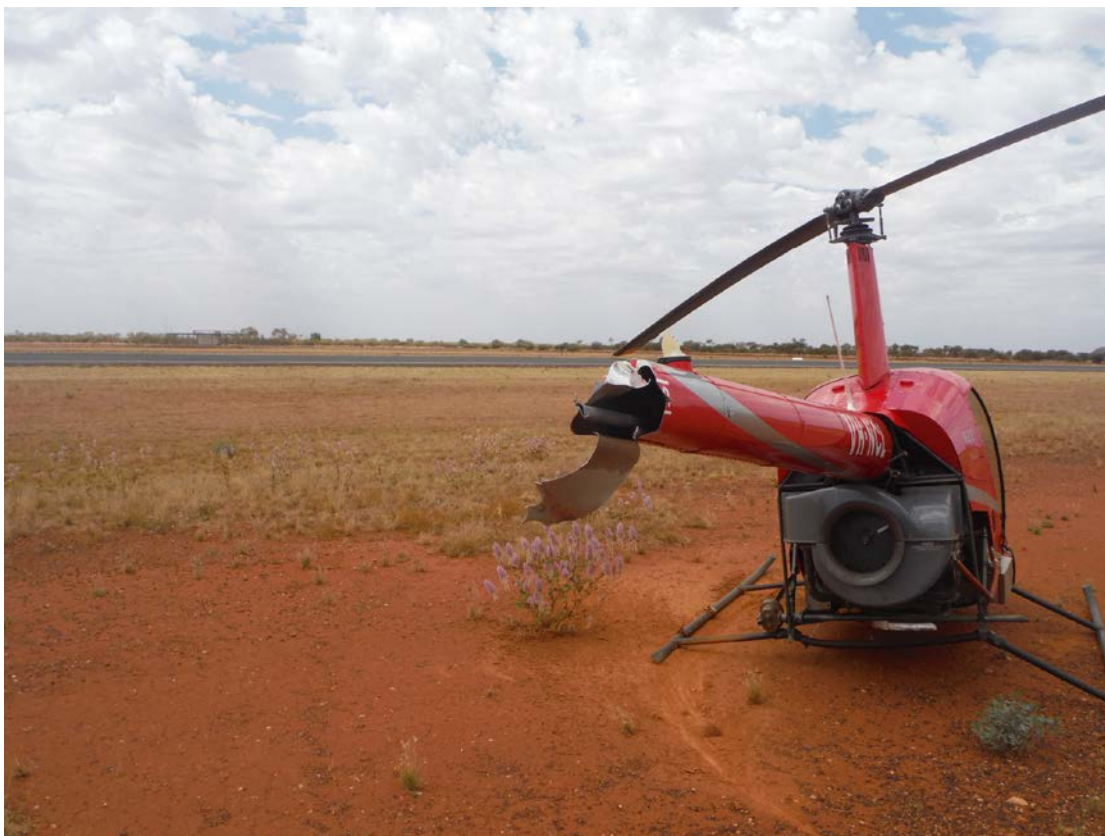
Figure 1: Accident site showing damage to VH-NCL

At about 0830 Western Standard Time (WST), the helicopter lifted off to about 10 ft above ground level, and the pilot commenced hover-taxiing. As the helicopter started to move forwards, it encountered a gust of wind from behind and sank rapidly. The helicopter landed heavily, then bounced and rotated rapidly to the right. During the accident sequence, the main rotor blade severed the tail, and the helicopter sustained substantial damage (Figure 1). The pilot and passenger were not injured.

Loss of tail rotor effectiveness (LTE) causes a yaw to the right in helicopters with a counter-clockwise rotating main rotor. When operating at airspeeds below 30 kt, a tailwind may result in an uncommanded turn, if the tail rotor is unable to provide adequate thrust to maintain directional control. To reduce the onset of LTE, the United States Federal Aviation Administration (FAA) [Helicopter Flying Handbook](#), advises pilots to:

Avoid tailwinds below an airspeed of 30 knots. If loss of translational lift occurs, it results in an increased power demand and additional anti-torque pressures.

If the rotation cannot be stopped and ground contact is imminent, an autorotation may be the best course of action. Maintain full left pedal until the rotation stops, then adjust to maintain heading.
