Australian Government
Australian Transport Safety Bureau

Man overboard fatality from *Cape Splendor*

Port Hedland, Western Australia | 6 October 2014

ATSB Transport Safety Report
Marine Occurrence Investigation
314-MO-2014-011
Final – 9 February 2016

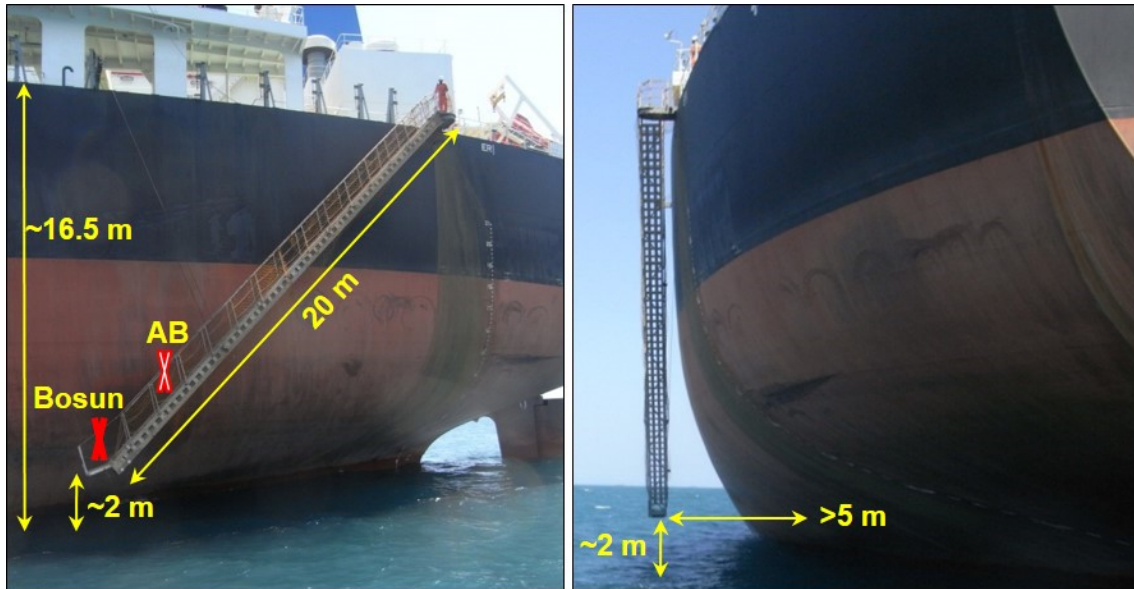
Figure 3: The accommodation ladder as rigged at the time of the accident showing distances and approximate positions of bosun and able seaman

Shortly thereafter, the bosun was standing with both hands occupied with fishing gear when the AB felt the accommodation ladder move. The bosun lost his balance and fell, backwards, off the platform into the water.

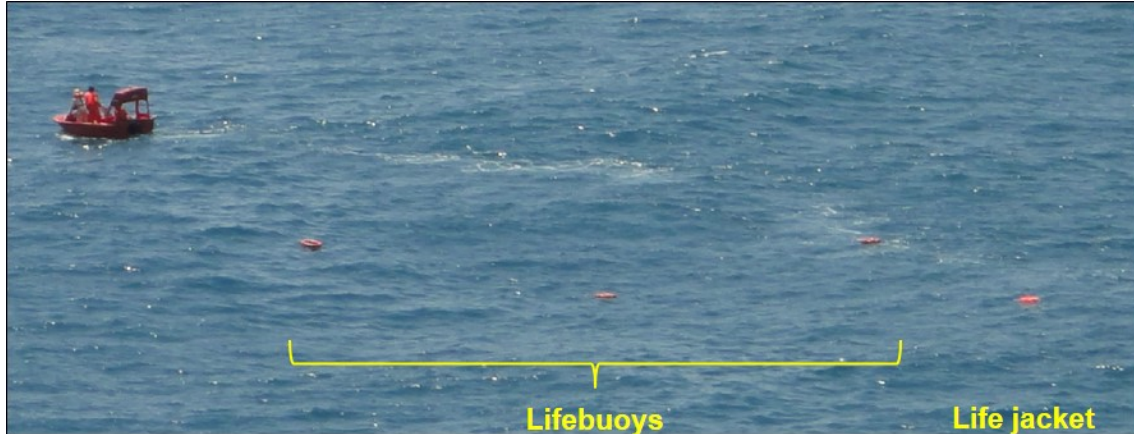
Soon after, *Cape Splendor's* rescue boat was amongst the flotation aids that the crew had thrown in to help (Figure 4). However, there was no sign of the bosun. The rescue boat crew continued searching amongst the aids and the surrounding area while communicating with the ship.

Figure 4: The rescue boat in the search area about 200 m from the ship at 1302

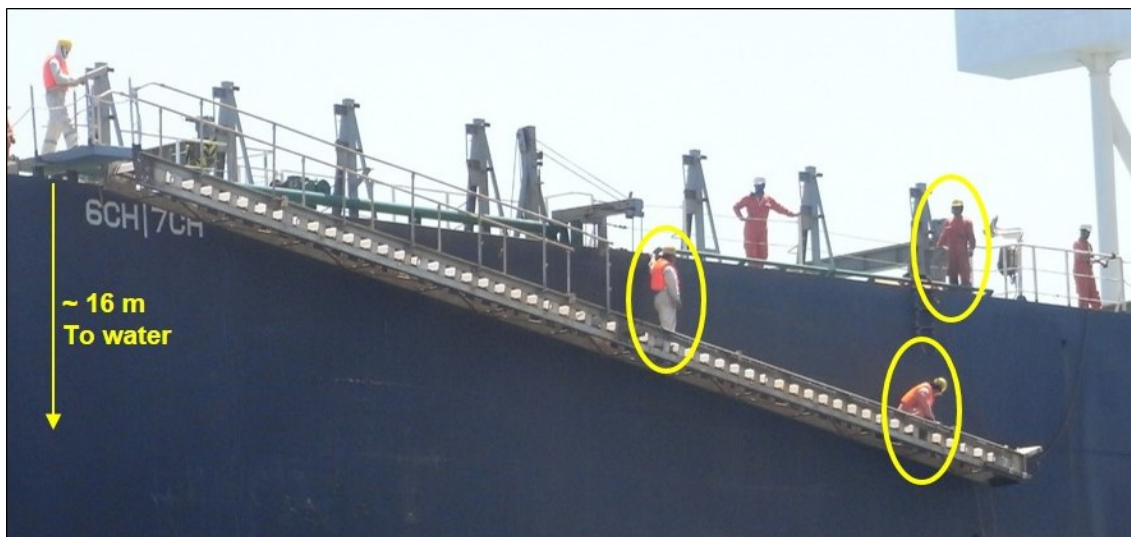
When ATSB investigators attended *Cape Splendor* after the accident, they observed the crew rigging the ship's port side, midships accommodation ladder (Figure 6). Some of the significant observations included the:

Figure 6: Crew rigging the accommodation ladder without fall protection and/or lifejacket

However, following the accident, ATSB investigators witnessed the ship's crew rigging the ladder in a manner that was contrary to its SMS procedures and relevant risk assessments. Accordingly, it appeared that company safety circulars and training to support those SMS procedures had not resulted in the crew learning lessons for safe work over the side – nor had such lessons been learned from the accident on 6 October.

When ATSB investigators attended *Cape Splendor*, they observed an accommodation ladder being rigged without appropriate working at height precautions. Interviews with crewmembers of *Cape Splendor*, however, indicated that it was usual to comply with safety procedures during work activities. Similar behaviours within the fleet had been previously identified by U-Ming Marine as evidence of poor safety culture on board ships.
