Navigation event involving a Fairchild SA227 aircraft, VH-UUO

Brisbane Airport, Queensland | 3 September 2014

ATSB Transport Safety Report
Aviation Occurrence Investigation
AO-2014-147
Final – 12 February 2016

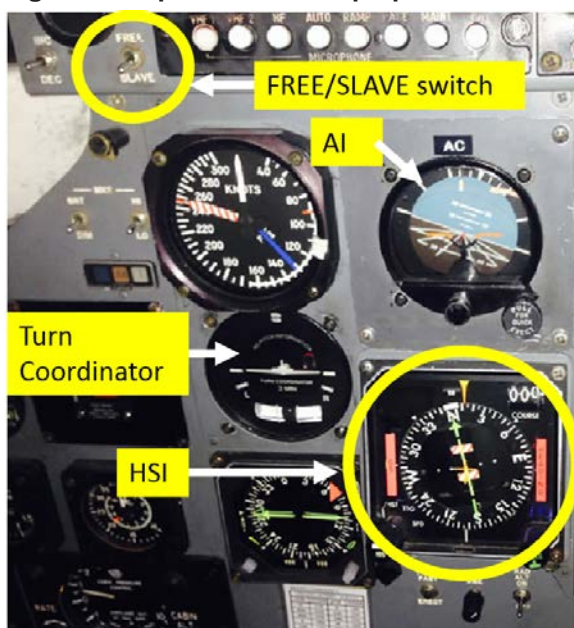
Figure 2: Captain-side cockpit panel of VH-UUO

For the incident flight, the left gyro slaving switch had been selected to FREE. The right compass system was slaved and indicating the correct heading. The captain's side HSI was showing about 50° left of the aircraft's actual heading, and the co-pilot's side HSI was showing the aircraft's correct heading.

With the left heading reference system set to FREE, when the left (captain's side) HSI erected, it would have appeared serviceable, but not aligned to the earth's magnetic field. Consequently, the direction indicator (DI) reading on the HSI would not have correctly indicated the aircraft's heading. Flight data showed it indicated about 50° left of the actual heading. The left radio magnetic indicator (RMI), located below the HSI, was slaved. It would have been showing the correct heading information, but not matching the HSI.

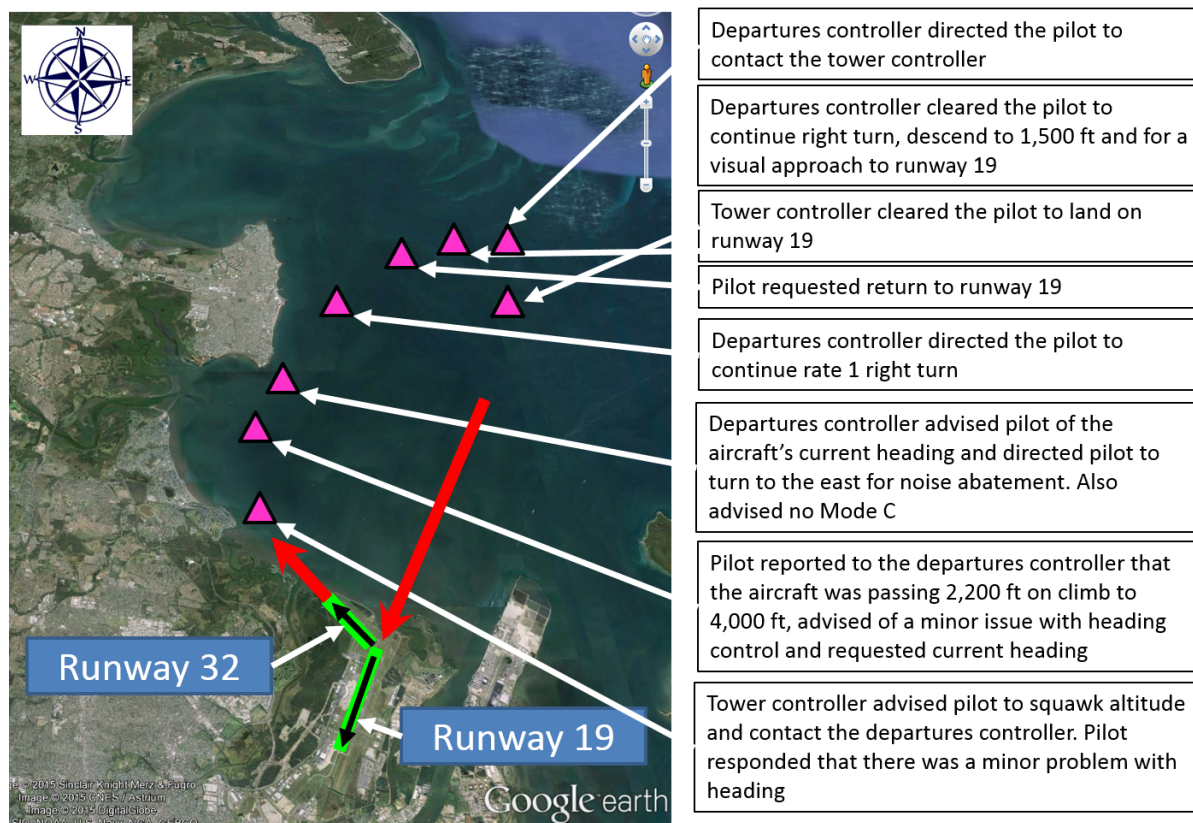
Figure 3: Radar track of VH-UUO with aircraft position annotated at time of pertinent radio communications

Figure 3 shows the location of the aircraft at the time of radio communications between the pilot of VH-UUO and Brisbane ATC.

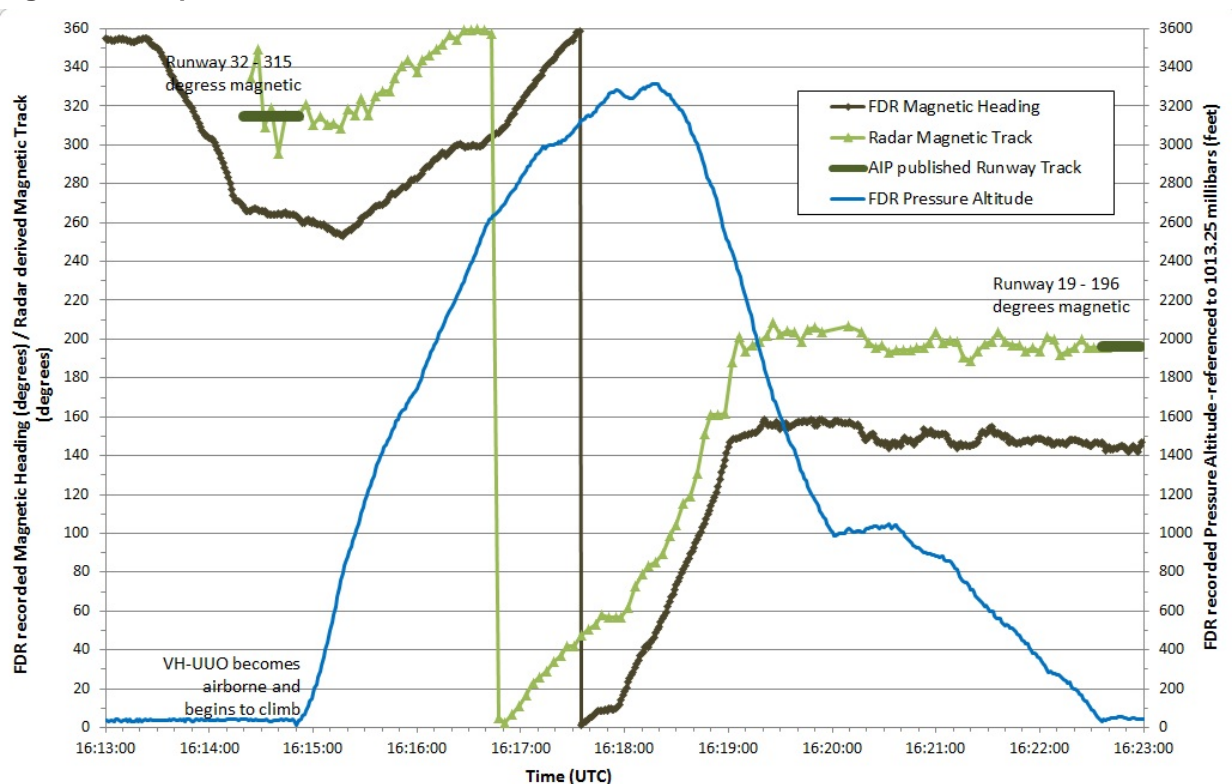
Figure 4: Comparison of radar and FDR information

Figure 4 provides a comparison of the magnetic heading of the aircraft recorded by the FDR and the aircraft track derived from the radar data. A detailed examination of the aircraft heading and the derived track was made from the take-off and landing roll phases. The derived radar track was found to be consistent with the published runway heading, however the recorded FDR magnetic heading was offset by about 50°. The offset varied slightly from 49-53° throughout the flight. This variation was consistent with precession⁵ of the gyro, due to the HSI selected in 'free' mode, and therefore not automatically slaved to the compass heading.
