In-flight break-up involving modified PZL Mielec M18A Dromader, VH-TZJ

37 km west of Ulladulla, New South Wales | 24 October 2013

ATSB Transport Safety Report
Aviation Occurrence Investigation
AO-2013-187
Final – 15 February 2016

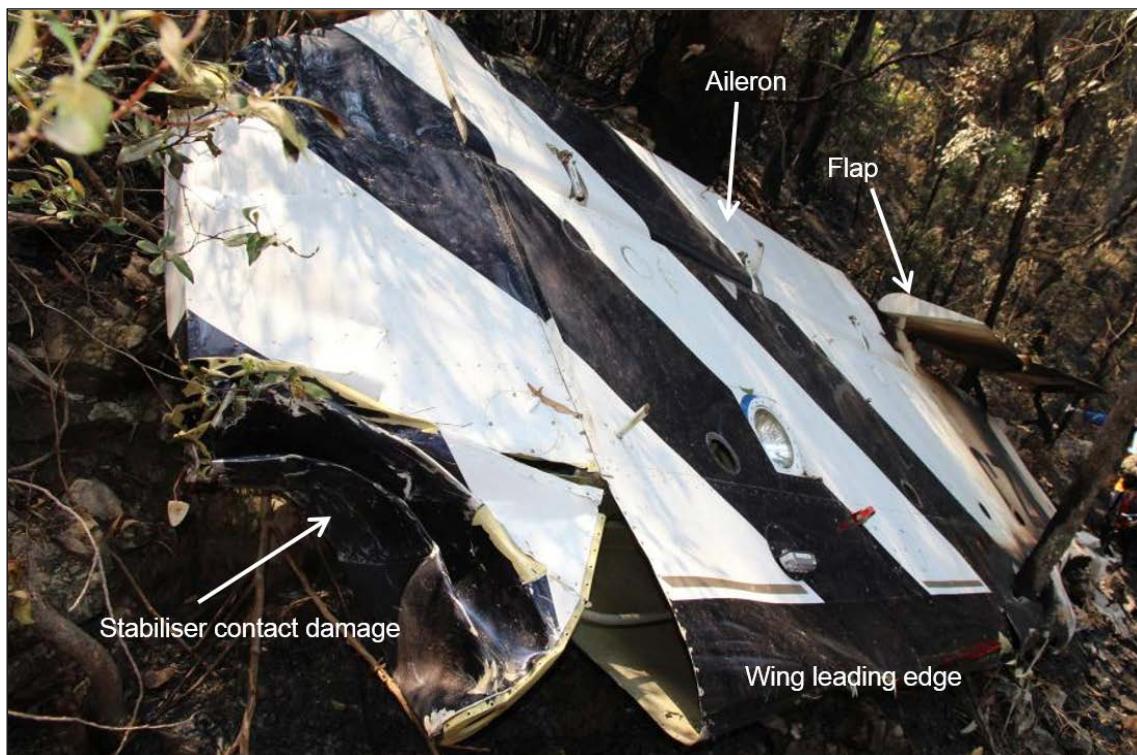
Figure 11: Left outboard wing, looking from the wingtip inboard and showing the lower surface of the wing

The outboard left wing had separated at the centre-to-outboard wing attachment joint and was found in the wreckage trail as a single piece containing the outboard section of flap and the left aileron (Figure 11). Fire had damaged the inboard end and there were numerous indentations that were consistent with post-separation impact with the left stabiliser and terrain (Figures 11 and 12). Examination of the left centre-to-outboard wing attachment fittings indicated that the outboard wing lower attachment lug had fractured (Figure 12).

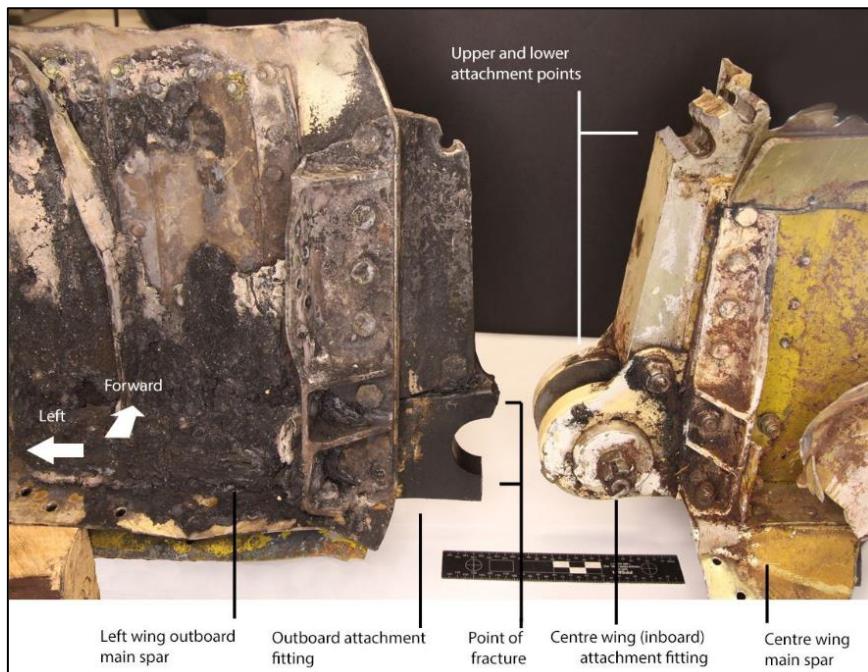
Figure 13: Left wing main spar at the centre-to-outboard attachment point (the upper attachment fitting separated from the assembly during the accident and is not shown)

The recovered sections of the main spar from the centre and outboard wing are shown in Figure 13. The upper and lower ligaments¹⁷ of the fractured outboard lower wing fitting lug contained two distinctly different fractures:

- the upper ligament had a rough, three dimensional form with gross deformation of the material
- the lower ligament had a flat, planar fracture with no obvious deformation.

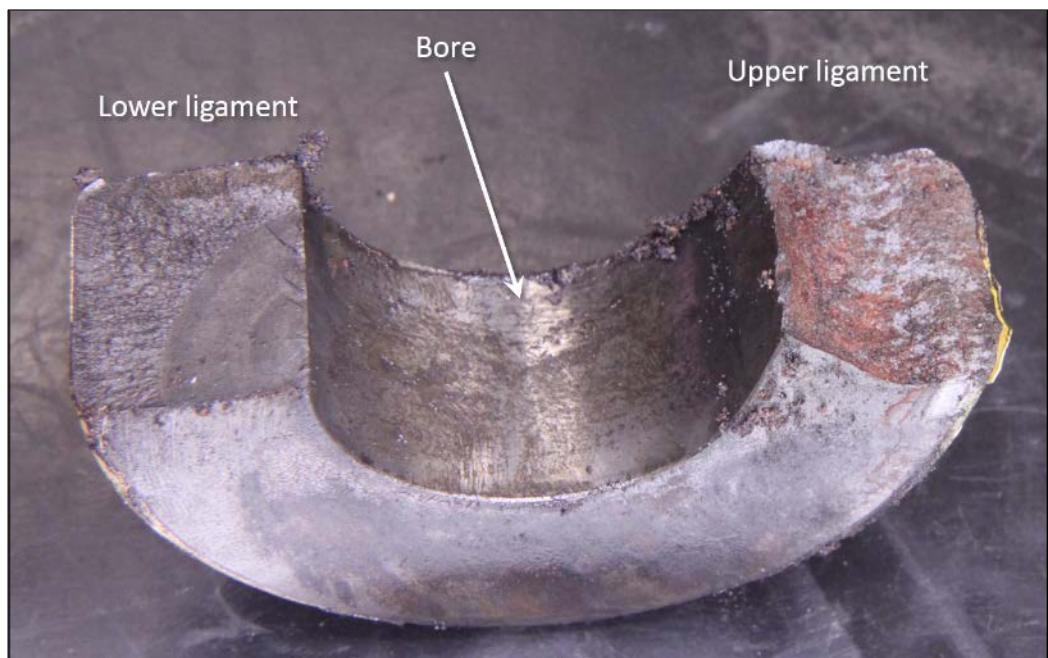
Figure 14: Detached portion of the left outboard wing lower attachment lug that was recovered from the centre wing lower attachment fitting (prior to cleaning and detailed examination)

A post-impact fire damaged the portion of the lug that remained in place on the outboard wing section. However, the detached portion of the lug that was retained in the centre wing lower attachment fitting contained no post-failure damage (Figure 14).

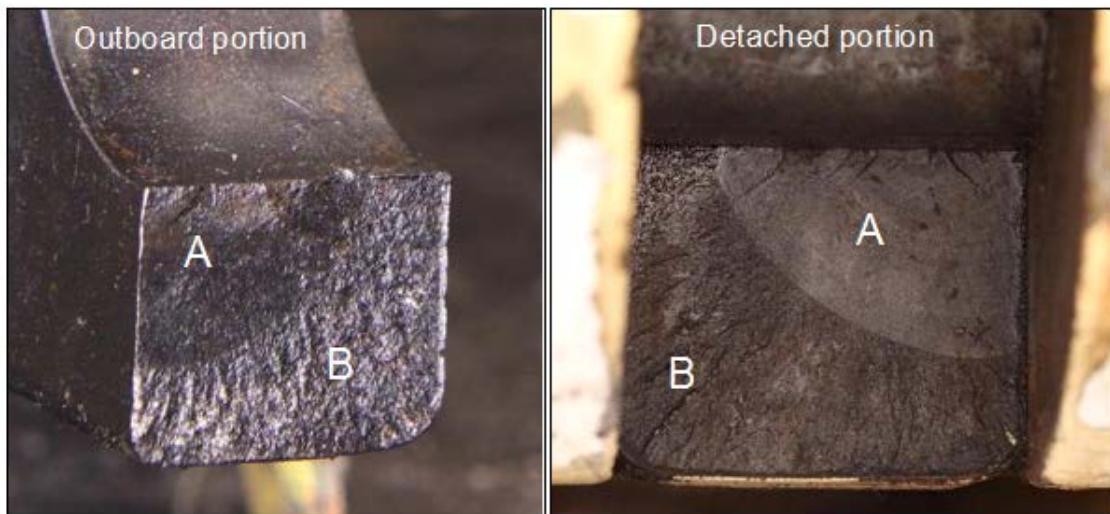
Figure 15: Left lower attachment lug showing the two different fracture regions on the lower ligament. Region A is a smooth area of progressive crack growth and Region B is an area of rapid fracture (the detached portion was retained in the centre attachment fitting when image taken)

The fracture surface of the lower ligament exhibited two distinct regions (Figure 15):

- a smooth area of progressive crack growth that originated at the inner bore of the lug (region A)
- a rough area of rapid fracture that corresponded to the final failure of the fitting material (region B).

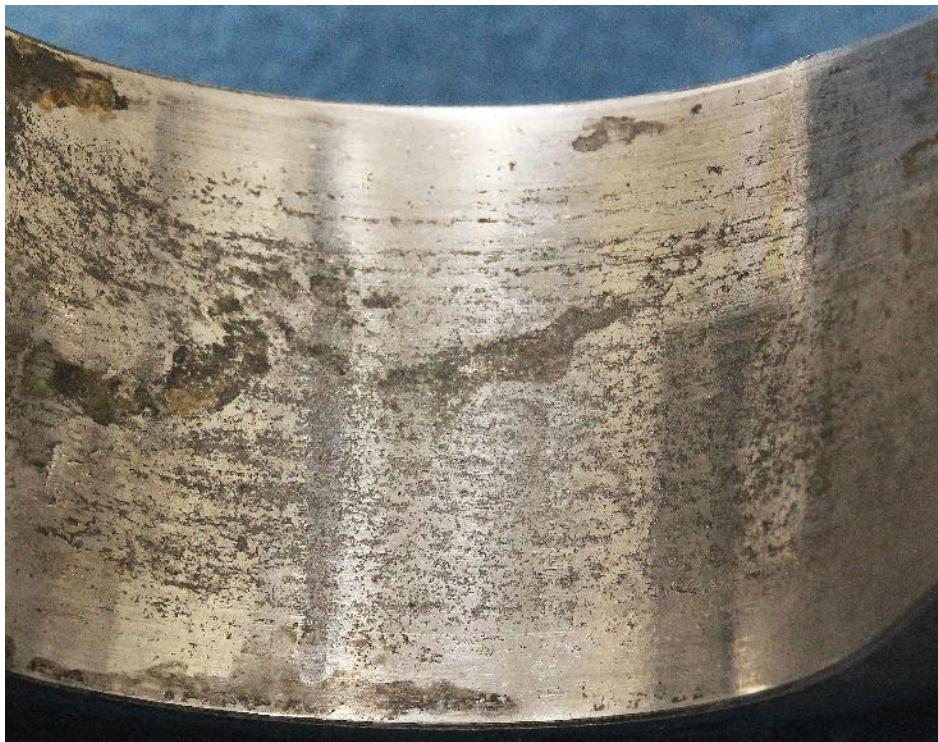
Figure 16: Surface condition of the wing attachment fitting bore with dark staining (corrosion damage)

The bore of the wing attachment fittings, through which the mandrel passed, were also covered in a thin greasy film. The surface of the bore of the detached portion of the outboard fitting lug presented a generally bright appearance with a distribution of darker regions (Figure 16). Microscopic examination found that these darker regions consisted of corrosion pitting.

Measurement of a number of the corrosion pits found that they varied in depth. Most were less than 0.03 mm deep, but the deepest observed was 0.16 mm. It was also noted that the surface of the bore:

The greasy film identified in the bore of the outboard wing attachment fitting would have protected the surface from corrosion. This would suggest that the corrosion occurred, and that the corrosion product was removed, at some time prior to examination by the ATSB.

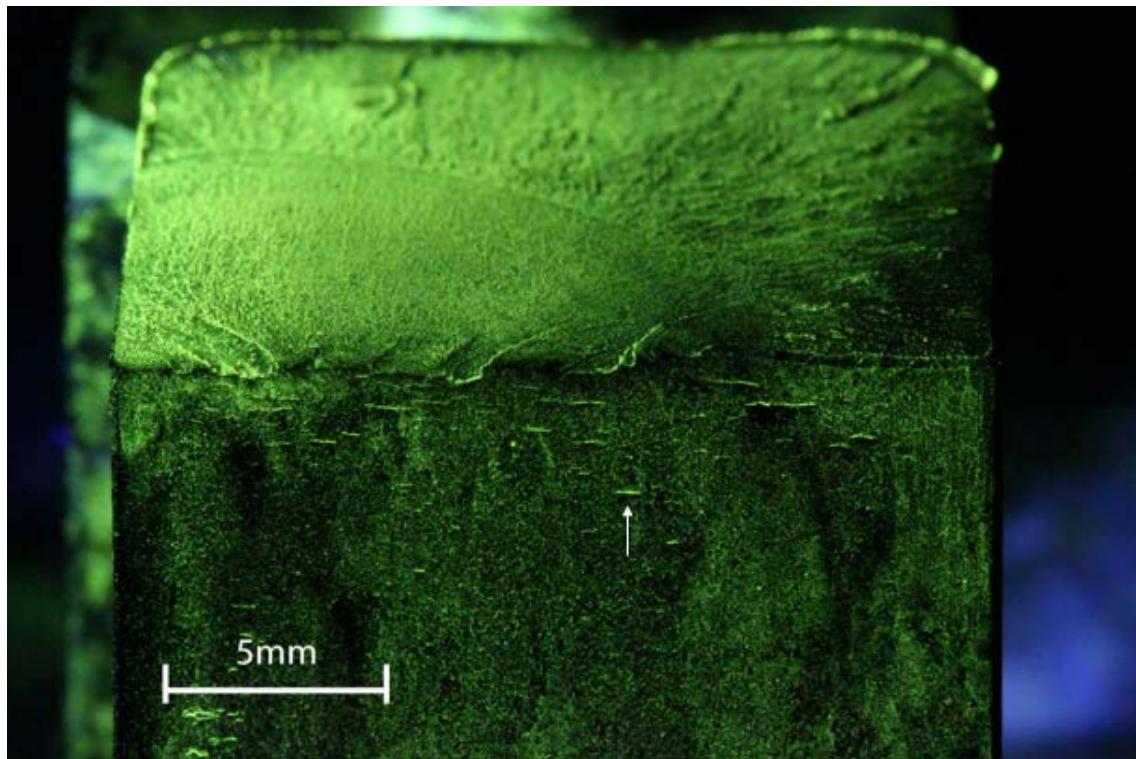
Figure 17: Fluorescent magnetic particle inspection of the detached portion of the left outboard wing lower attachment fitting lug. The micro-cracks present as short horizontal bright lines (an example micro-crack is identified by a white arrow)

The lower section of the outboard wing attachment fitting lug bore contained numerous microscopic cracks (micro-cracks) that were co-located with corrosion pits. Examination using a

fluorescent magnetic particle inspection (MPI) technique¹⁸ found that some, but not all of the micro-cracks were detectable using that method (Figure 17).¹⁹

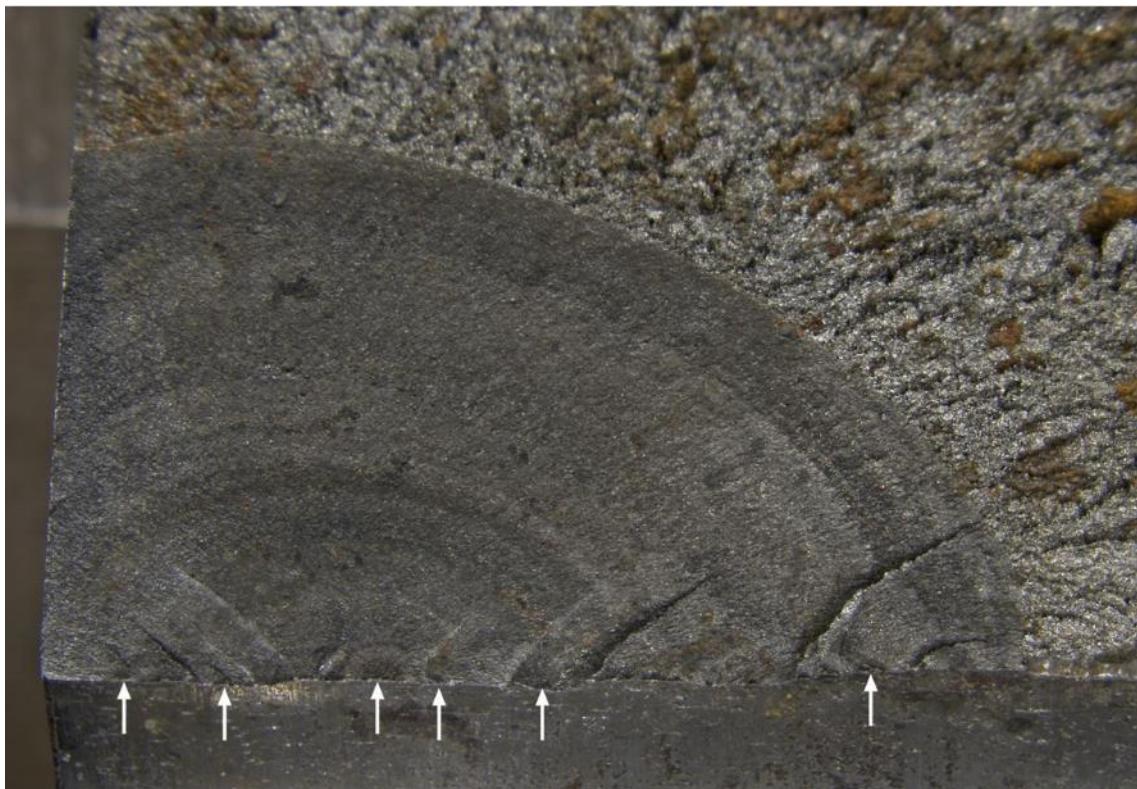
Figure 18: Portion of the lower ligament fracture surface showing the fatigue crack. White arrows indicate the location of some of the fatigue origins

The progressive crack growth area identified as region A in Figure 15, contained markings that were consistent with a fatigue fracture mechanism.²⁰ The fracture surface markings indicated that the crack had multiple origins located at the bore of the lug (Figure 18). Each of the fatigue origins corresponded to a corrosion pit in the bore of the lug.

A number of fatigue cracks formed at the sites of localised pitting in the bore of the lug on the outboard wing attachment fitting. A number of these cracks joined to form a single fatigue crack, which continued to grow until the fitting fractured on the accident flight.

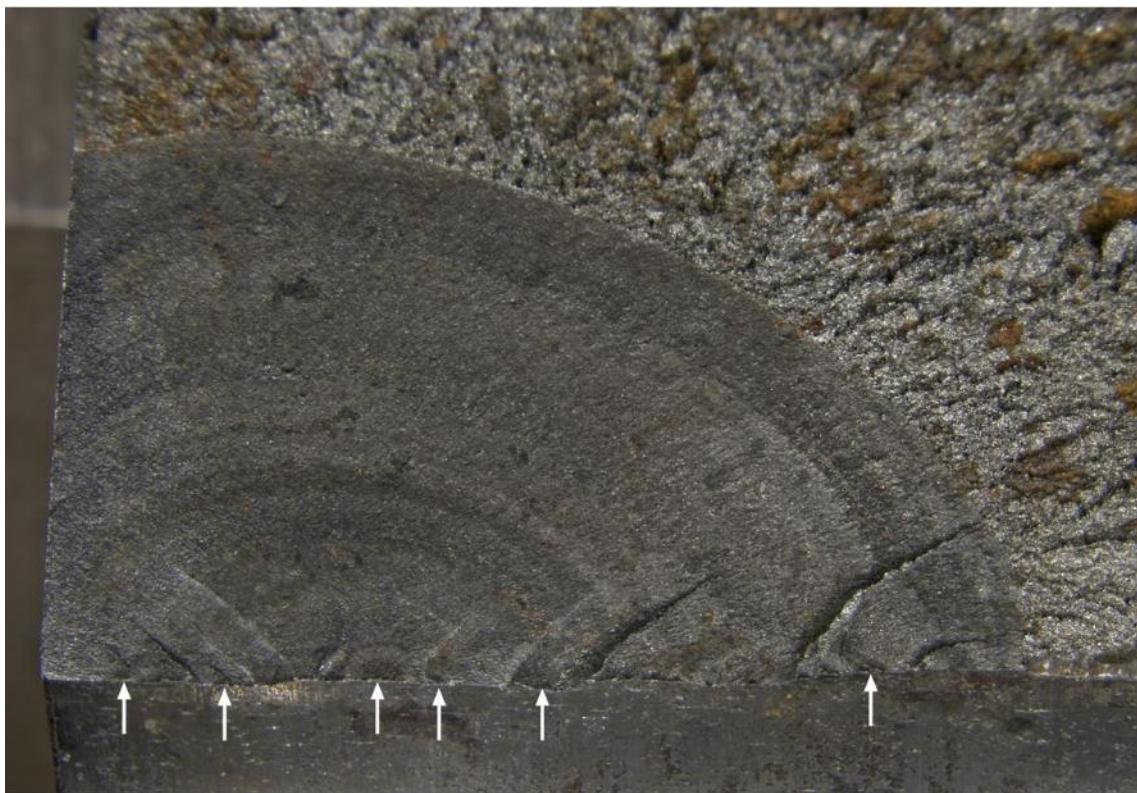
Figure B11: The fatigue crack with some of the fatigue origins arrowed

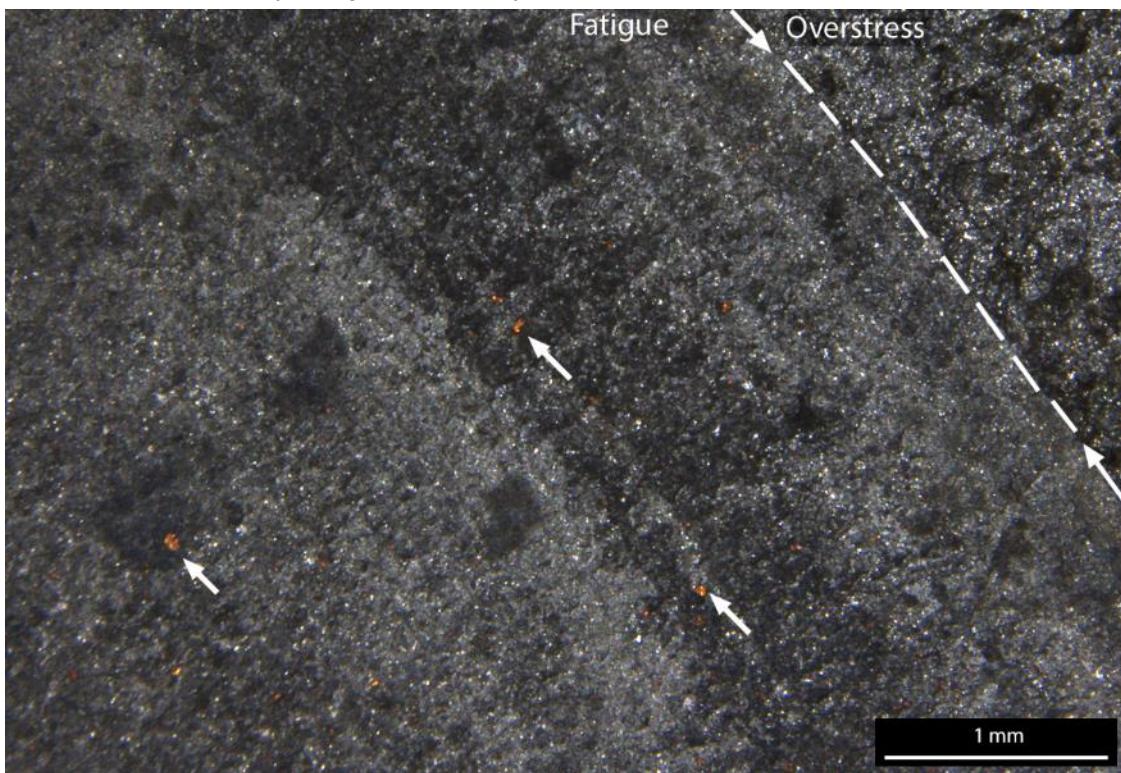
Figure B12: High magnification optical view of the fracture surface. Bands of crack progression (beach marks) show the advance of the fatigue crack front as it propagated through the lug to the point of overstress. Note also the small copper-coloured particles on the crack surface (examples arrowed)

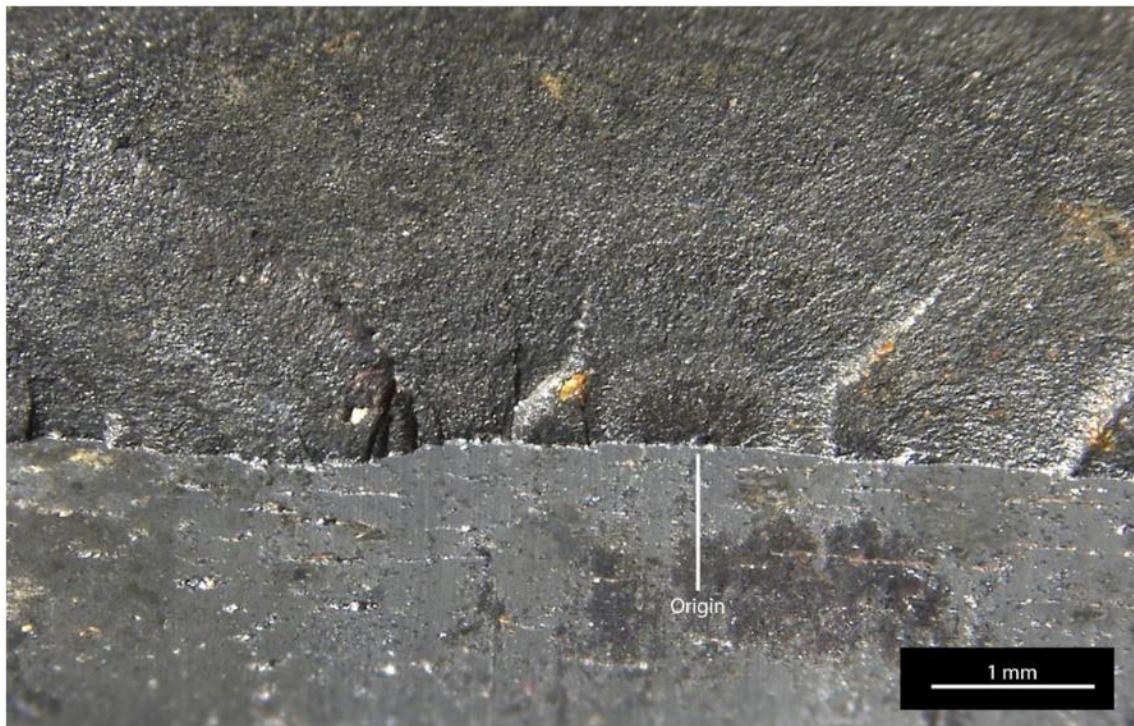
Figure B13: One of the fatigue crack origins (labelled) initiated from a corrosion pit within the bore of the fitting

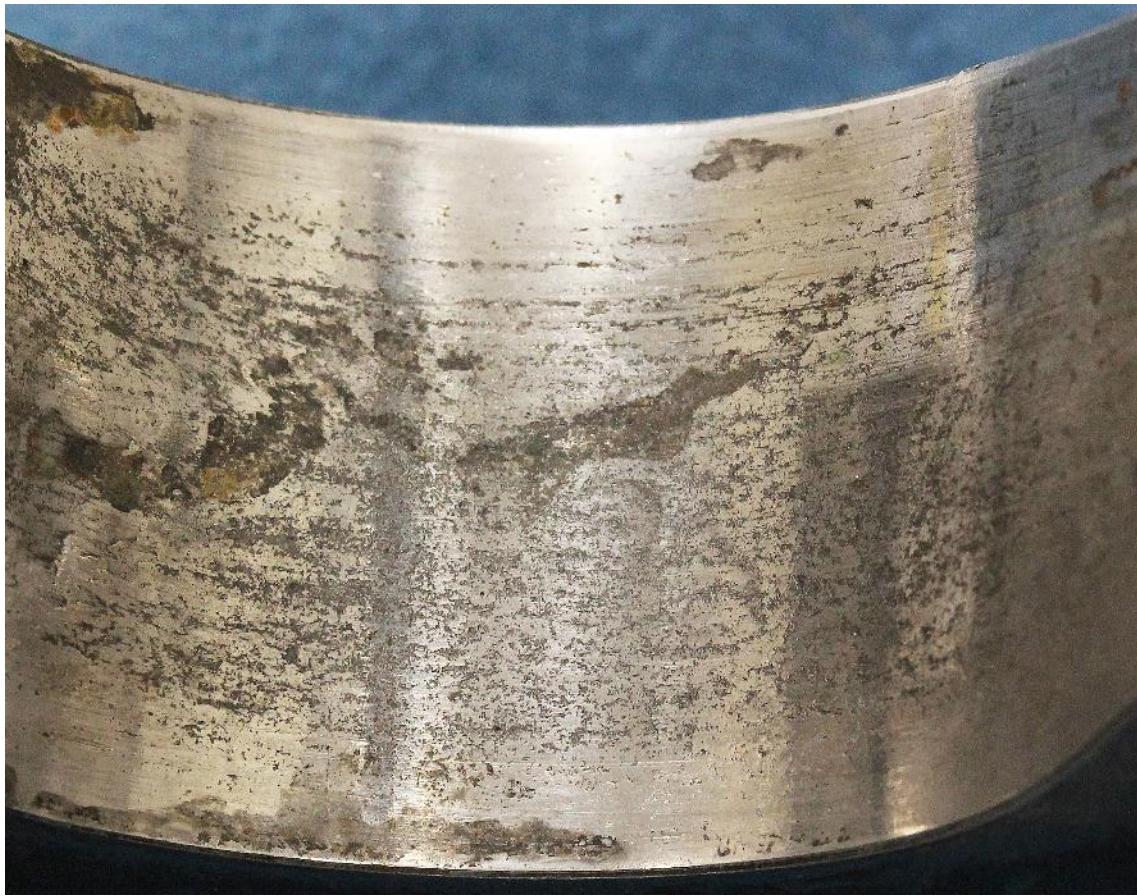
Figure B15: Fractured lug bore exhibiting extensive corrosion pitting

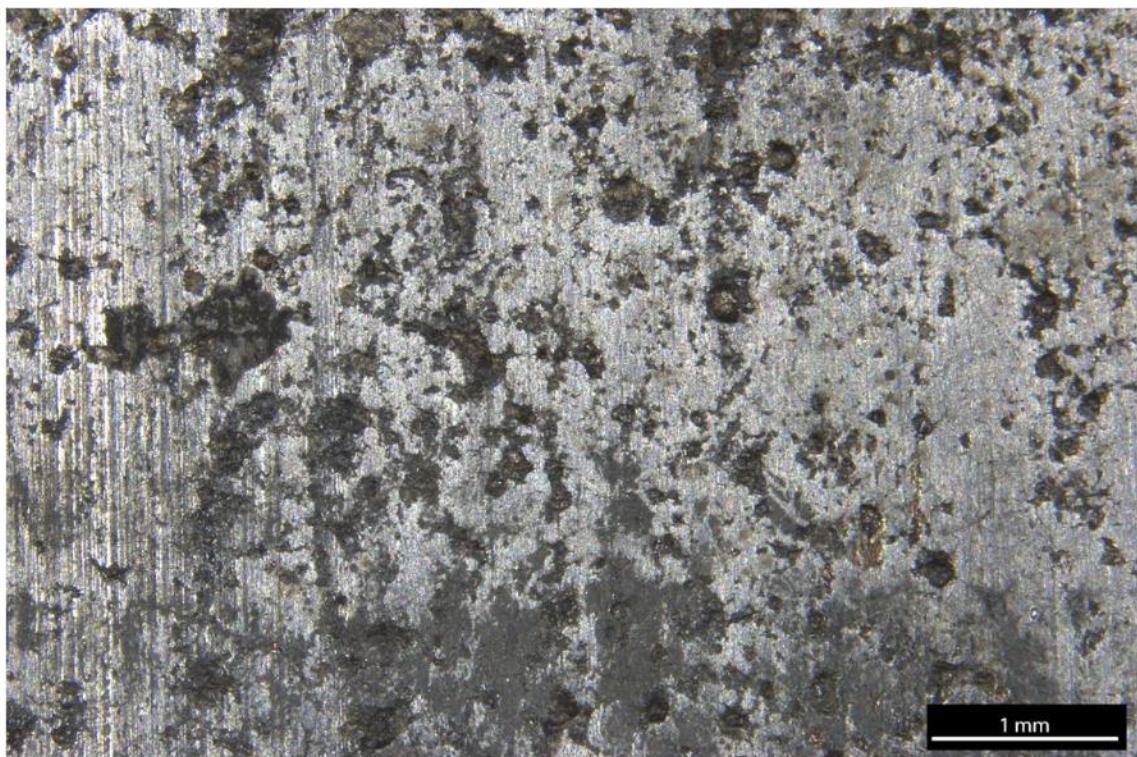
Figure B16: High magnification view of characteristic pitting damage within the bore of the fitting. Fine circumferential scoring can be seen (aligned vertically in this image).

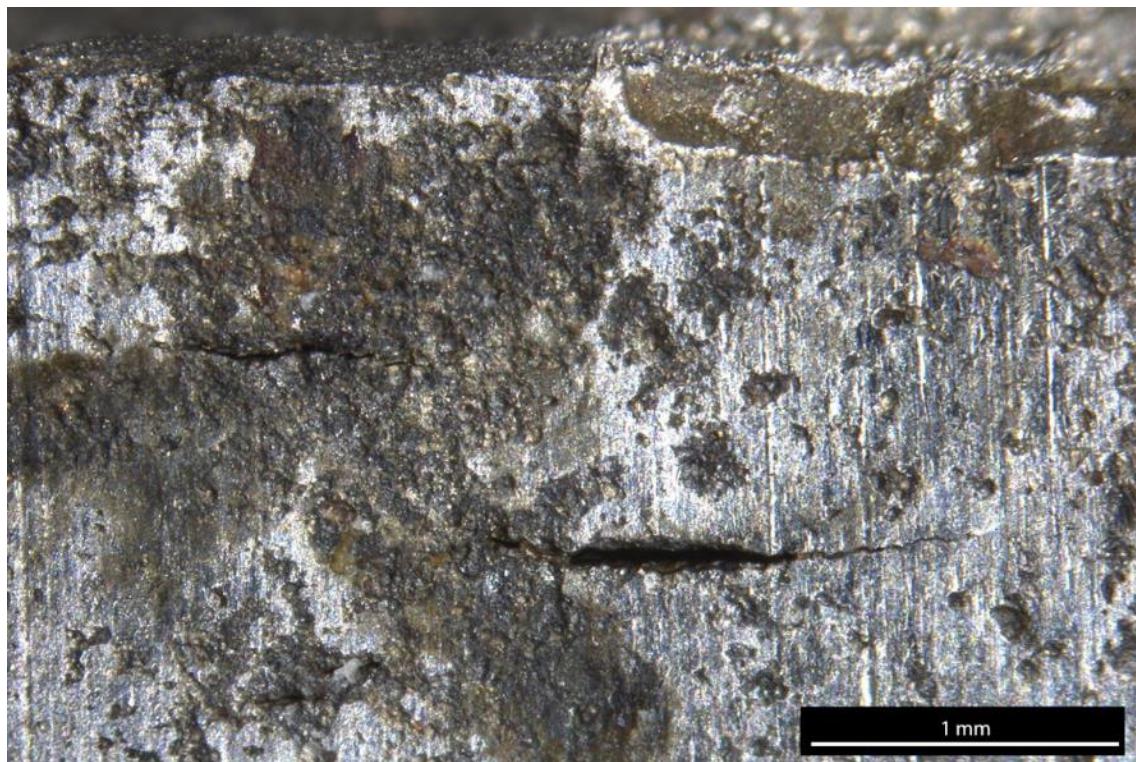
Figure B19: Secondary micro-cracking adjacent the primary fracture plane

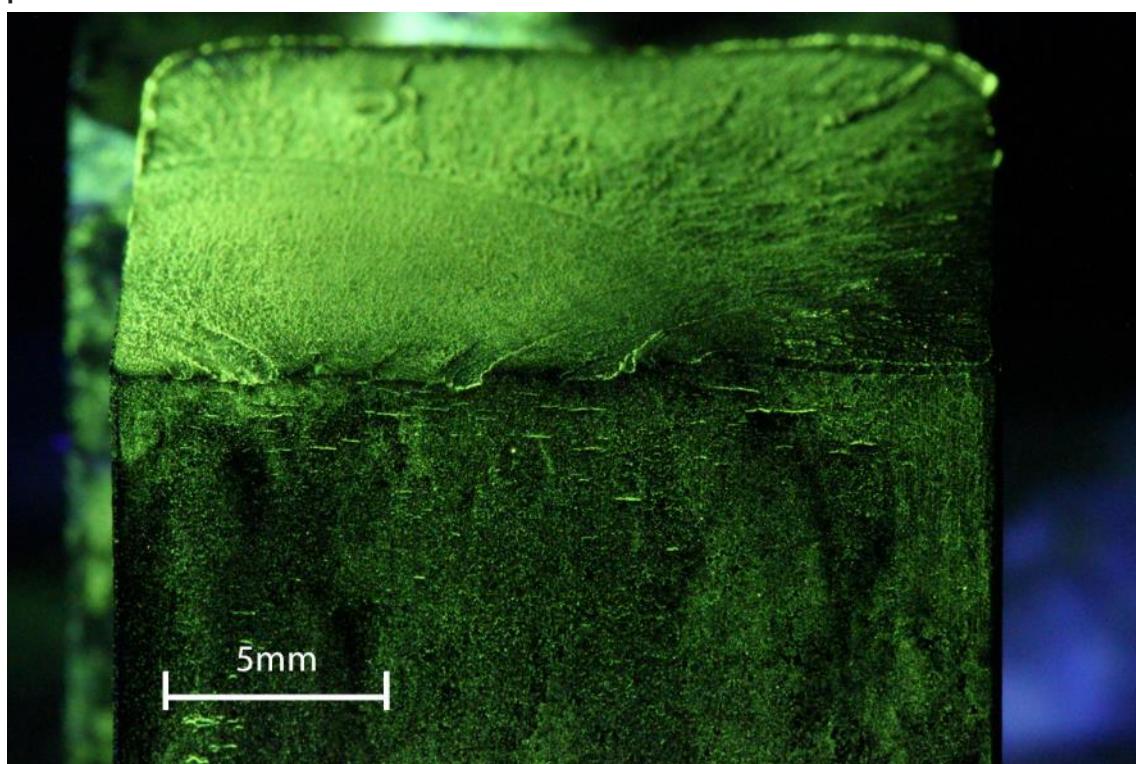
Figure B21: Fluorescent magnetic particle inspection of the fractured fitting. Many small secondary micro-cracks can be seen within the bore adjacent the primary fatigue fracture plane

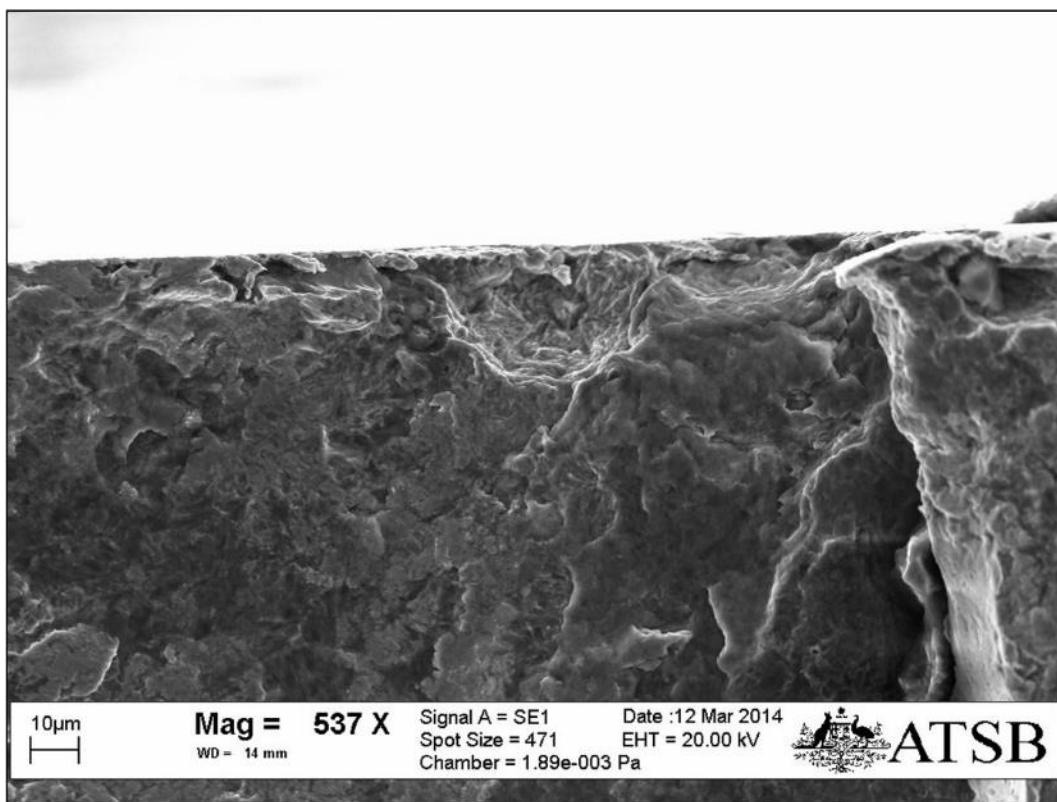
Figure B22: SEM micrograph of a corrosion pit at a site of fatigue crack initiation

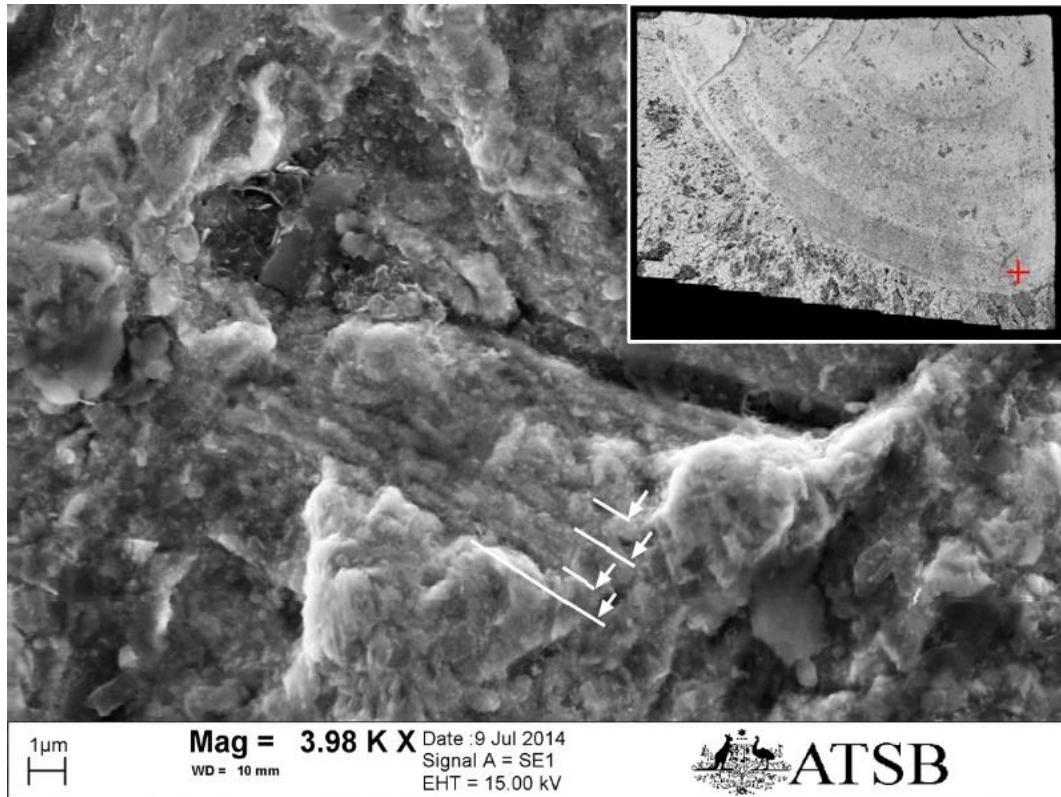
Figure B23: Composite SEM micrograph - very high magnification view of the only fatigue striations (arrowed) was identified on the fracture toward the overstress boundary (inset)

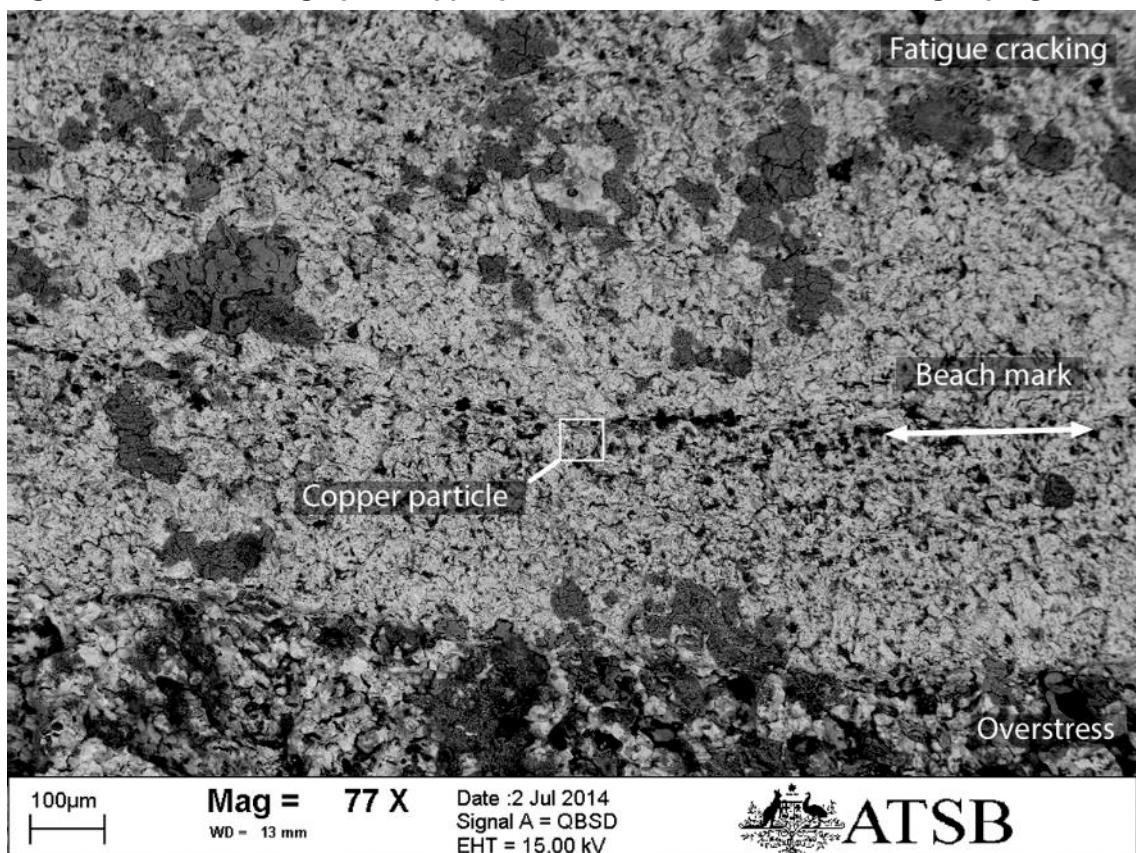
Figure B24: SEM micrograph – copper particle shown at final band of fatigue progression

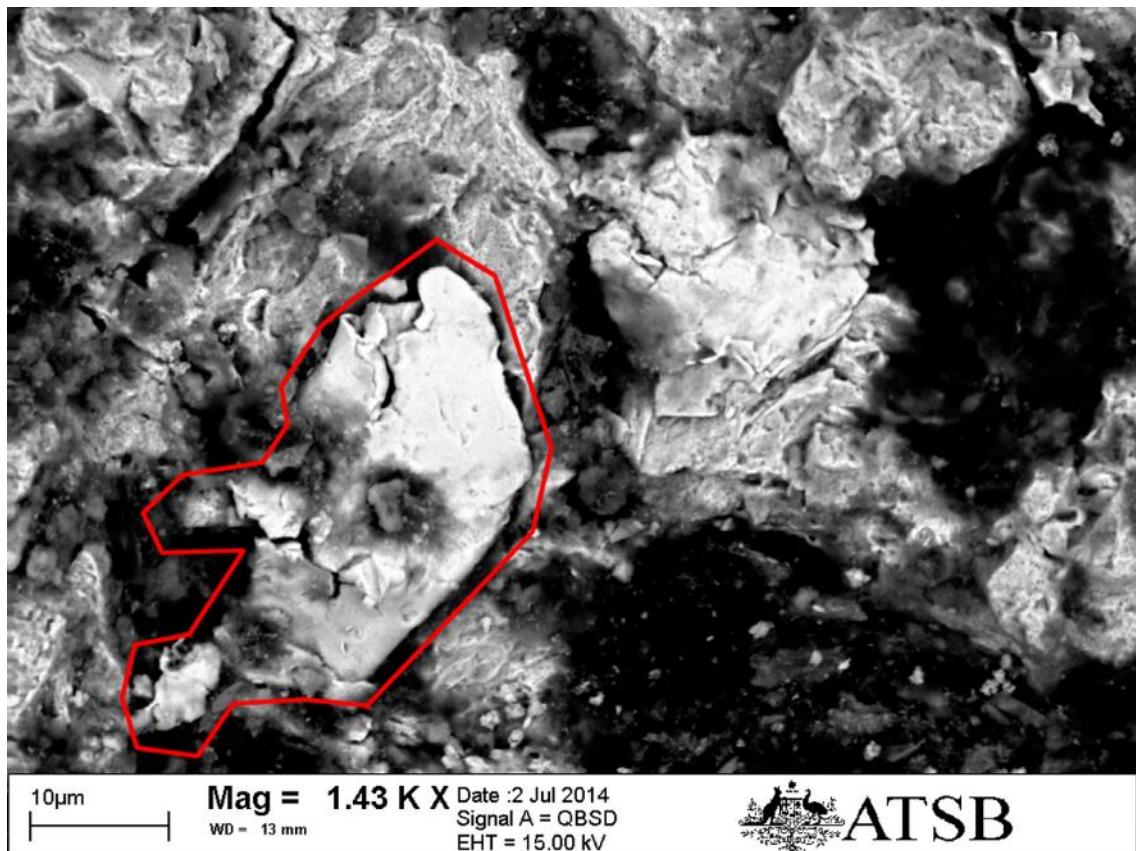
Figure B25: SEM micrograph showing copper particles from the grease that were pressed onto the fracture
