Collision with terrain involving a Robinson R22, VH-ZZM

115 km W of Rockhampton Airport, Queensland, 12 July 2014

ATSB Transport Safety Report
Aviation Occurrence Investigation
AO-2014-126
Final – 3 September 2014

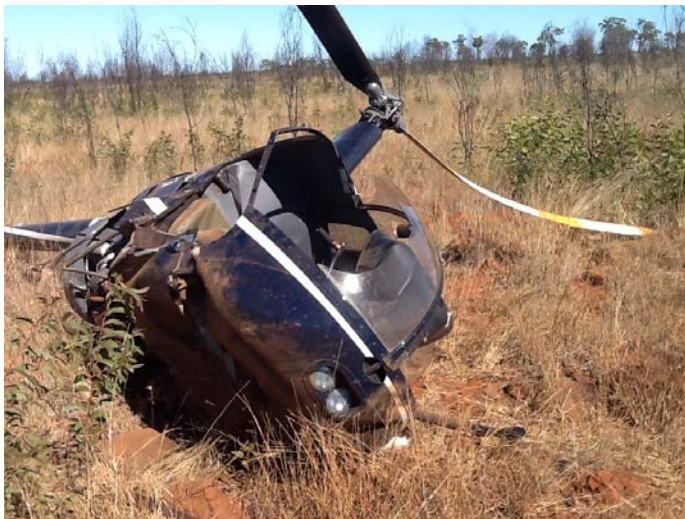
Figure 1: Damage to VH-ZZM

The helicopter landed hard, bounced once and rotated through about 180° before coming to rest. The supervising pilot turned off the master switch, activated the emergency beacon, selected the fuel to OFF and contacted emergency services. The pilot sustained serious injuries and the supervising pilot minor injuries. The helicopter was substantially damaged (Figure 1).
