Australian Government
Australian Transport Safety Bureau

Collision with terrain involving Cessna T210N, VH-ZFW

near Inverell Airport, New South Wales | 4 July 2014

ATSB Transport Safety Report
Aviation Occurrence Investigation
AO-2014-119
Final – 7 March 2016

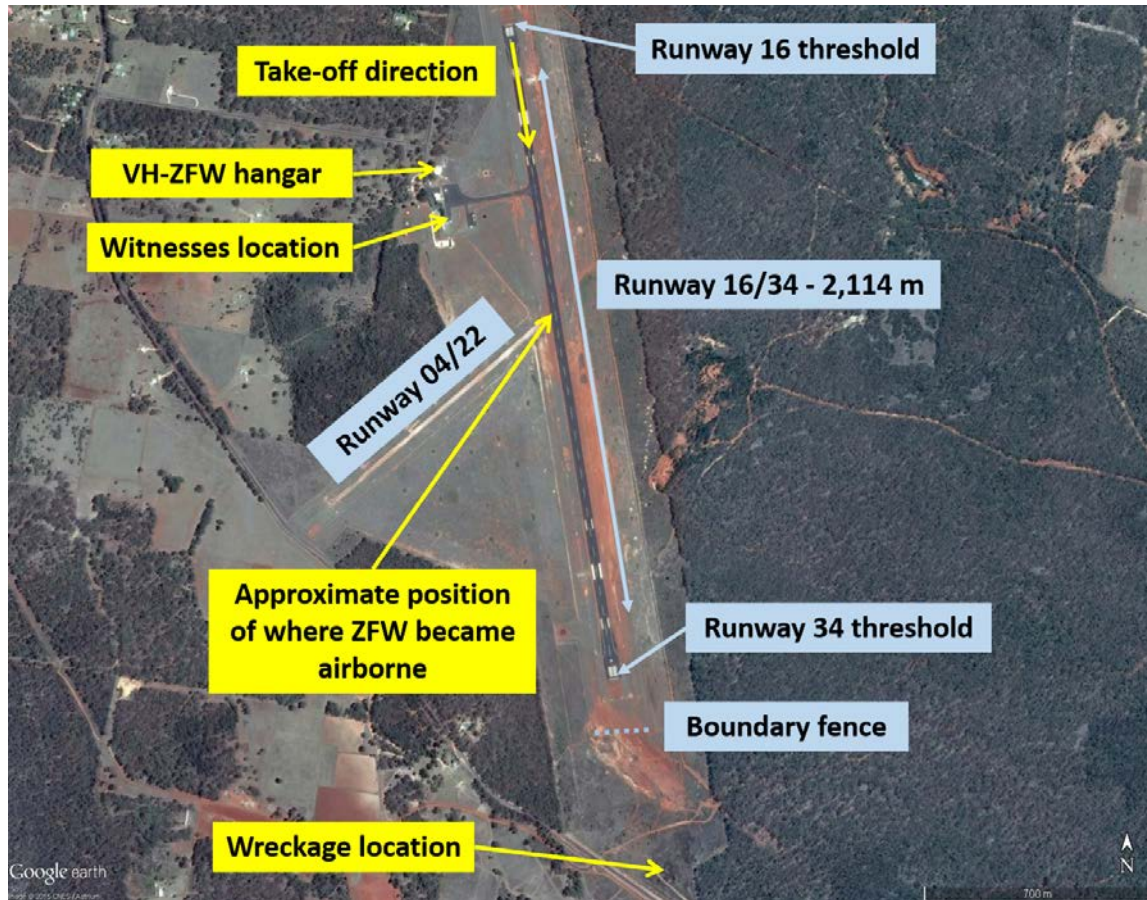
Figure 1: Runways at Inverell Airport, showing the location of the witnesses, approximate position that VH-ZFW became airborne and wreckage location

A witness who was familiar with ZFW and had observed the aircraft take-off from Inverell Airport on numerous occasions was positioned near a hangar overlooking runway 16/34 (Figure 1). The witness reported hearing ZFW start up and observed it taxi to the runway end and, soon after, commence the take-off. The witness indicated that during the initial stages of the take-off, the aircraft's acceleration along the runway and engine sound appeared normal.

As the aircraft passed runway 04/22, which is about 1,000 m along runway 16 and just before the depression in this runway (see the section titled *Operational information - Airport information*), it became airborne to about 10–13 ft (3–4 m). The witness reported that it looked like there was a slight crosswind as the aircraft's tail moved to the right. The witness believed the pilot then rejected the take-off, as the aircraft appeared to settle back onto the runway. However, due to the depression in the runway, the witness could only see the aircraft's wings. By this time, a second witness came out of the hangar.

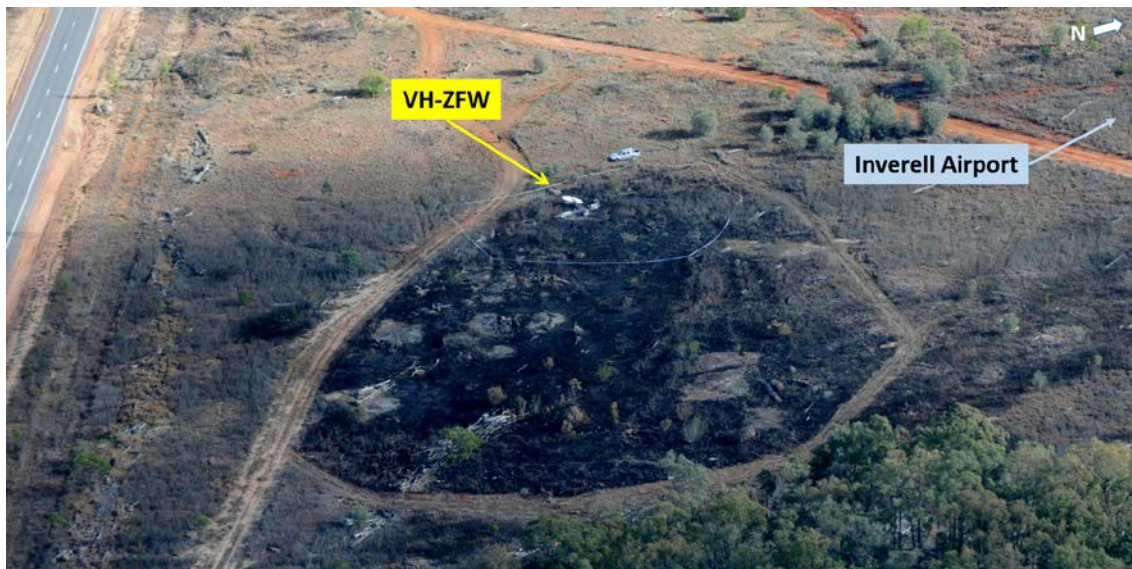
Figure 2: Aerial view of the accident site showing VH-ZFW (looking west-north-west)

The pilot and front seat passenger were hospitalised with serious injuries. The second passenger, who was sitting in the middle row of seats, received minor injuries. The front seat passenger later succumbed to their injuries. The combined effects of the impact forces and post-impact fuel-fed fire destroyed the aircraft (Figure 2).

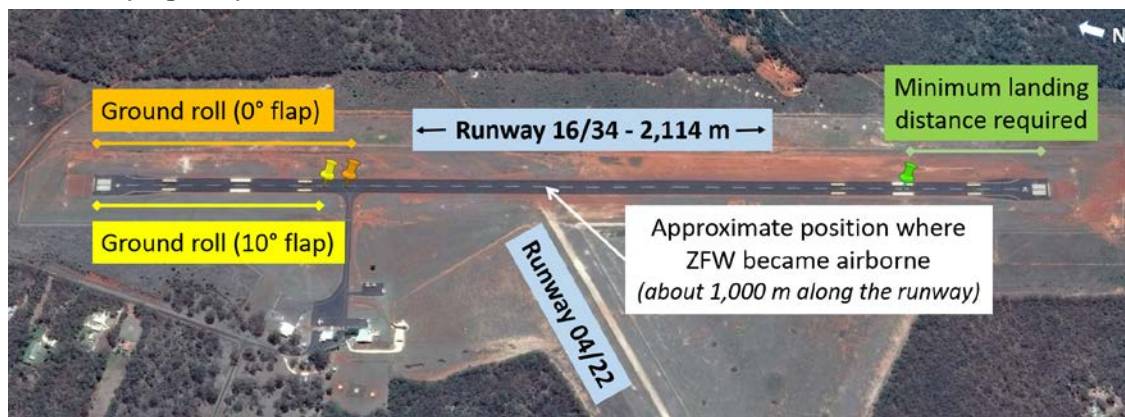
Figure 3: Estimated take-off distances with 10° (in yellow) and 0° (in orange) of wing flap set, the observed lift-off position along runway 16 and the minimum estimated landing distance (in green)

The landing distance was also estimated from information in the POH and was based on a flap setting of 30°, engine power at idle and the application of maximum braking. Given these conditions, depending on the aircraft's actual configuration at the time, the minimum distance

required for landing and braking to a complete stop would have been at least 320 m (Figure 3). However, the actual runway distance remaining when the pilot rejected the take-off was unable to be determined.

longer-than-normal take-off. In combination with the estimated minimum landing distance needed of 320 m, by the time the oil leak appeared and the pilot reacted to the associated loss of forward visibility, it was very likely that there was insufficient runway remaining for the pilot to continue the rejected take-off. This was consistent with the pilot and passenger's assessment of the aircraft's position at that time.

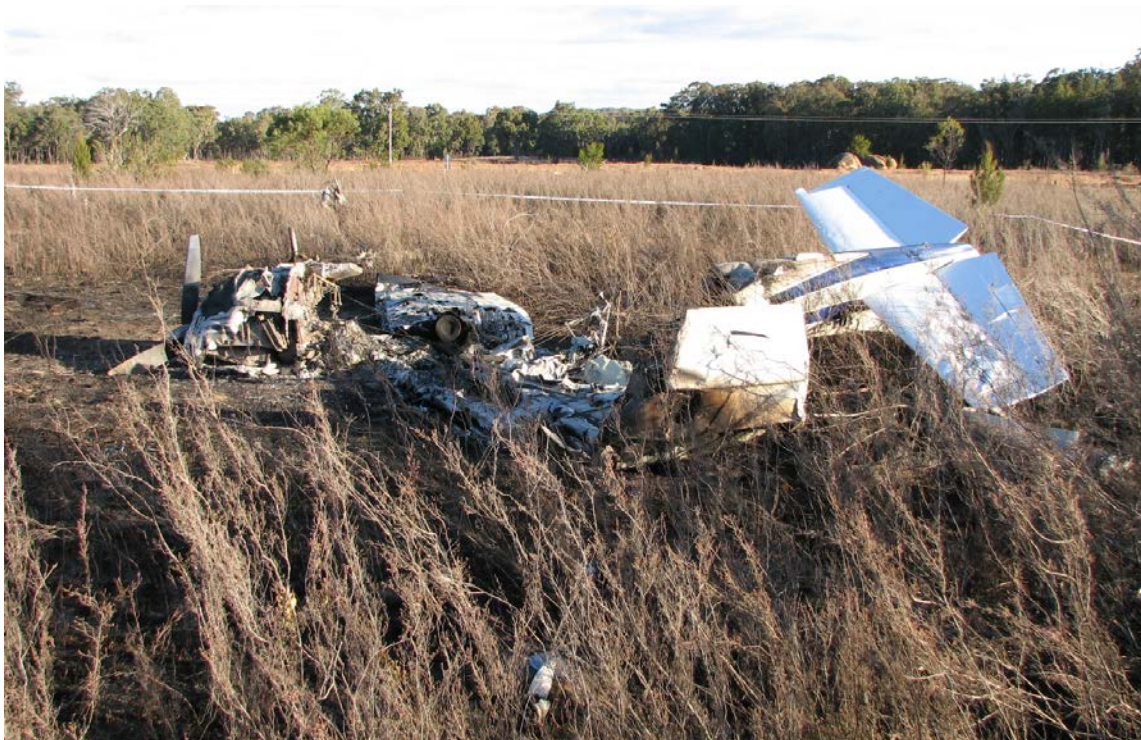
Figure 4: Aircraft wreckage showing the tail empennage inverted to the right and the propeller visible on the left (looking south-south-west)

An examination of the wreckage found that the aircraft approached terrain in a relatively level attitude, with the nose and left wing slightly down. The nose wheel contacted the ground first and detached from the aircraft. The right wing then impacted a shrub, sustaining significant impact damage and the aircraft flipped, before coming to rest inverted. A post-impact, fuel-fed fire destroyed most of the fuselage (Figure 4).

- That the damage to the propeller blades and strike marks on the ground were consistent with the engine producing some power at impact, but not full power.

- That the left side of the engine sustained more fire and heat damage than the right. After placing the engine in an upright position, the oil filler cap was found detached from the oil filler tube but hanging by its chain. There was evidence of oil around the oil filler tube and on the ground. The separate oil dipstick remained secured in position.
