# Collision between track worker and passenger train

Guildford, Western Australia | 10 February 2015

**ATSB Transport Safety Report**  
Rail Occurrence Investigation  
RO-2015-002  
Final – 10 March 2016

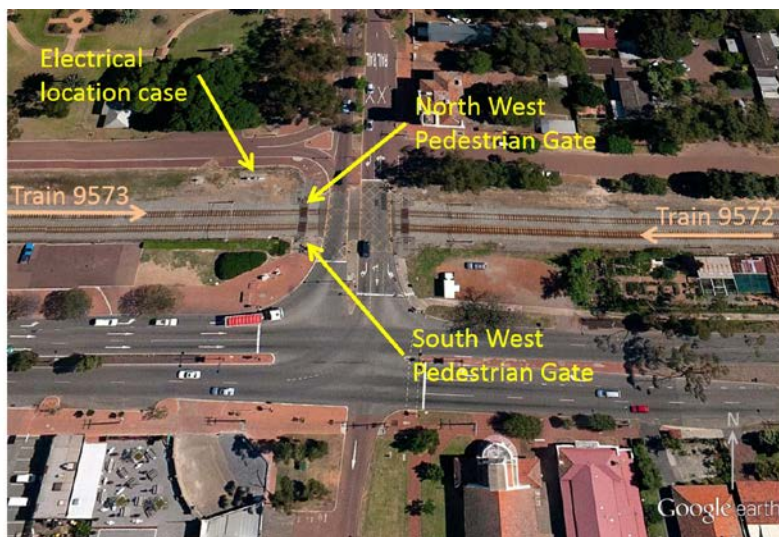
**Figure 1: Location map – Meadow Street level crossing, Guildford**

The maintenance crew were examining the north-west pedestrian gate until the passage of 9573. They then walked across the walkway to the south-west gate to compare the mechanism adjustments. The protection officer then turned and started to walk back across the railway when he was struck and fatally injured by train 9572. Source: Google Earth annotated by ATSB

At about 1032, train 9573 approached the Meadow Street level crossing from the west (Figure 1). The team, after again observing the operation of the pedestrian gate, decided to compare the control arm settings with the south-west pedestrian gate control arm. After train 9573 had passed through the crossing, the protection officer and the maintainer crossed the railway to the south-west pedestrian gate while the signal technician returned to the electrical location case. The level crossing protection equipment continued to operate because another train (9572) was

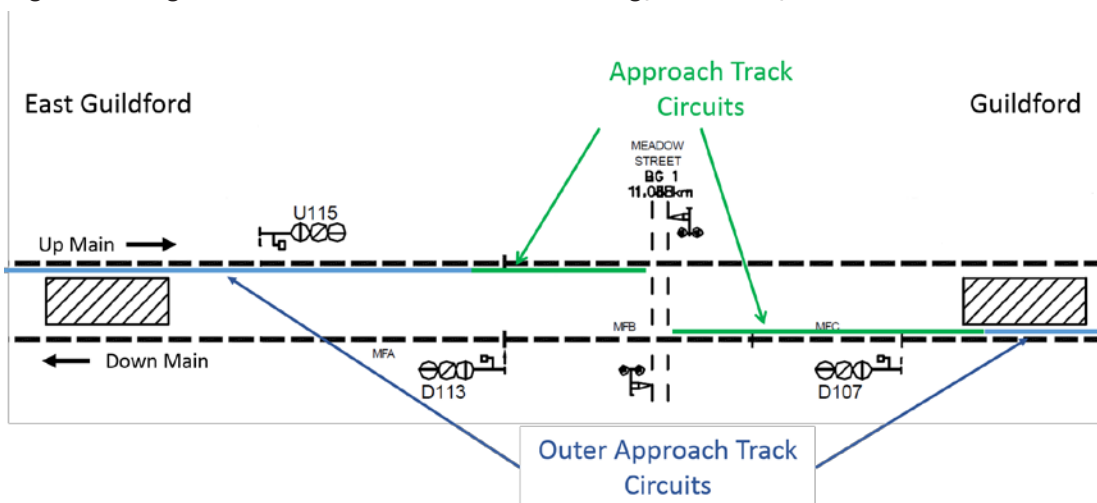
**Figure 2: Diagram of Meadow Street level crossing, Guildford, WA**

The Meadow Street level crossing used electronic approach and outer approach track circuits to detect the approach of trains from either direction on either line (Figure 2). When a train is detected on the approach, the control circuit causes the level crossing bells and lights to activate, and the boom gates to lower. In addition, the automatic pedestrian gates close and the pedestrian alarms sound. Due to the proximity to the James Street intersection, an indication is provided to the road traffic light control system to manage any traffic intending to turn into Meadow Street.

The purpose of the outer approach circuits is to prevent the level crossing boom gates from rising and descending in quick succession if a second train is approaching the crossing. If the level crossing equipment is already operating and a train detected on the outer approach, the boom gates remain lowered and the pedestrian gates remain closed until the second train has passed.

The level crossing bells and lights operate when trains are detected on the approach track circuits (shown in green). If the crossing is already operating, it will continue to operate if another train is detected on either the approach track circuits or the outer approach track circuits (shown in blue). Source: PTA amended and annotated by ATSB

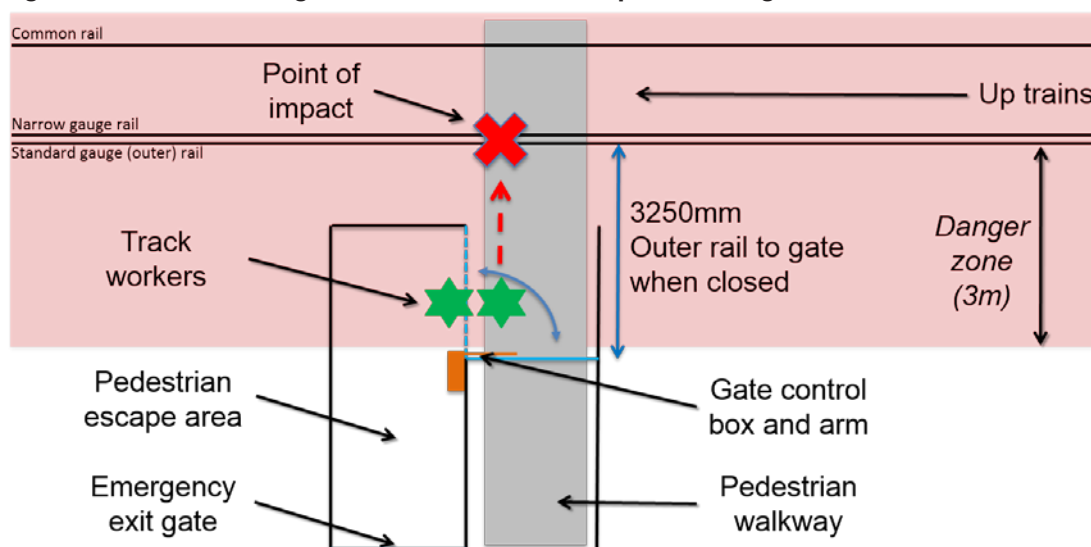
**Figure 3: General arrangement of south-western pedestrian gate**

One such task was the inspection and, if required, adjustment of the pedestrian gate closing mechanism. The gate control box was located inside the pedestrian escape, with the control arm running from the box to the gate on the track side (Figure 3) - about 3 m from the railway line.

The protection officer and signal maintainer reviewed the operation of the south-western pedestrian gate from the track side of the closed gate (within the danger zone). This examination placed the track workers in a position that was less safe than being within the pedestrian escape area or on the outside of the closed gate. Source: ATSB

Maintenance personnel advised that to assess or adjust the control arm required track workers to stand inside the three-metre danger zone. Some maintainers would carry out the task with the gate open, working in the escape area with the gate acting as a barrier to the track. However, it was evident that some other maintainers carried out the task when the gate was closed, in which case there was no barrier protecting them against inadvertently stepping onto the track.

The ATSB's investigation found that the process for conducting maintenance on level crossing pedestrian gates varied between personnel. In the subject case, the workers adopted a process whereby the presence of a train was used to operate the level crossing equipment and maintenance and/or adjustment of the gate control arm was undertaken while the gate was in the closed position. This process meant that workers would be positioned within the danger zone, and focused on the maintenance task, at a time when trains were present, and without a barrier between themselves and the track.
