# Engine failures and malfunctions in light aeroplanes

2009 to 2014

**ATSB Transport Safety Report**  
Aviation Research Statistics  
AR-2013-107  
Final – 9 March 2016

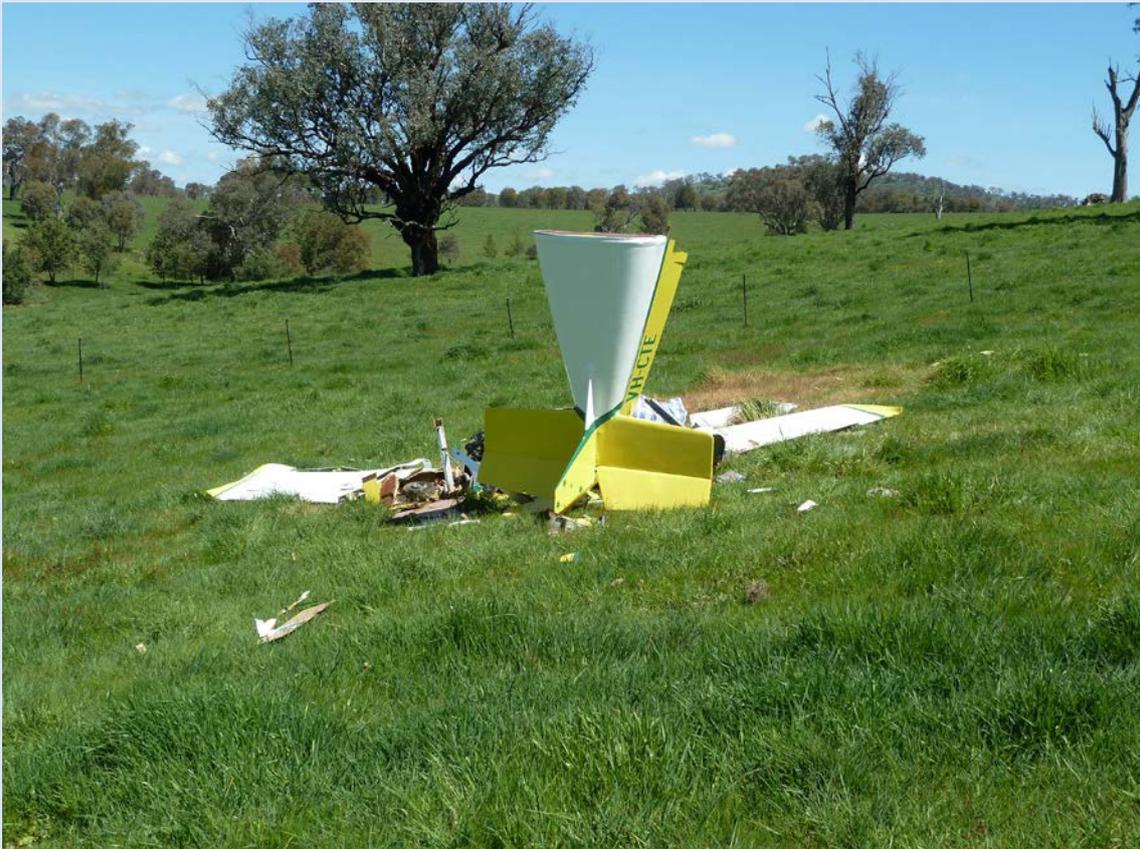
The ATSB investigation found that shortly after take-off, the number three cylinder upper sparkplug was ejected from the cylinder head hole, resulting in a significant loss of engine power. This failure was the result of an incorrectly installed spark plug thread insert. While positioning the aircraft for a return landing onto the departure airstrip after the power loss, the aircraft probably entered an aerodynamic stall from which the pilot was unable to recover before the aircraft impacted terrain. The pilot was fatally injured and the aircraft destroyed.

Wreckage of the Rand Robinson KR-2

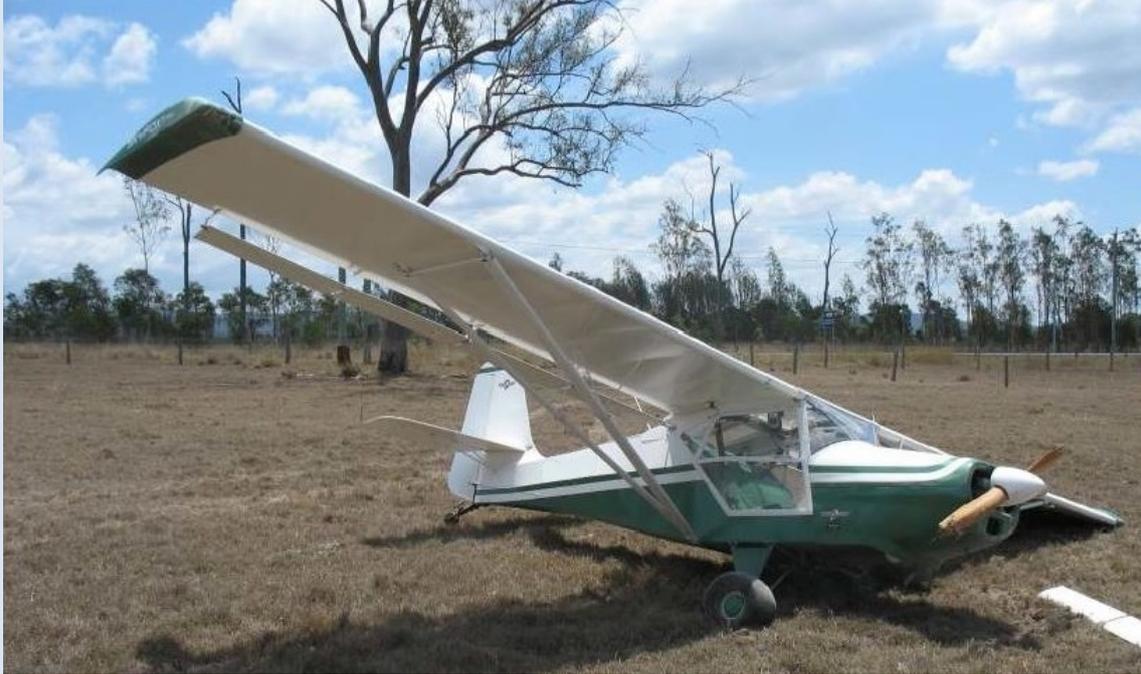
While cruising at 1,000 ft on a flight from Coominya to Emu Gully, Qld, the Skyfox aircraft experienced engine difficulties followed by a total engine failure. The pilot conducted an emergency landing into a paddock. During landing the pilot lost control during a cross-wind. The left wing tip struck the ground after which the aircraft landed heavily and slid along the ground for about 50 metres, resulting in substantial damage. Damage was caused to the landing gear, engine cowling, fuselage, flaps and propeller.

Wreckage of the Skyfox

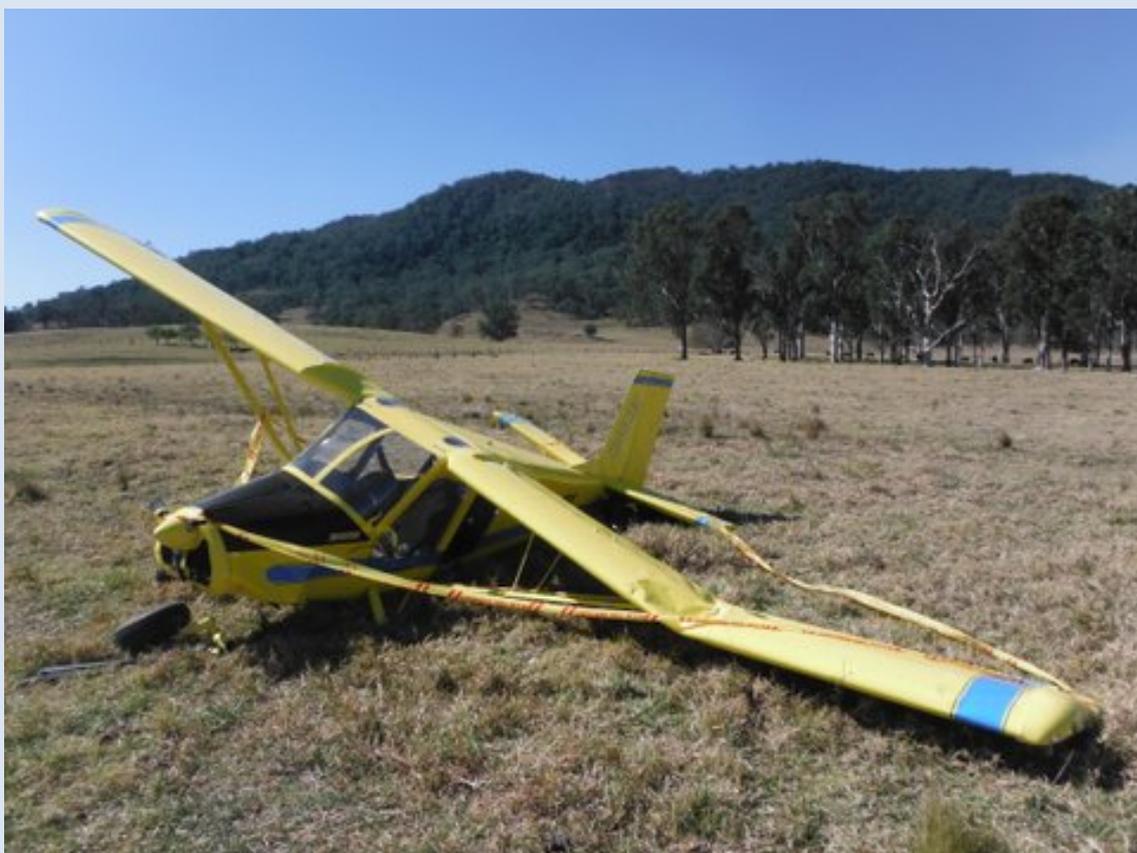
Following a complete loss of engine power, and a subsequent restart that only produced marginal power, the pilot of the Hornet STOL aircraft conducted a forced landing to a paddock east of Gloucester NSW. The aircraft sustained substantial damage from both the impact and post-impact fire. The sole occupant received minor injuries. Although fuel availability, flow and contamination were ruled out from initial investigation, the cause of the engine failure remains unknown.

Wreckage of the Hornet STOL aircraft

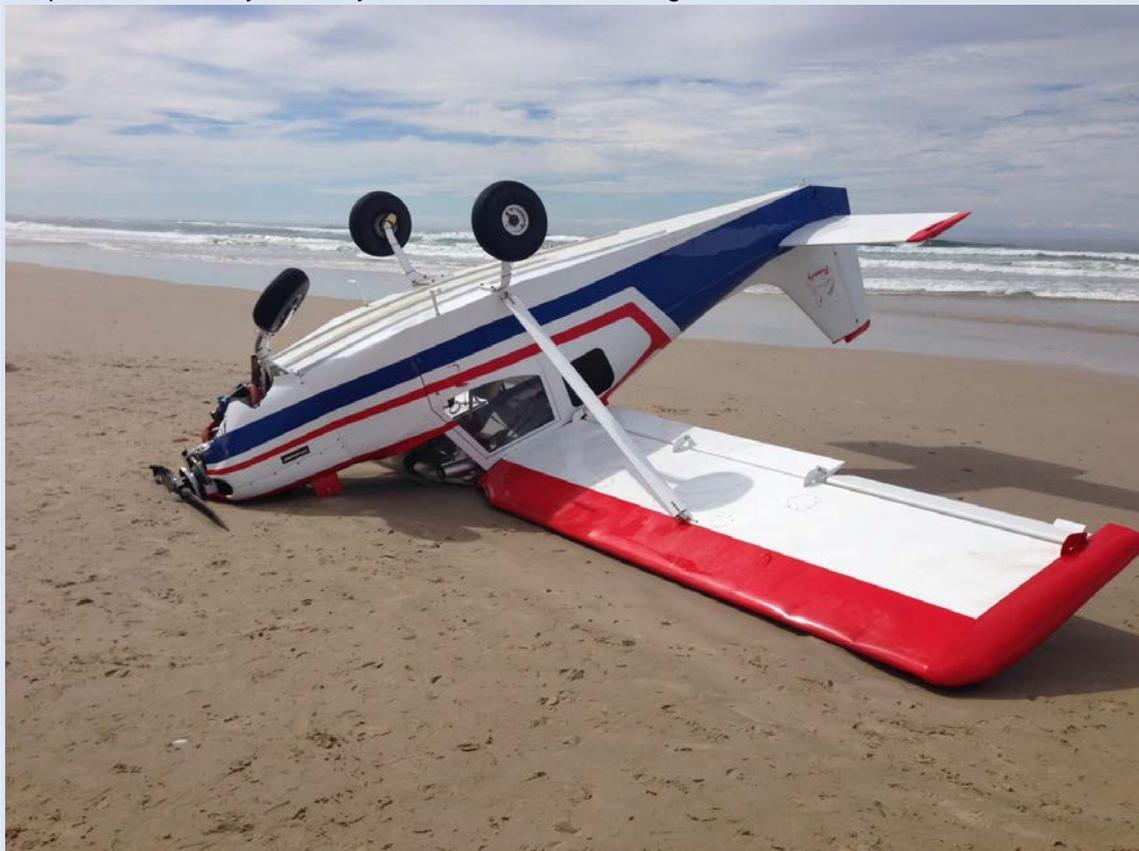
During the cruise from Broadwater to Mullumbimby, NSW, the engine in the factory-built Brumby aircraft started to run roughly and then failed. During an attempted forced landing on a beach, a wave caught the aircraft, flipping it on its nose. Although the aircraft sustained substantial damage, the pilot received only minor injuries. The cause of the engine failure remains unknown.

Wreckage of the Brumby aircraft

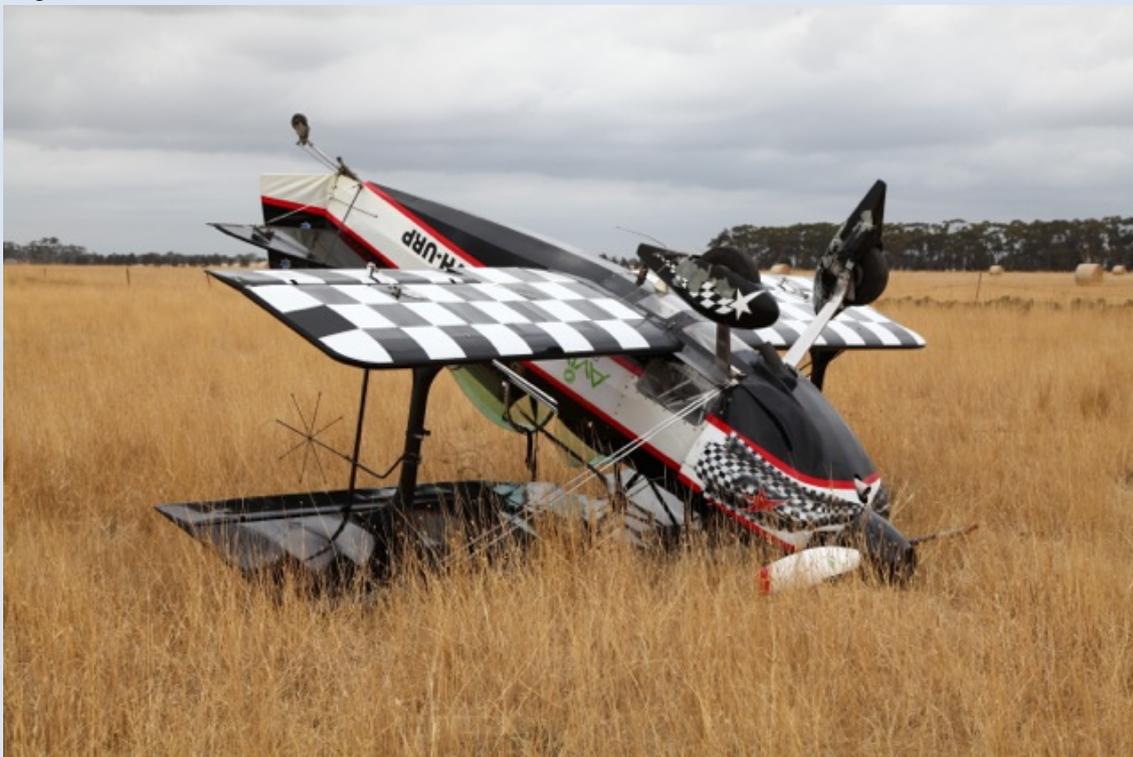
During the landing roll, the aircraft collided with a rock and nosed over, coming to rest inverted. The aircraft was substantially damaged.

The pilot reported that the 'flop tube' may have become stuck. It supplies the engine with fuel from the top of the tank when the aircraft is inverted. This may have been resolved by rolling the aircraft inverted. However, this was not a safe option at low altitude, with a partial or complete engine failure. The damage to the aircraft was assessed as being greater than the replacement cost therefore no post-accident engineering inspection was conducted to determine the cause of the engine failure.

Damage to VH-URP
