# Runway excursion involving a Fairchild Metro 23, VH-UUB

Portland, Victoria | 20 February 2014

**ATSB Transport Safety Report**  
Aviation Occurrence Investigation  
AO-2014-028  
Final – 22 March 2016

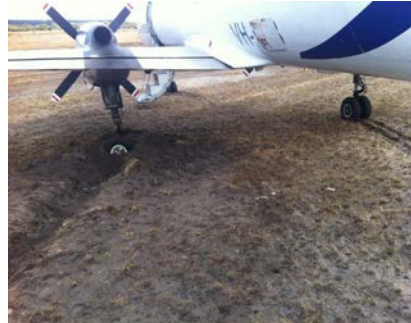
On 20 February 2014 at 1425 EDT, a Fairchild Industries Metro 23 aircraft, registered VH-UUB, was being operated on a charter flight from Avalon to Portland, Victoria with 10 passengers and two crew on board. Shortly after touch-down the torque link on the left, main landing gear (MLG) failed. The aircraft veered left as a result, and came to rest beside the runway. There were no injuries as a result of the occurrence.

**UUB after veering off runway**

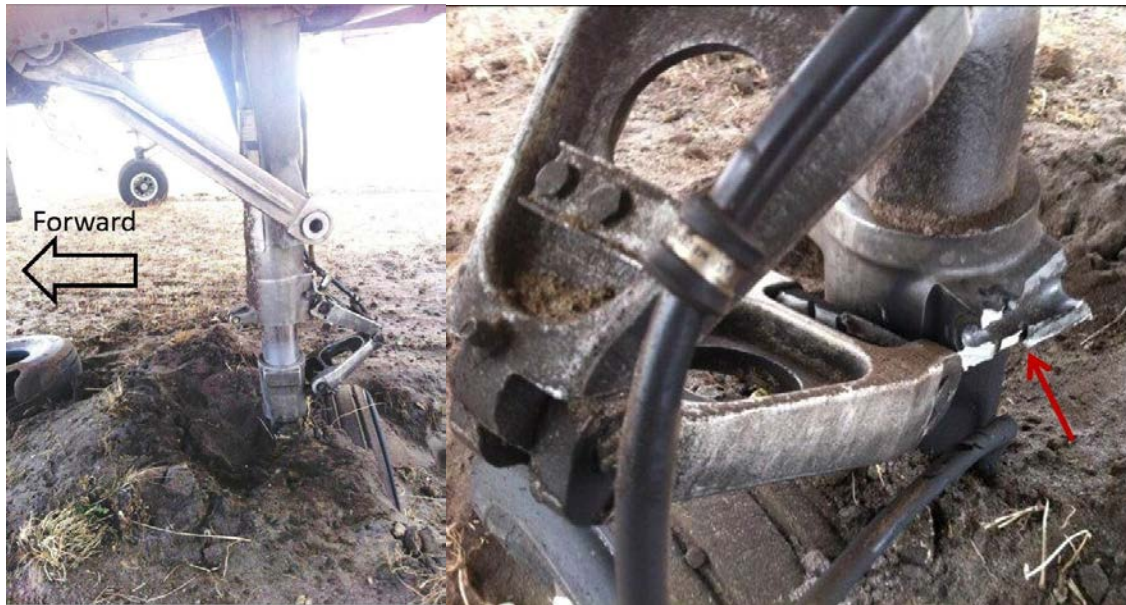
**Figure 1: Damage to the left MLG**

Subsequent inspection of the aircraft found that the torque link<sup>2</sup> had detached from a fractured lug on the lower section of the left MLG (arrowed in Figure 1b), allowing the wheel assembly to rotate through 90° w.r.t. the direction of aircraft travel. This resulted in skidding wheels, producing a significant braking effect on the left main gear and causing the aircraft to veer to left and depart the runway (Figure 2).

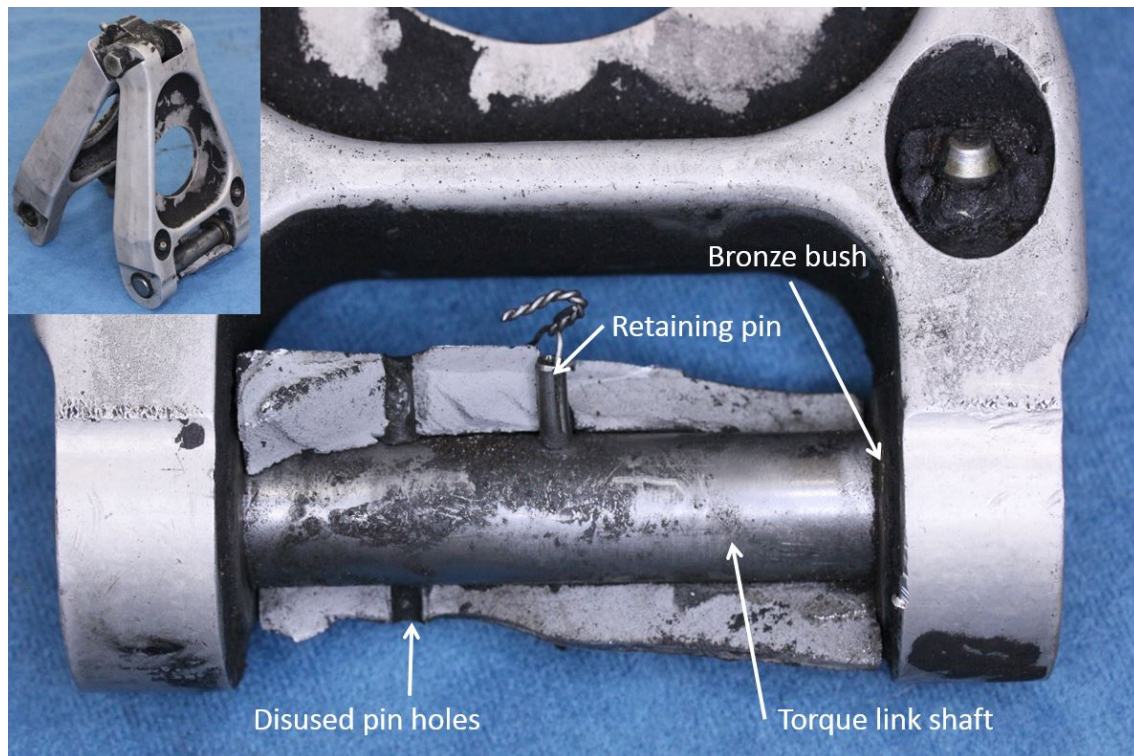
**Figure 4: Lower torquelink attachment assembly with fractured lug segment in-situ**

The aluminium torque link and yoke were assembled via a steel torque link shaft (TLS) that mated with bronze bushes in the lower link. It was secured with a single, stainless steel retaining (spring) pin with stainless steel lockwire in its bore (Figure 4).

The fractured yoke contained four disused retaining pin holes (two each top and bottom) as a result of compliance with a service bulletin (SB) for installing a replacement TLS (CC7-32-012), released in 2002. The SB required drilling of a new pin hole in the lug to secure the replacement TLS and filling of the redundant holes with sealant. As-examined, the disused holes in the fractured yoke were not sealed, but instead contained black corrosion/wear product. However, traces of sealant around some of the holes suggested that they had probably been filled at the time of service bulletin compliance.

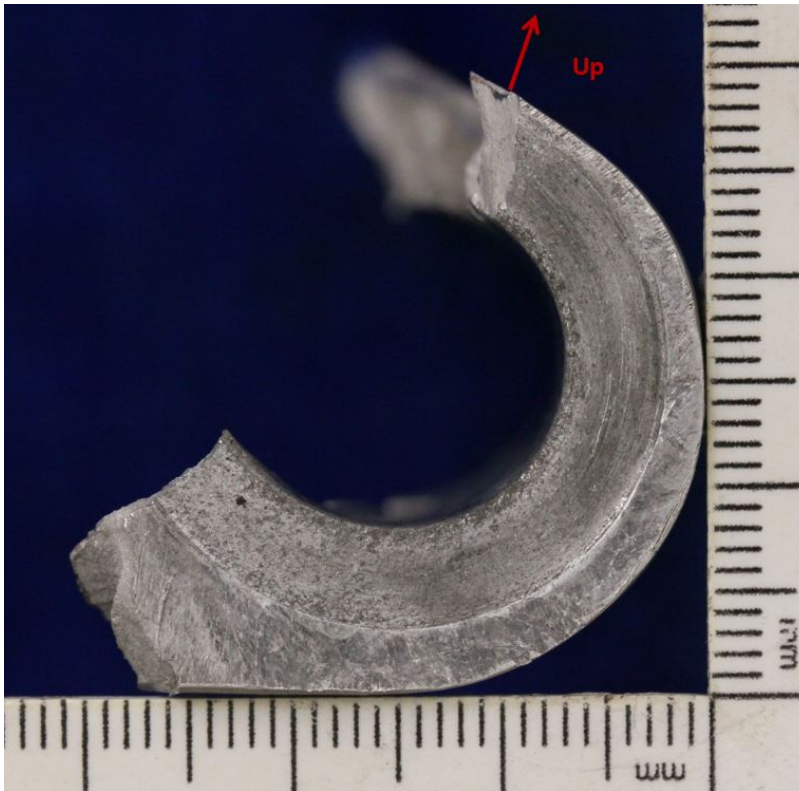
**Figure 6: Flank of the fractured yoke lug showing surface wear from mating bush**

The bronze bushes installed in the lower torque link had worn against the yoke's lug flanks during normal operation such that, in the areas of greatest wear, the width of the lug was now 66.03mm (2.6") which was 0.26mm (0.01"), below the minimum dimension of 2.61" (66.294mm) specified in the structural repair manual (Figure 6).
