Runway excursion involving ATR72, VH-FVY

Moranbah Airport, Queensland | 8 July 2013

ATSB Transport Safety Report
Aviation Occurrence Investigation
AO-2013-114
Final – 31 March 2016

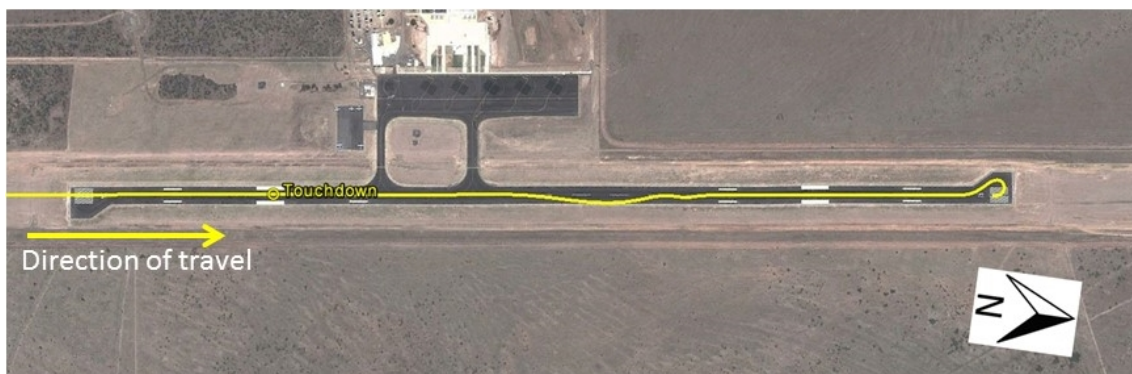
Figure 1: Aircraft path along runway 34 during the landing roll

Subsequent examination found no aircraft damage. Runway tyre marks associated with the landing showed that at least one of the right main landing gear wheels had departed from the runway.

The aircraft's path during the touchdown and landing roll are derived from recorded flight data, and matched the runway tyre marks. The aircraft touched down in the correct location and the changes in direction did not start immediately. The aircraft had a number of larger changes in direction before slowing to taxi speed before the end of the runway.

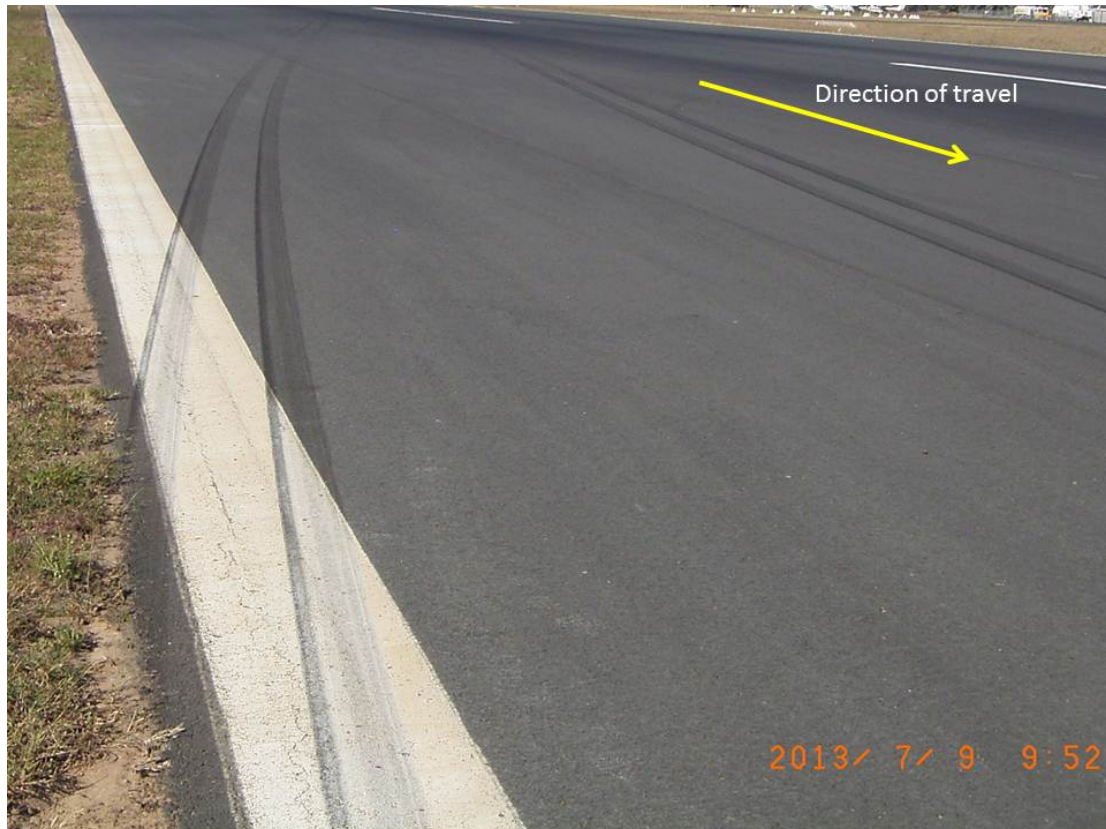
Figure 2: Runway tyre marks

An examination of the runway tyre marks was carried out. Striation marks running in the same direction as the tyre marks indicated that the main wheels were braking. However, the tyres were approaching their limits of adhesion.

There was no evidence of any oblique striation patterns. This indicated that there was sufficient friction available to overcome the cornering forces exerted at the tyre/runway interface.

The darker edges on the outside of the turn indicated a shift of the weight to the outside of the tyres. There was no indication that any of the wheels locked up. This indicated the correct operation of the aircraft anti-skid system (Figure 2).

The four tyre marks preceding the runway excursion were produced by the main landing gear. They indicated:

- *hard wheel braking was applied*
- *the braking did not exceed the limits of adhesion on any tyre*
- *the aircraft was turning left exerting more force on the outside-right of the tyre*
- *at least one wheel left the runway surface and rolled onto the adjacent grass.*

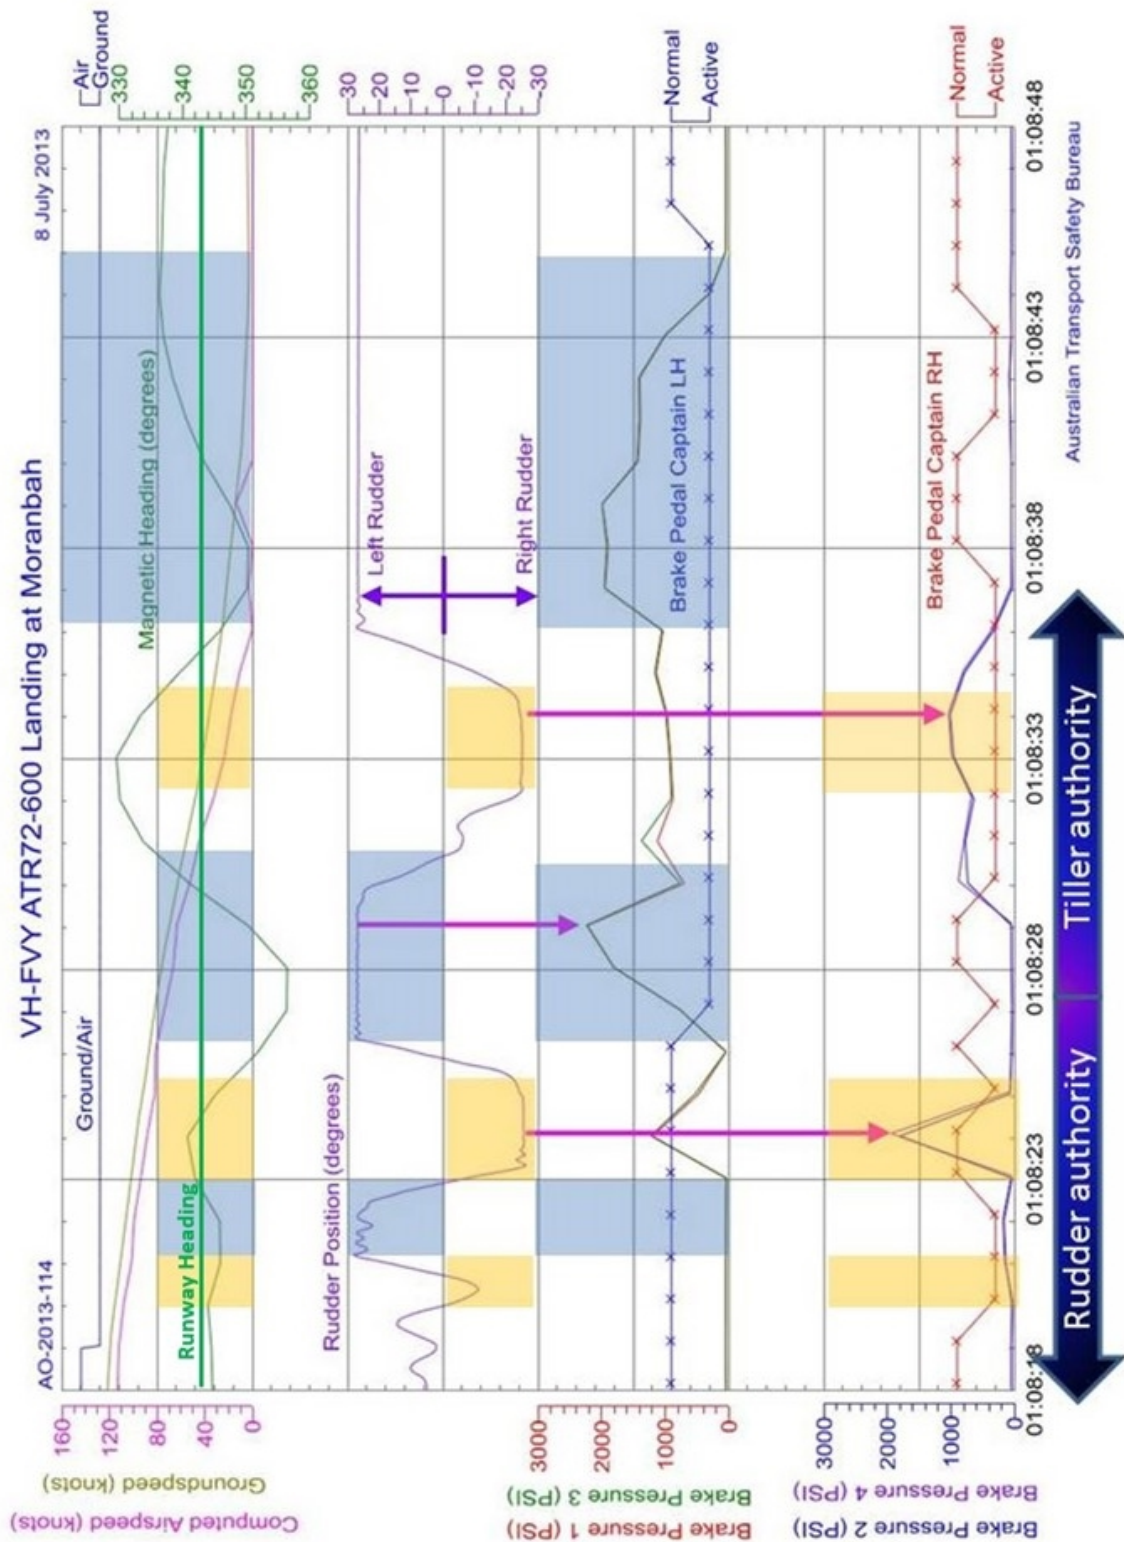
Appendix A - Recorded flight data

Data obtained from the aircraft's flight recorder showed the control inputs immediately before touchdown at Moranbah. At that time, the aircraft was flying 3°–4° right wing-low and with 5°–10° left rudder applied. These control inputs changed the aircraft heading 1°–2° left to align the landing gear with the direction of movement over the runway (appendix A).

Recorded data indicated that neither brake was depressed during the touchdown sequence, although left rudder was being used.

Two seconds after touchdown, the left rudder input changed to a small right rudder input for less than 1 second. At the same time, a very small amount of right wheel brake pressure was applied. There was no indication that asymmetric wheel brake had a significant influence on directional control. The aircraft yawed right by less than 2°.

The right yaw was controlled by the application of full left rudder at 100 kt airspeed for about 2 seconds. The aircraft yawed left until beyond the runway centre-line.

Full right rudder was then applied at 90 kt airspeed, which stopped the left yaw. However, the aircraft then started a faster right yaw.

There was a momentary application of wheel brakes, with more brake pressure applied to the right landing gear. Again, there was no indication that asymmetric wheel brake had a significant influence on directional control. About 3 seconds later, after the aircraft had turned past the runway heading, full left rudder was applied at 80 kt airspeed. The right yaw was stopped after a 15° heading change.

During the next 4 seconds with full left rudder application, the aircraft yawed left through the runway heading. During this time, the aircraft continued right, departing the runway for a short period. The left wheel brake was increasingly applied until the aircraft passed through the runway heading. From then, symmetrical wheel braking was applied to the wheel brakes.

After the 4-second period and the aircraft had turned past the runway heading, rudder input was changed from full left to full right over 2 seconds at about 40 kt airspeed. The left yaw stopped after a 26° left heading change. The aircraft had slowed to about 40 kt ground speed by this time.

The aircraft then yawed 20° right as the aircraft slowed to a taxi speed. Full left rudder input was then applied and the left wheel brake pressure increased while the right wheel brake pressure reduced to zero.
