# Collision with a vehicle, involving an Air Tractor AT-502B, VH-FNX

23 km W of Hay, New South Wales, on 17 September 2015

**ATSB Transport Safety Report**  
Aviation Occurrence Investigation  
AO-2015-111  
Final – 13 April 2016

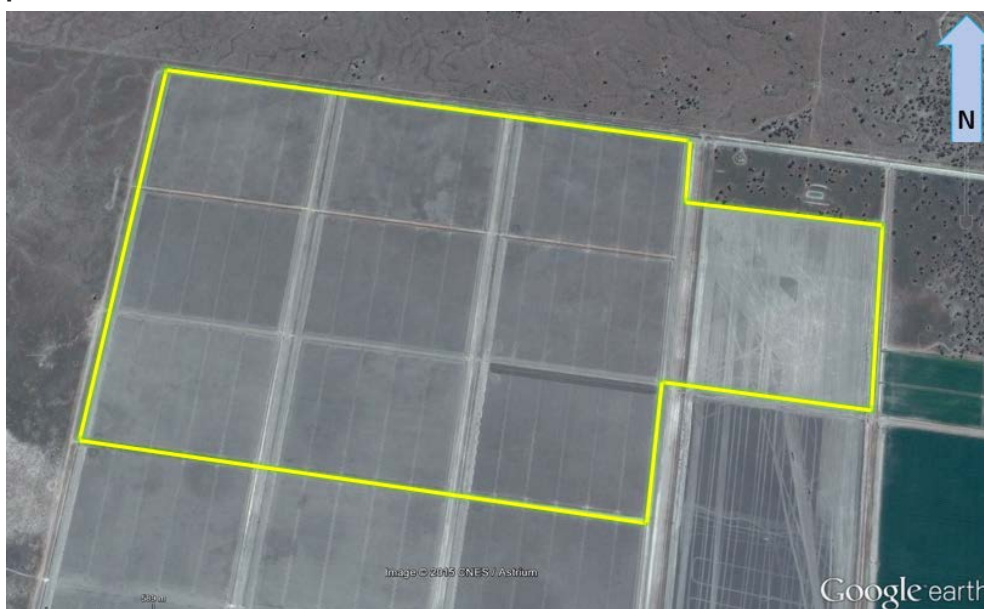
**Figure 1: Spray application area - a block of nine paddocks with another adjoining paddock at the eastern end**

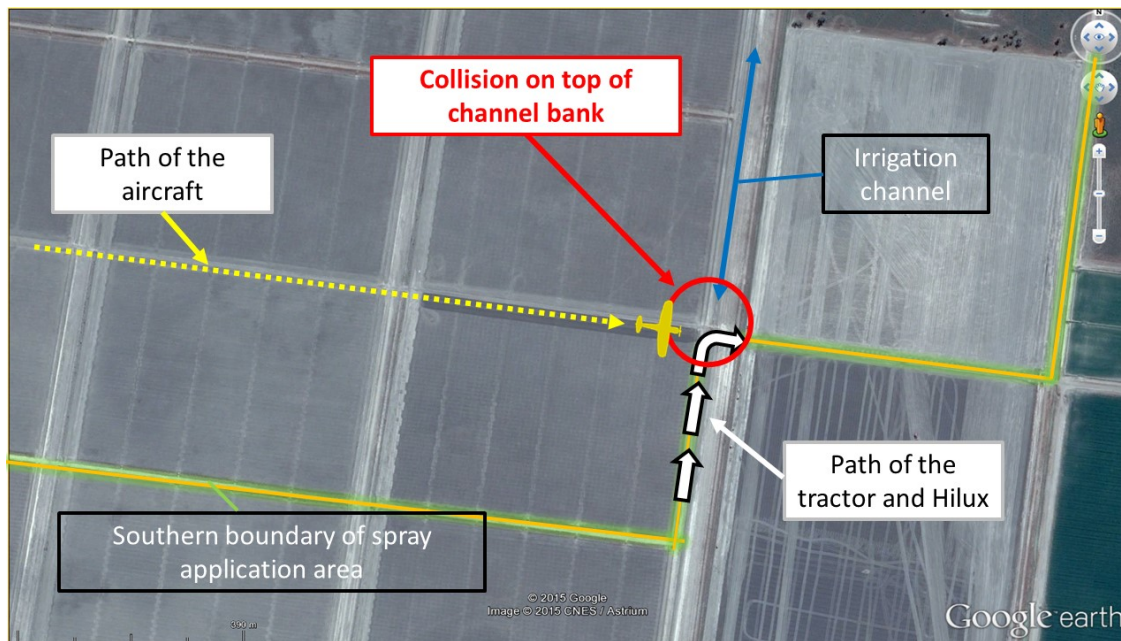
During this run, the pilot reported seeing a white Toyota Hilux Double Cab utility vehicle turn onto an irrigation channel crossing ahead of the aircraft (Figure 2). However, the Hilux appeared to the pilot to be slowing to a stop, short of the intersection/irrigation channel crossing. The pilot assumed that the driver of the Hilux had seen the aircraft, and was stopping to allow the aircraft to continue its run over the channel crossing.

**Figure 2: Layout of accident site, showing path of the aircraft, path of the tractor and Hilux along the irrigation channel bank, the south-eastern border of the spray application area, and the point where the collision occurred**

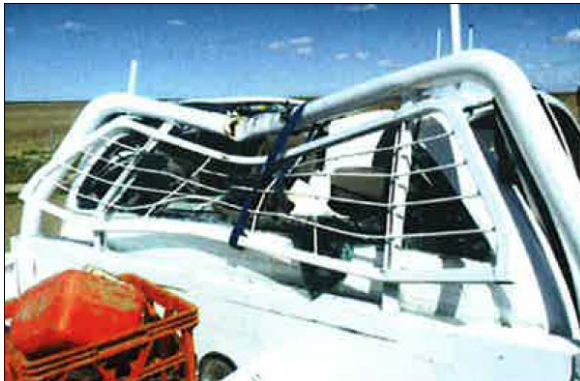
The pilot immediately stopped the spray and continued to climb, but was unable to clear the Hilux. The left wheel of the aircraft struck the tray headboard of the Hilux. As the vehicle and aircraft were both heading east, the aircraft struck the Hilux from behind.

Subsequent inspection of the aircraft revealed that the parts of the left landing gear were damaged, particularly in the area where the leg of the landing gear attaches to the aircraft structure. The vehicle was substantially damaged in the collision, particularly the tray headboard and roof structure on the passenger side of the cabin area (Figures 3 and 4).

**Figure 3: Rear view showing damage to the Hilux headboard**

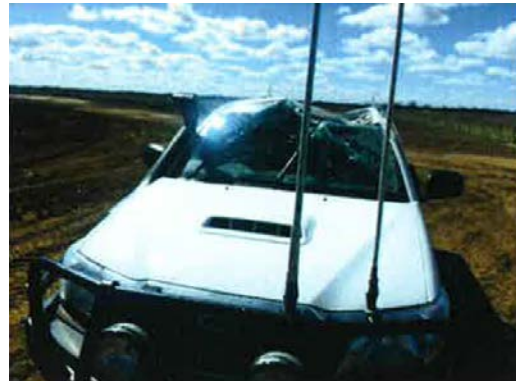
**Figure 4: Roof structure damage on passenger side**
