# Collision with a pole involving an Air Tractor AT-502B, VH-PTF

24 km SW of Dalby, Queensland, on 4 December 2015

**ATSB Transport Safety Report**  
Aviation Occurrence Investigation  
AO-2015-142  
Final – 13 April 2015

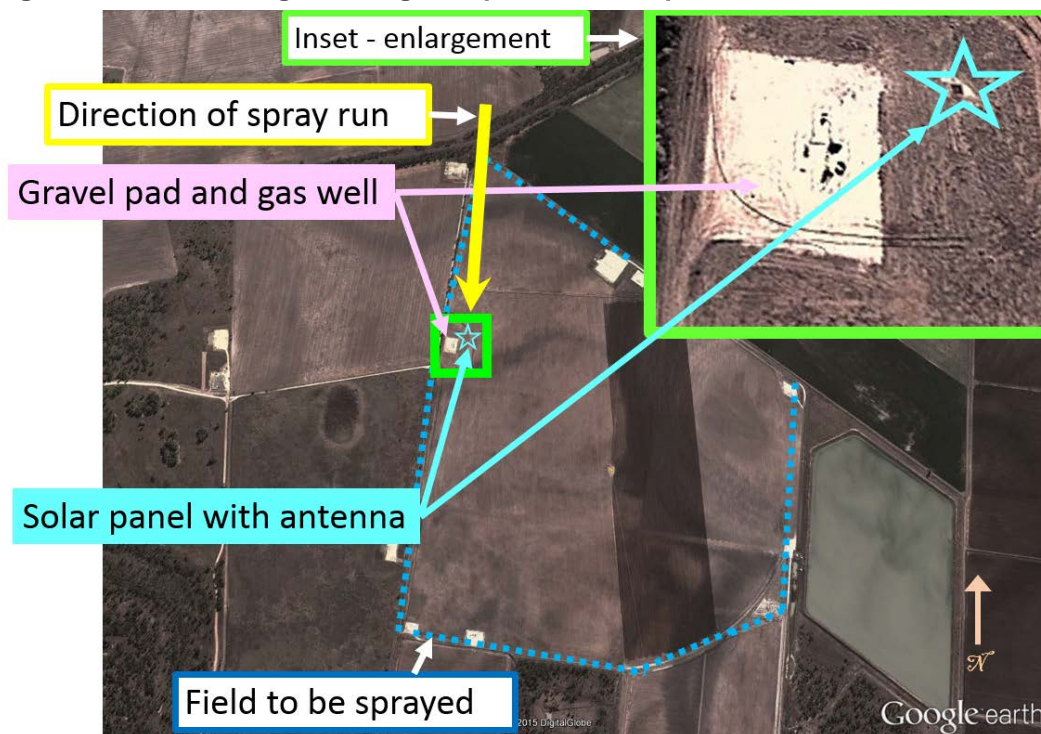
**Figure 1: Field showing well on gravel pad and solar panel**

The aircraft was fuelled and 1,600 L of liquid chemical loaded into the aircraft hopper. The aircraft departed at about 1210, and tracked towards the field to be sprayed, which was about 13 NM to the south-west. The pilot then overflew the area to inspect the field, first at about 100 ft above ground level (AGL), then at about 50 ft AGL. The pilot noted the wells on the gravel pads, and verified that there were no powerlines in the treatment area. The pilot also saw a solar panel a short distance from a well, located in the crop and not on a separate pad (Figure 1). The pilot did not see an antenna at the site of the solar panel at that time.

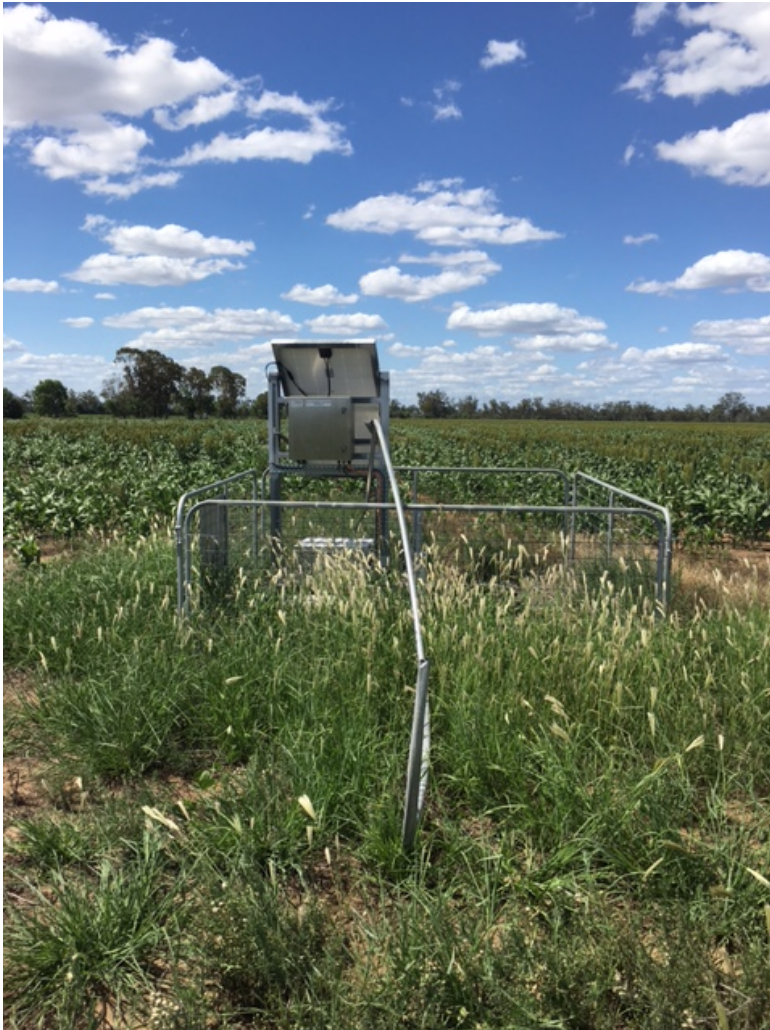
**Figure 2: Bore with solar panels and pole (after collision)**

The pilot commenced the first spray run, tracking towards the solar panel. As the aircraft came within about 20-30 m of the panel, the pilot noticed a pole behind the panel, protruding about 3 m above the crop, with an antenna on it. The pilot immediately conducted a climb to avoid the pole and antenna, but the aircraft struck the pole (Figure 2).

- Most of the gas wells had an antenna on a pole, similar to the one the aircraft struck, however they were of a considerable height and on a gravel pad. The pilot had assumed that the gas company equipment was located on gravel pads.
- The galvanisation on the pole had no shine and it blended into the background of the crop. A line of trees beyond the crop also made the pole difficult to see. It would have stood out more clearly against a blue background of sky.
- The solar panels were located on a ground water quality bore, with the (pole and) antenna for satellite transmission.
- Pilots from the same company had previously conducted spraying operations in that field, but the pole had not been in place then.

This incident highlights the importance of communication in identifying risks for low-level flying operations. Additionally, unknown hazards can be very difficult to see. The use of clearly visible markings may help pilots identify hazards during a field inspection. Pilots can then make a plan to avoid them during spraying operations.

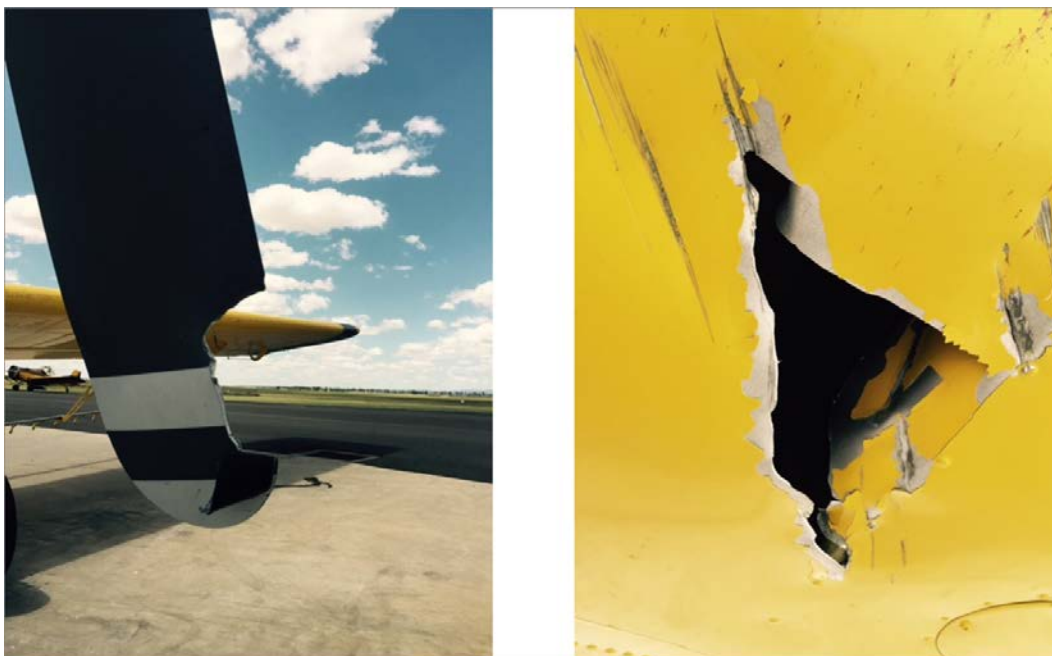
**Figure 3: Damage to propeller (left) and wing damage (right)**

the damage caused by the collision with the pole. The aircraft landed safely at about 1240, and the pilot was uninjured. The aircraft sustained damage to the left wing and the propeller (Figure 3).
