Australian Government
Australian Transport Safety Bureau

Aviation Short Investigations Bulletin

Issue 47

ATSB Transport Safety Report
Aviation Short Investigations
AB-2016-014
Final – 13 April 2016

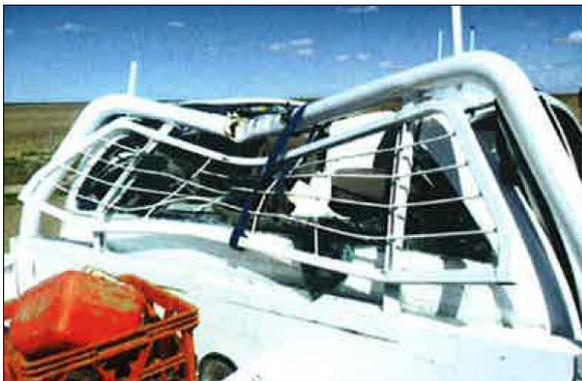
Subsequent inspection of the aircraft revealed that the parts of the left landing gear were damaged, particularly in the area where the leg of the landing gear attaches to the aircraft structure. The vehicle was substantially damaged in the collision, particularly the tray headboard and roof structure on the passenger side of the cabin area (Figures 3 and 4).

Figure 3: Rear view showing damage to the Hilux headboard

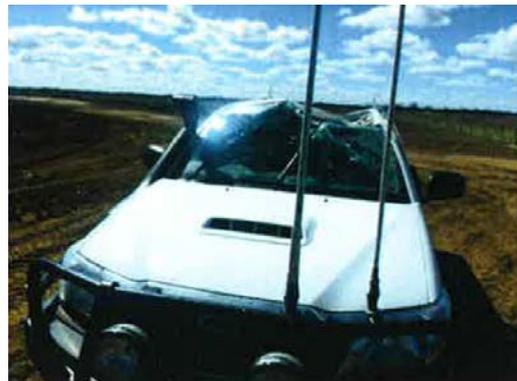
Figure 4: Roof structure damage on passenger side

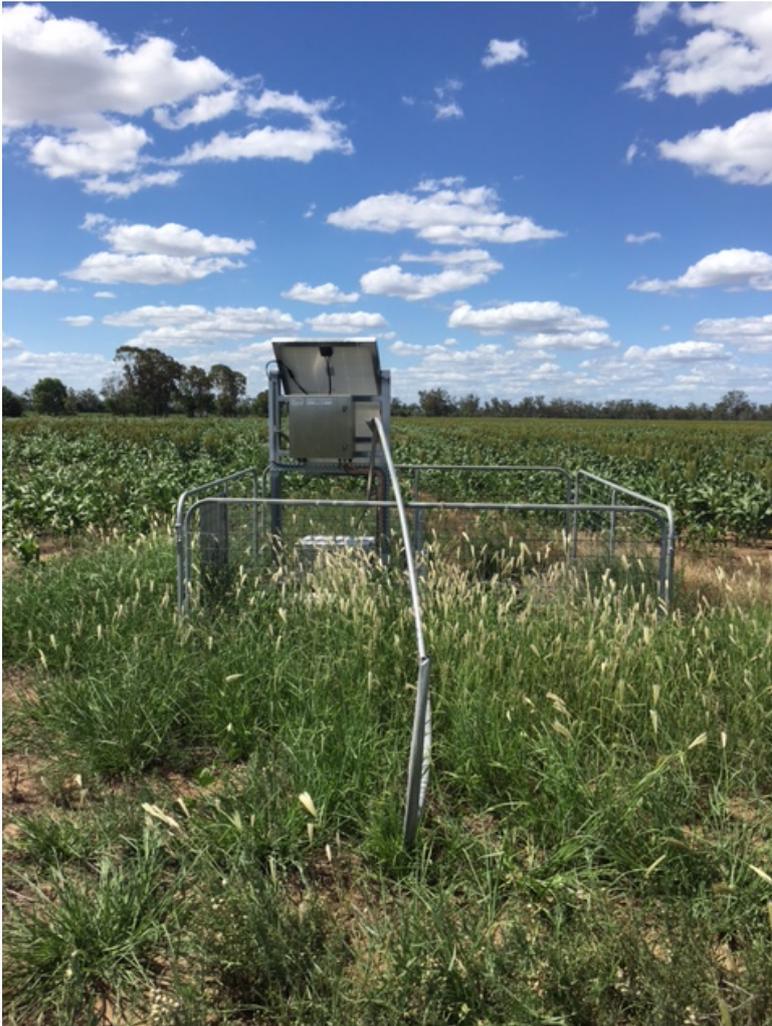
Figure 2: Bore with solar panels and pole (after collision)

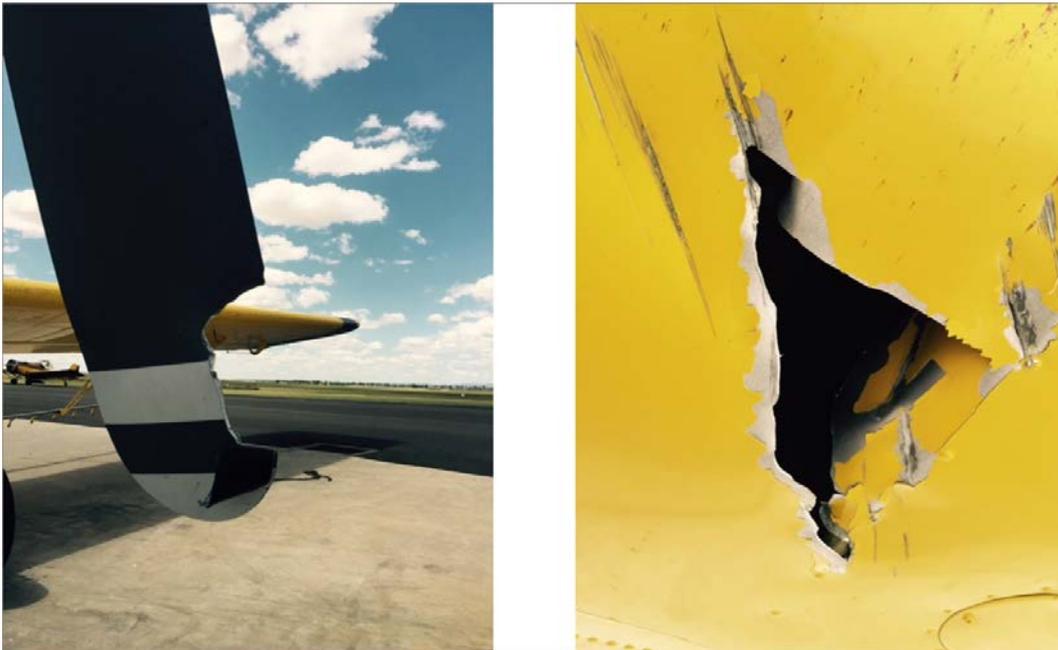
During the return flight, the aircraft still had a minor vibration. The pilot overflew the runway at Dalby to check the wind direction and speed before joining the circuit. The pilot conducted the approach about 5 kt faster than normal, due to the weight of the aircraft and the unknown effect of the damage caused by the collision with the pole. The aircraft landed safely at about 1240, and the pilot was uninjured. The aircraft sustained damage to the left wing and the propeller (Figure 3).

Figure 3: Damage to propeller (left) and wing damage (right)

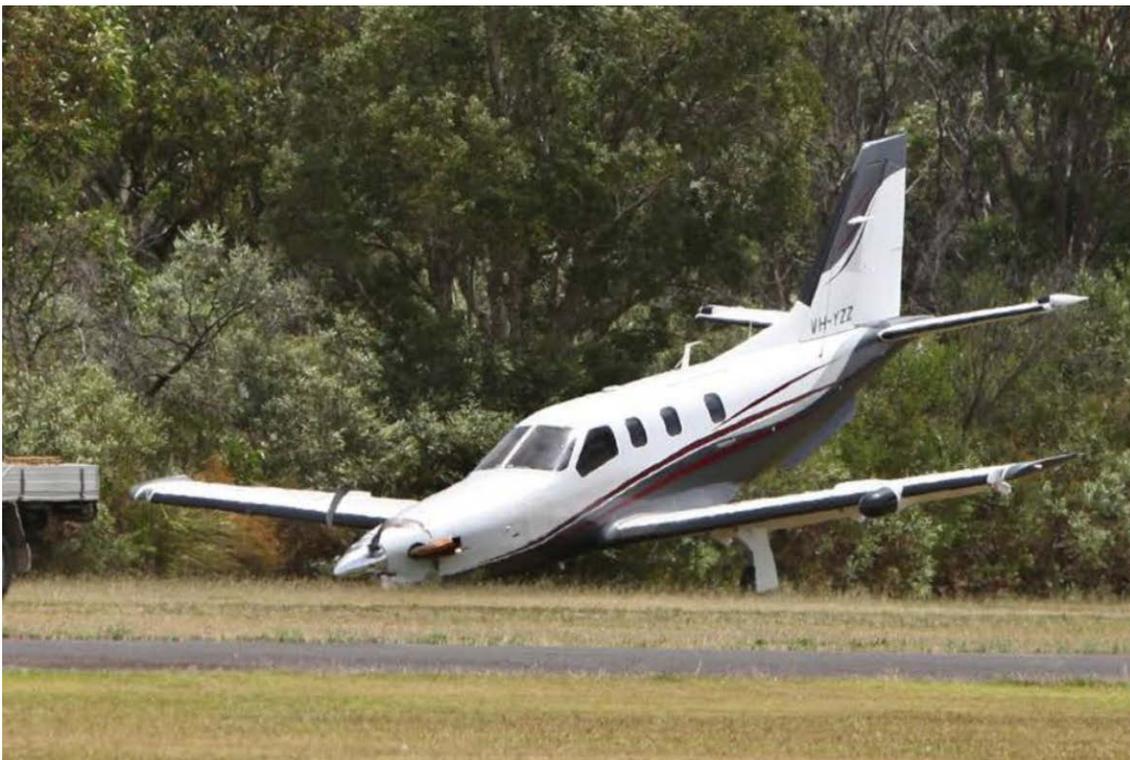
When YZZ was on short final, the pilot began to feel ‘woozy’ and, shortly after, lost consciousness. Closed circuit television footage showed the aircraft descended onto the runway and bounced before impacting the runway in a nose-low attitude to the left of runway centreline. The nose-low impact collapsed the nose gear and caused the forward section of the aircraft to strike the runway, bending all four propeller blades. It was at this time that the pilot regained consciousness, approximately 5 to 10 seconds after losing consciousness. The aircraft then skidded on the runway before veering to the right, and onto the grass (Figure 2). The aircraft eventually stopped on the grass area next to the runway (Figure 3).

Figure 3: YZZ post-accident showing the damage to the forward section of the aircraft as a result of the nose gear collapse and skidding on the ground

Medical tests and monitoring after the accident found that the loss of consciousness was due to a previously undiagnosed heart condition.

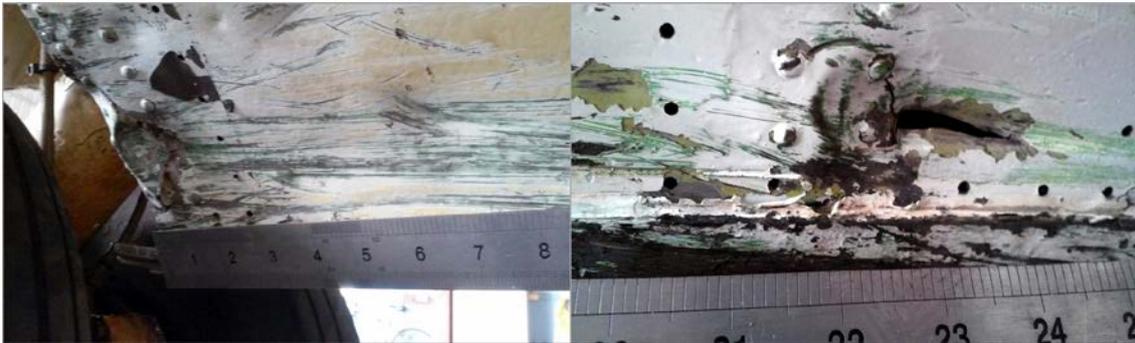
The pilot and seven passengers were uninjured and the aircraft sustained minor damage (Figure 3).

Figure 3: Damage to AWI floats included two holes on the bottom side of each float compartment immediately forward of the wheel well.

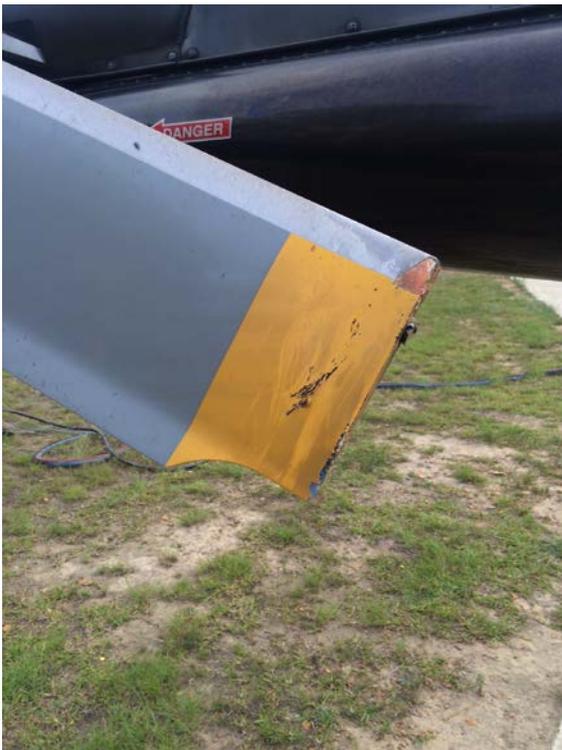
The tail rotor was damaged (Figure 2); the pilot and crewperson were uninjured.

Figure 2: Damage to VH-NPS tail rotor

Where possible, pilots who are more experienced with a particular type of operation, such as fire control work, will be rostered with less experienced crewpersons and vice versa.

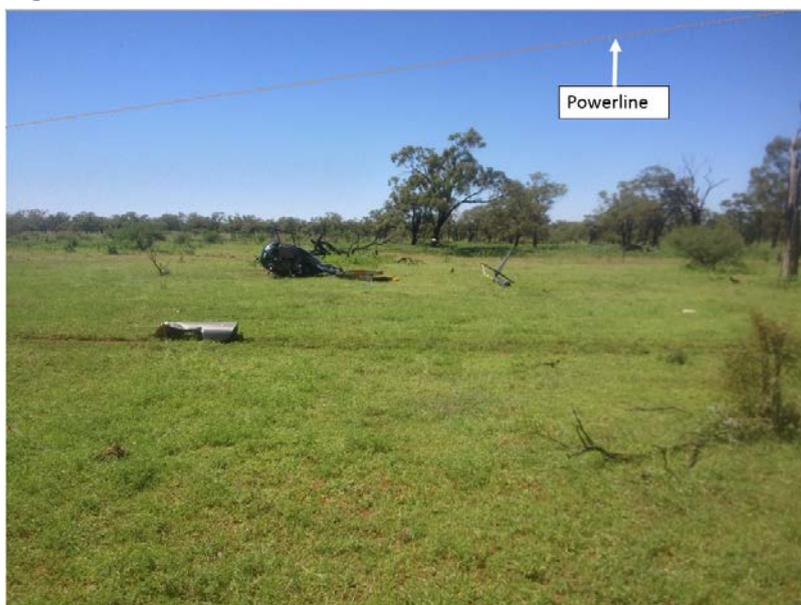
Figure 4: Accident site
