# Collision with terrain involving One Design DR-107, VH-EGT

Goolwa Airport, South Australia | 10 October 2014

**ATSB Transport Safety Report**  
Aviation Occurrence Investigation  
AO-2014-163  
Final – 14 April 2016

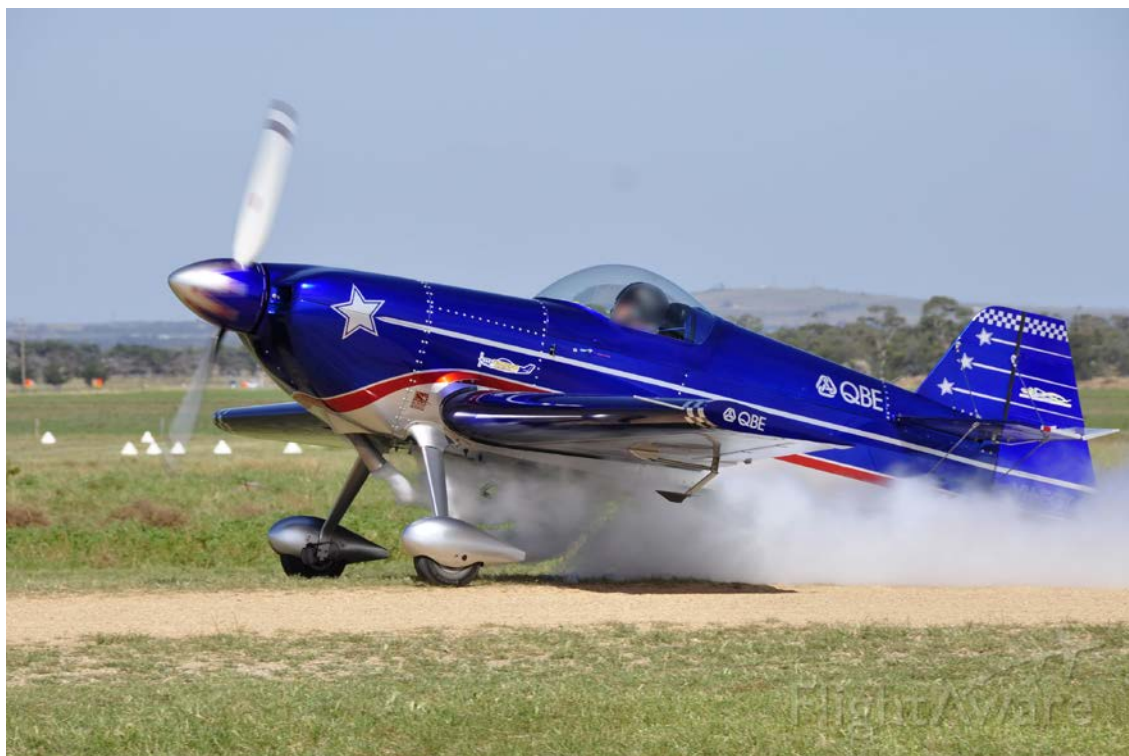
**Figure 2: VH-EGT**

The aircraft was a single-seat, low-wing, fixed-gear, amateur-built<sup>3</sup> aircraft designed for competition aerobatics (Figure 2). Entries in the aircraft's logbook indicated that the pilot commenced construction of the aircraft as an amateur builder in October 2003. The aircraft was completed in March 2008. A CASA authorised person issued a special certificate of airworthiness in the experimental category on 13 March 2008.

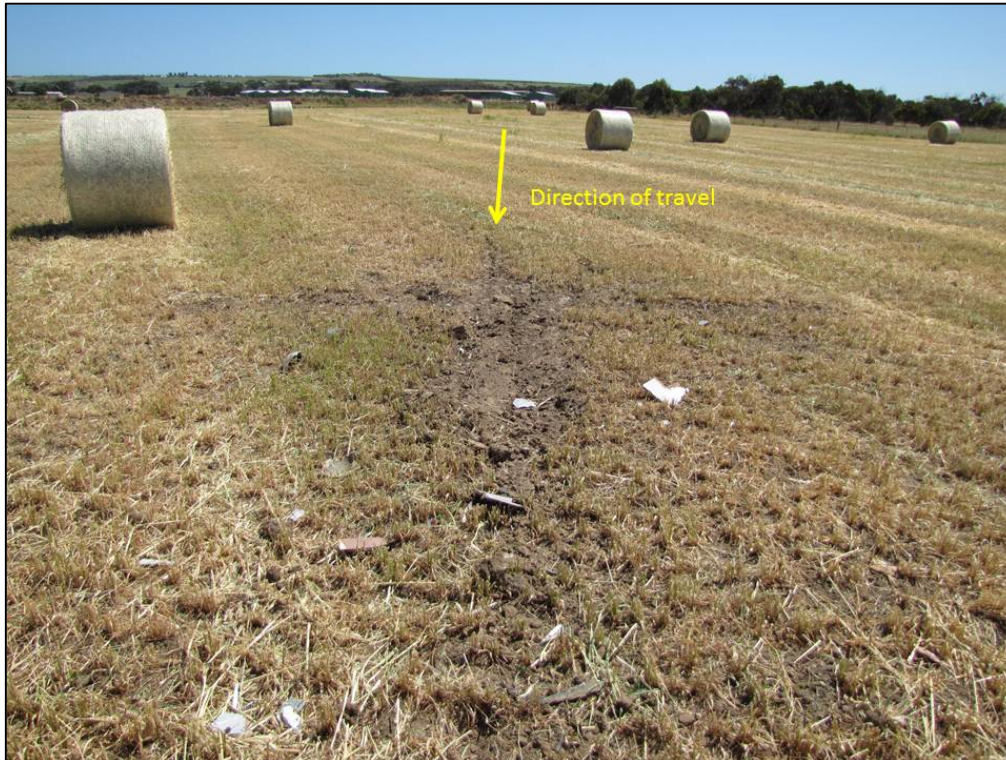
**Figure 3: Initial ground scar**

The accident site was in a flat, recently-harvested paddock adjacent to Goolwa Airport. The aircraft collided with terrain approximately 400 m east of the northern end of runway 01/19.<sup>10</sup> The wreckage trail was approximately 45 m long on a bearing of 115°. The length of the wreckage trail, combined with the initial ground impact mark and damage to the aircraft, indicated an impact at relatively high vertical and horizontal speed. Ground impact marks and aircraft damage further indicated that the aircraft collided with terrain in a wings-level, slightly nose-down pitch attitude (Figure 3).

The accident site ground impact marks and aircraft damage indicated that the aircraft was in a slightly nose-low, wings-level attitude at impact. Additionally, the ATSB determined that the aircraft collided with terrain with a high vertical and horizontal speed. This evidence is consistent with witness reports indicating that the aircraft appeared to be pulling out of a dive when it collided with terrain.
