# Airspace related event involving Boeing 737, VH-VOM

near Darwin, Northern Territory | 27 February 2014

**ATSB Transport Safety Report**  
Aviation Occurrence Investigation  
AO-2014-044  
Final – 15 April 2016

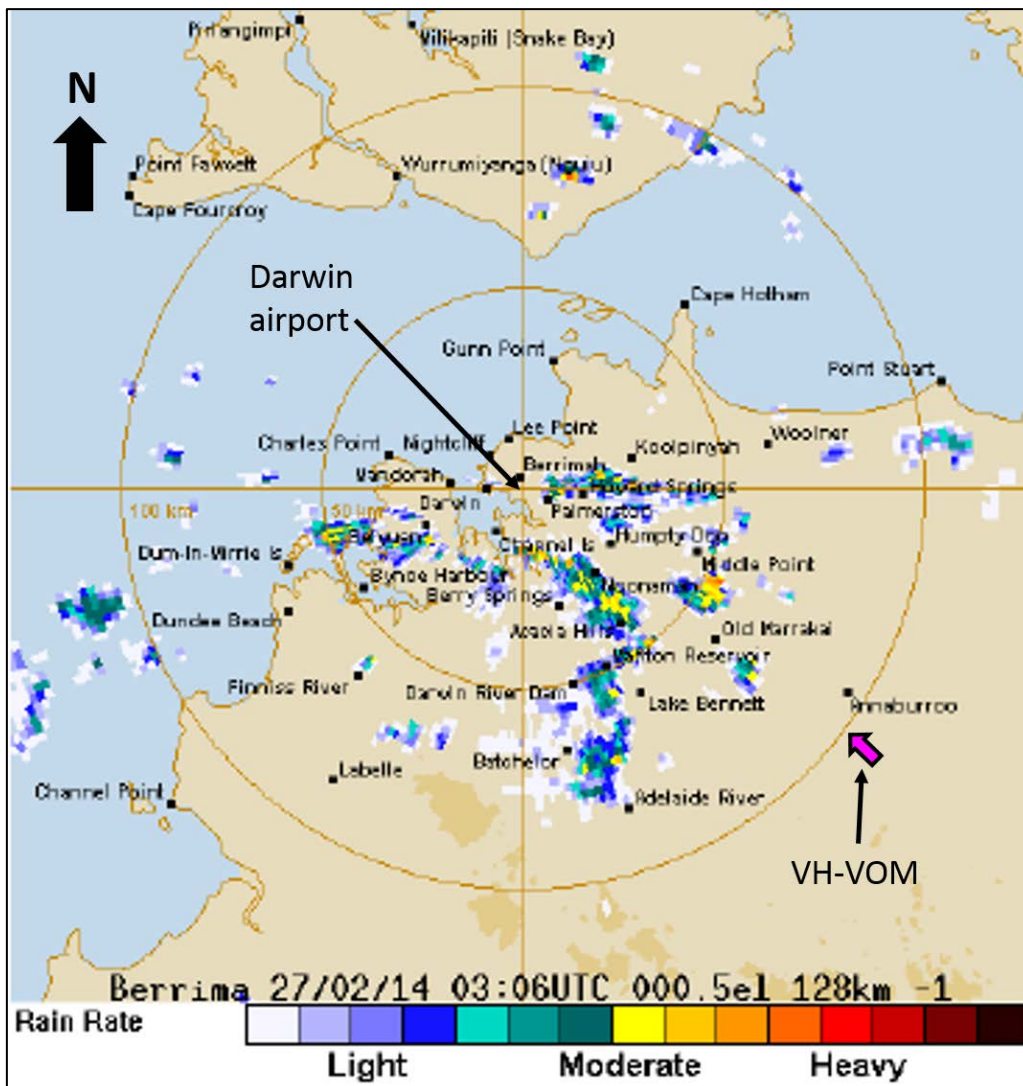
**Figure 1: Darwin weather radar picture at 1236 Central Standard Time<sup>1</sup> showing rainfall associated with thunderstorm cells. The approximate location of VOM at that time is indicated by an arrow showing direction of travel. The range rings are at 50 km (27 NM) and 100 km (54 NM)**

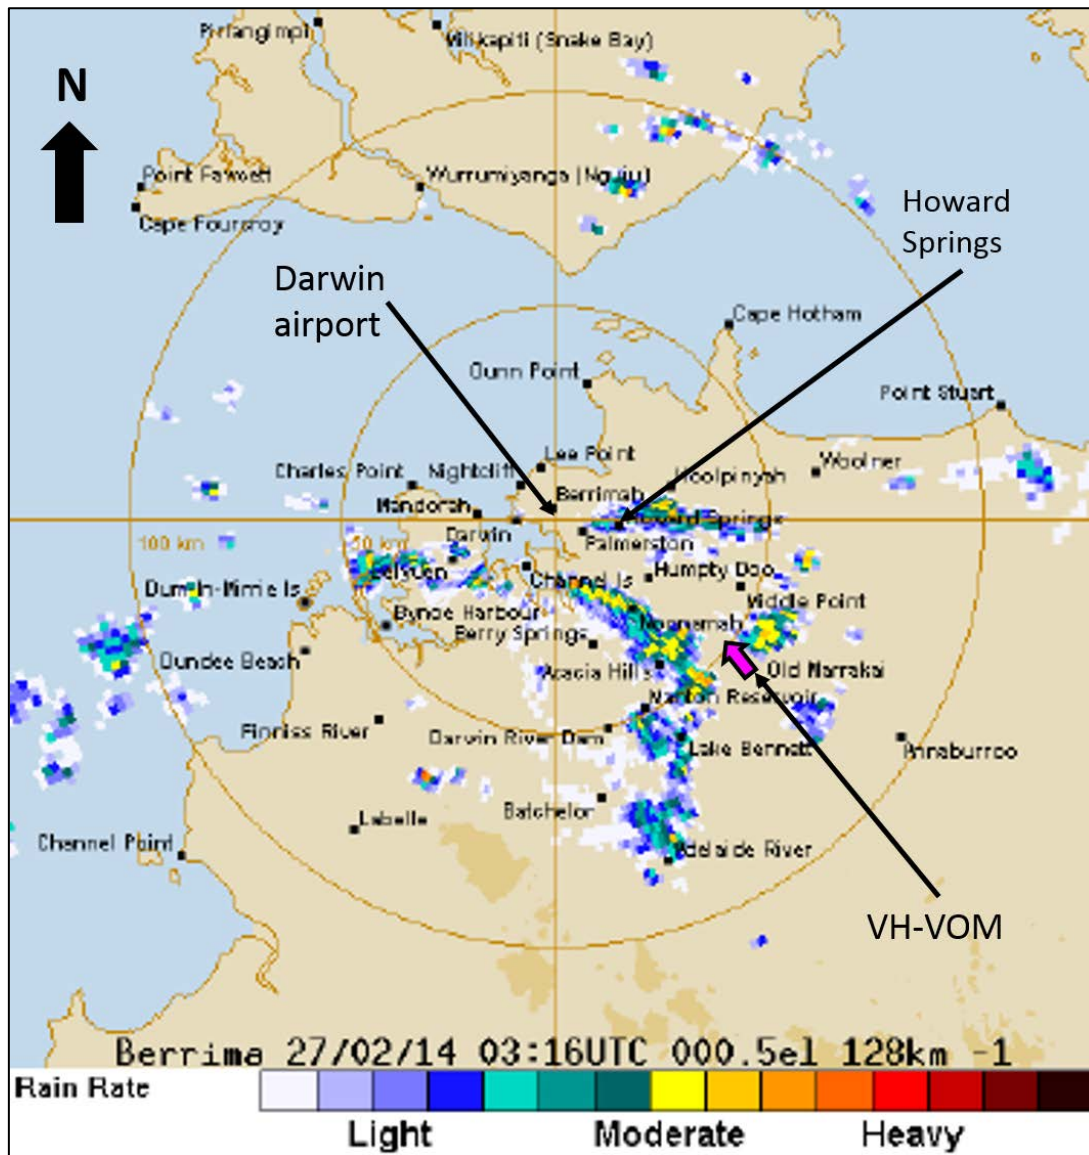
**Figure 2: Darwin weather radar picture at 1246 showing the approximate location of VOM while avoiding storm cells**
