Breakaway of *Spirit of Tasmania II*

Station Pier, Port Melbourne, Victoria 13 January 2016

ATSB Transport Safety Report
Marine Occurrence Investigation
324-MO-2016-001
Preliminary – 18 April 2016

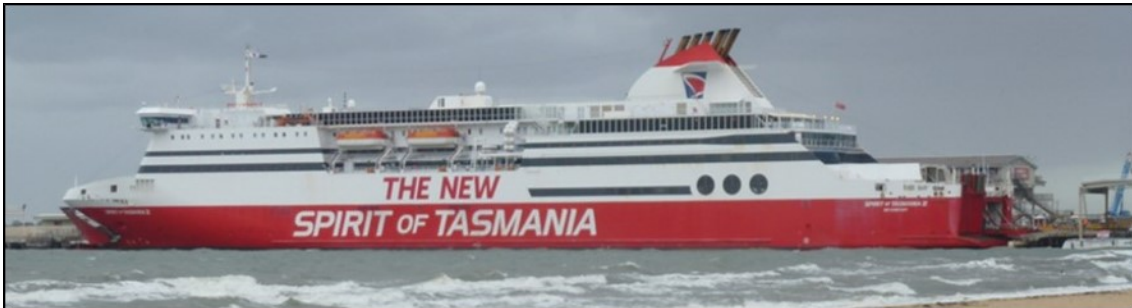
Figure 1: *Spirit of Tasmania II* alongside Station Pier after the incident

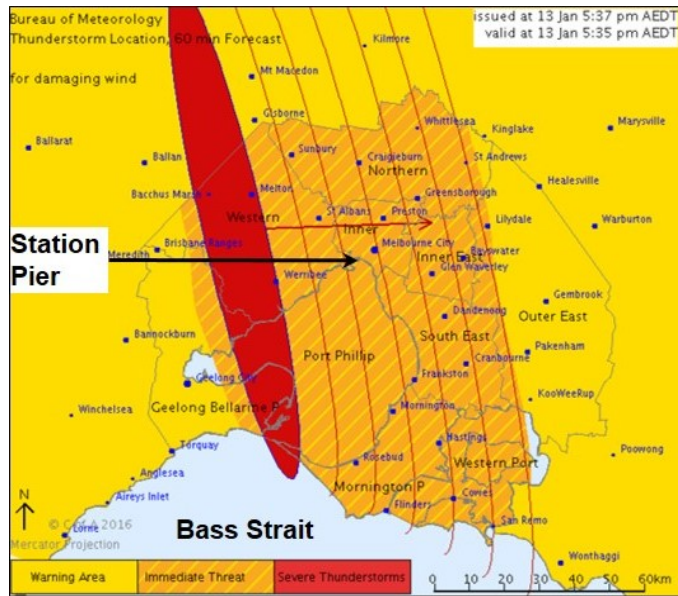
At about 1750, the master returned to his cabin and again checked the BoM website. He saw that a 'severe thunderstorm warning'⁴ had been issued at 1737. The website indicated a series of thunderstorms approaching Station Pier from the southwest. The thunderstorms were about 13 miles off (Figure 2).

Figure 2: Thunderstorm map at 1737 on 13 January

At 1737, the severe thunderstorm warning was re-issued for Melbourne with the storms now moving in an easterly direction. This warning indicated that a band of severe thunderstorms with winds up to 100 km/hr (about 51 knots) was moving toward Melbourne from the southwest. The storms were expected to affect Melbourne City by 1805. The warning included a map showing the band of storms and its expected movement (Figure 2).

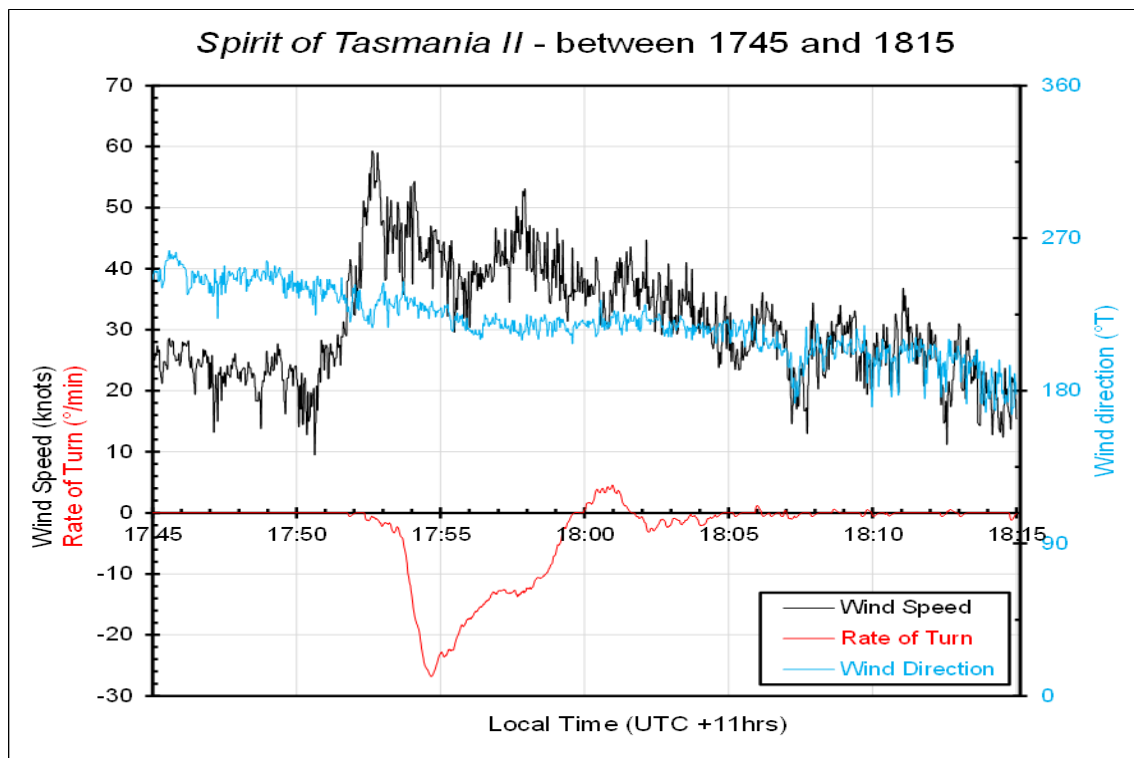
At 1753, the wind at *Spirit of Tasmania II*'s location was nearly 60 knots from the southwest (Figure 3). By then, about 120 passengers had boarded and the ship's stern had moved off the wharf. With the violent storm force wind⁵ pushing the stern off, the ship's aft mooring lines failed in rapid succession. As the stern broke away from the wharf, the ship swung away and towards the shore (Figure 4).

Figure 3: Wind speed and direction, and the ship's rate of turn

By 1755, the ship was at an angle of approximately 45 degrees to the wharf and turning away from it (negative rate of turn in Figure 3) at 27°/min.

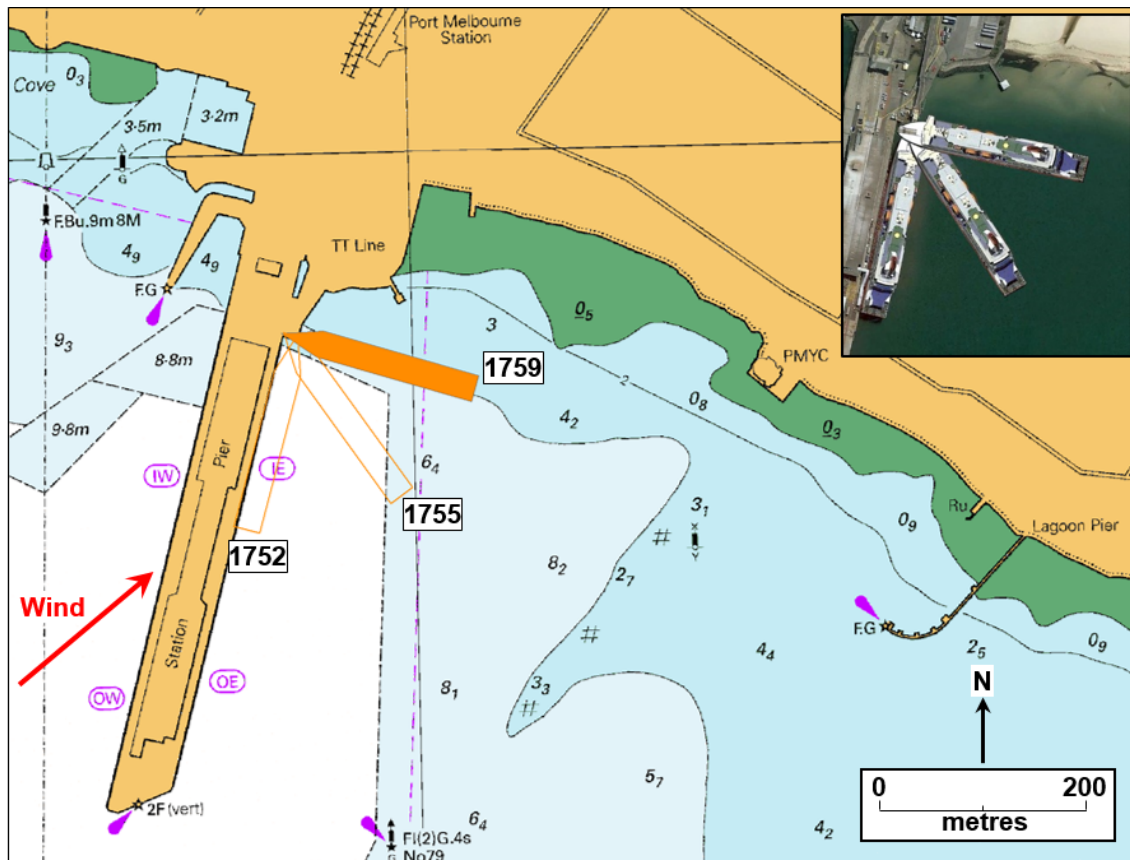
Figure 4: Section of navigational chart AUS154 showing the ship's breakaway

As the ship's stern came off the wharf, all the aft mooring lines and all except one of the forward lines parted. The ship pivoted about the bow, its bow ramp slid across and dropped off the wharf leaving it hanging over the bulbous bow. As the ship continued to turn, the end of the bow ramp swung under the wharf, damaging two wooden piles below the wharf apron.

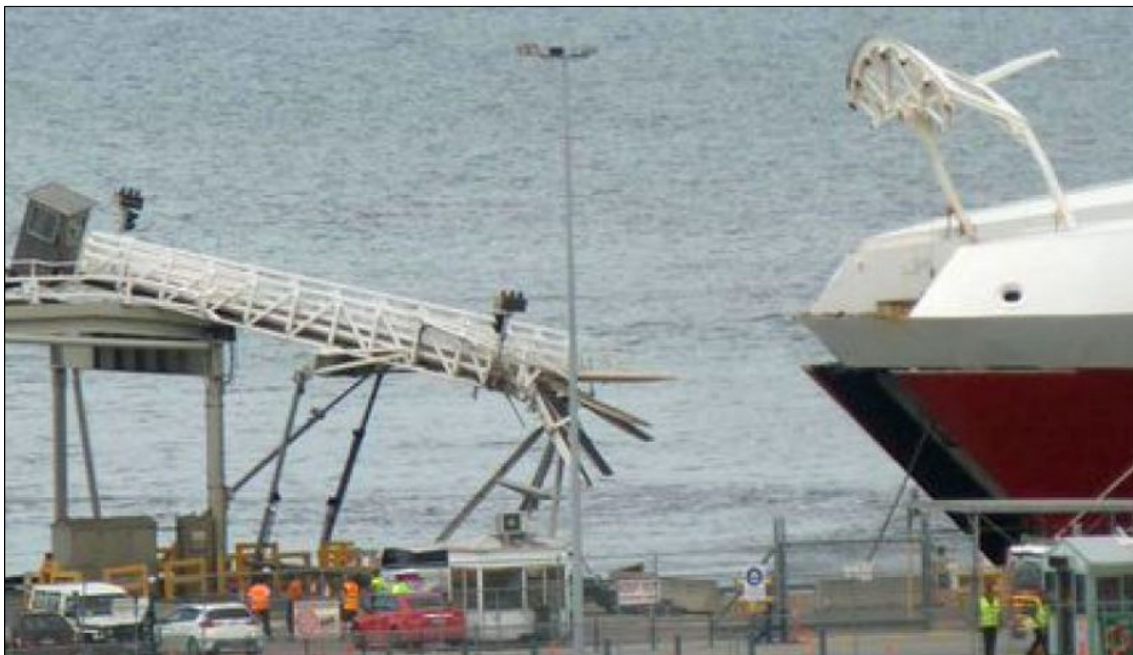
The upper vehicle ramp detached from the ship's bow and jammed between the bow bulwarks. As the ship continued to turn, this ramp twisted away from the bow and hung down from its elevated roadway base.

When *Spirit of Tasmania II* had turned off the wharf, its starboard bow door had come to rest against the wharf structure. Weight had then come onto it and pushed it against the bow ramp, resulting in damage to a number of its door operating components. The hydraulic system used to operate the doors and ramp was not damaged. The upper vehicle ramp suffered extensive damage (Figure 5) requiring it to be removed from the wharf and taken away for repairs.

Figure 5: Photograph showing damaged upper vehicle ramp near *Spirit of Tasmania II*'s bow

Inspections and repairs were undertaken to the satisfaction of the ship's flag State and classification society. On 17 January, 4 days after the incident, *Spirit of Tasmania II* returned to service.

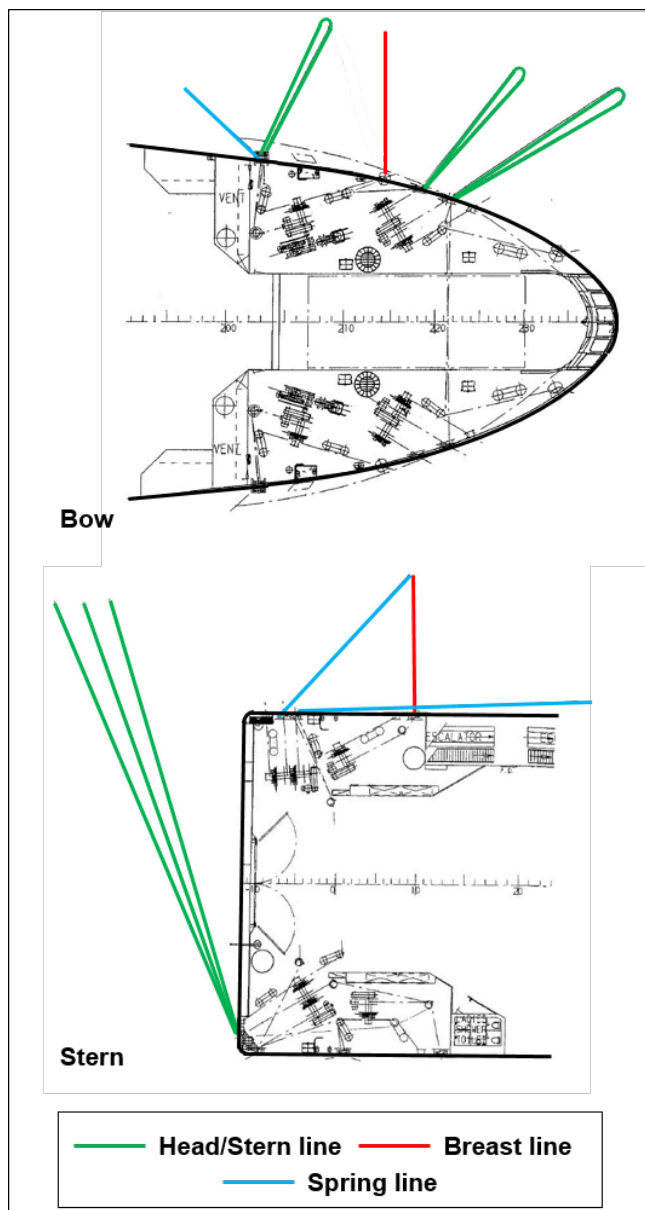
Spirit of Tasmania II's standard mooring arrangement had been developed for the Station Pier berth. This consisted of three head lines, a spring line and a breast line at the bow, and three stern lines, two spring lines and a breast line at the stern (Figure 6). All mooring ropes were 64 mm diameter KapaFlex 24 (24 strand, 40 percent polyester, 60 percent polypropylene/polyethylene) mixed rope, each with a breaking load of 82 t.

Figure 6: *Spirit of Tasmania II*'s mooring arrangement
