# In-flight engine fire involving AVRO 146-RJ100, VH-NJI

Departing Perth Airport, Western Australia | 29 April 2014

**ATSB Transport Safety Report**  
Aviation Occurrence Investigation  
AO-2014-076  
Final – 2 May 2016

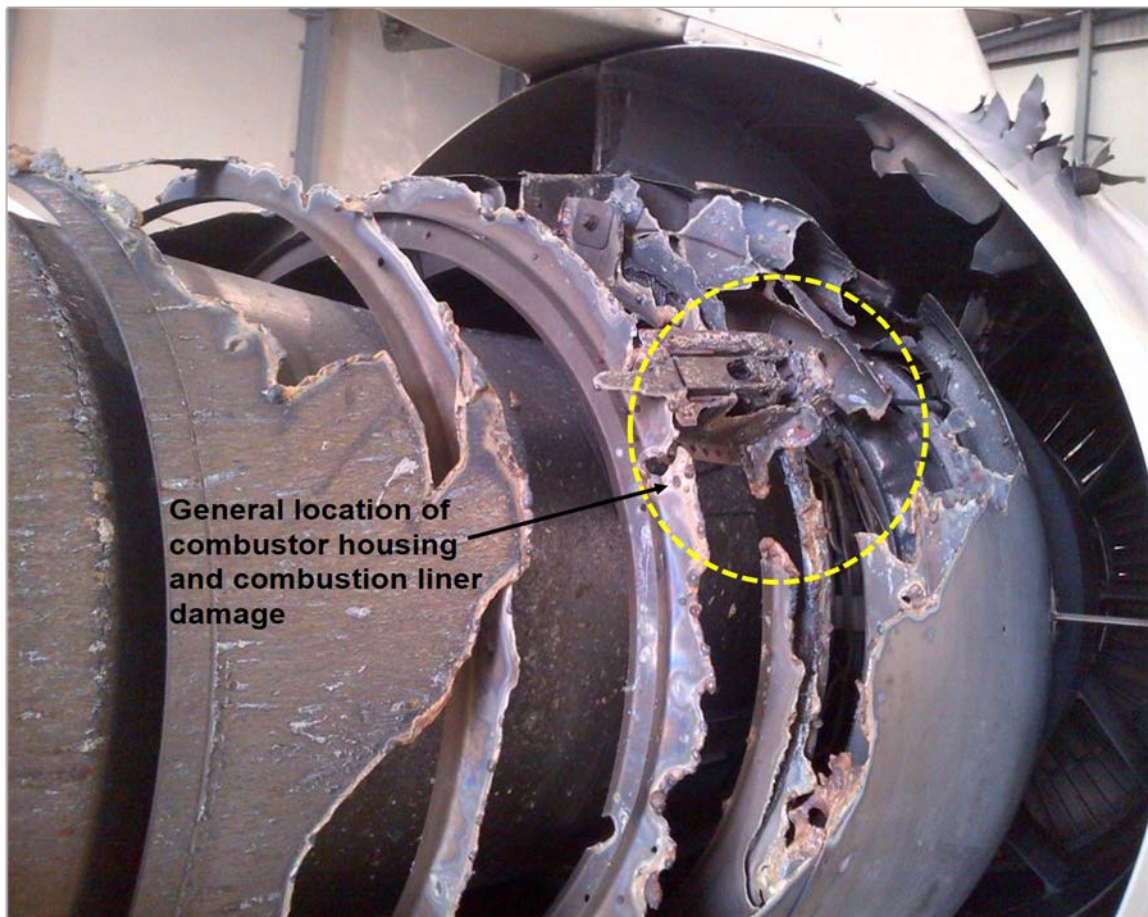
Technical inspection of the aircraft after landing found that the No. 2 engine sustained an in-flight fuel-fed engine fire that significantly damaged the engine and its cowling (Figure 1).

**Figure 1: Right side of the No.2 engine showing the fire damage to the combustor housing and liner (looking forward)**

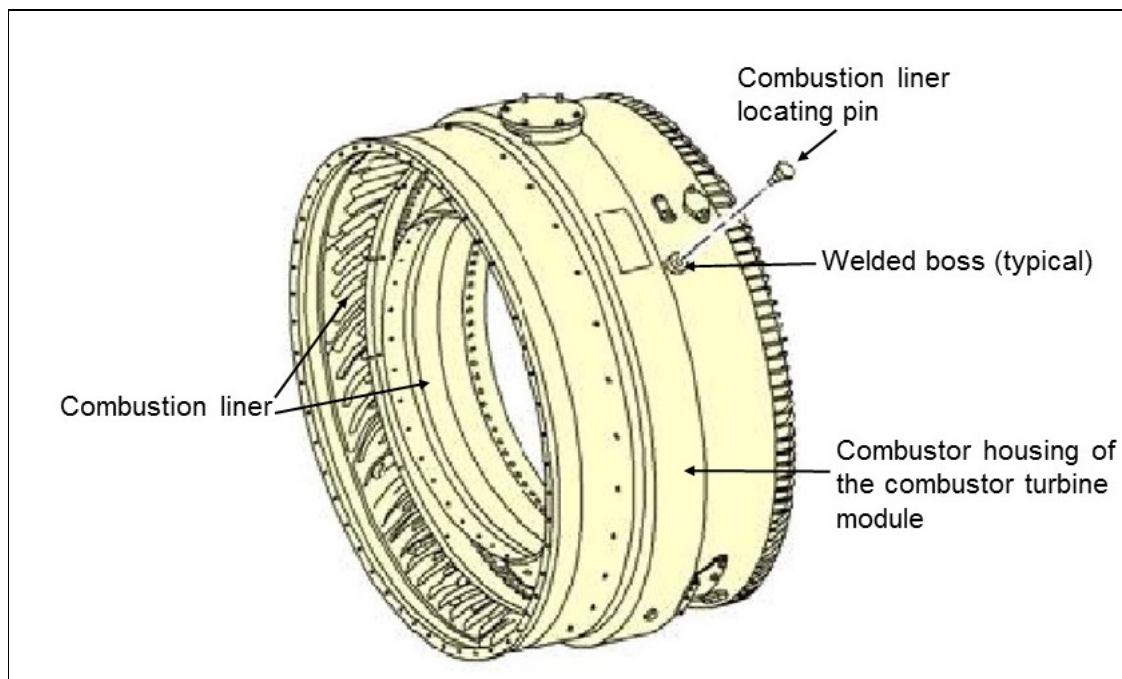
Examination of the engine found that the combustion liner welded boss (welded boss) at the two o'clock position had fractured and separated from the housing (Figure 3).

**Figure 3: Exemplar LF507 engine showing the combustor housing and combustion liner highlighting a typical welded boss and combustion liner locating pin**

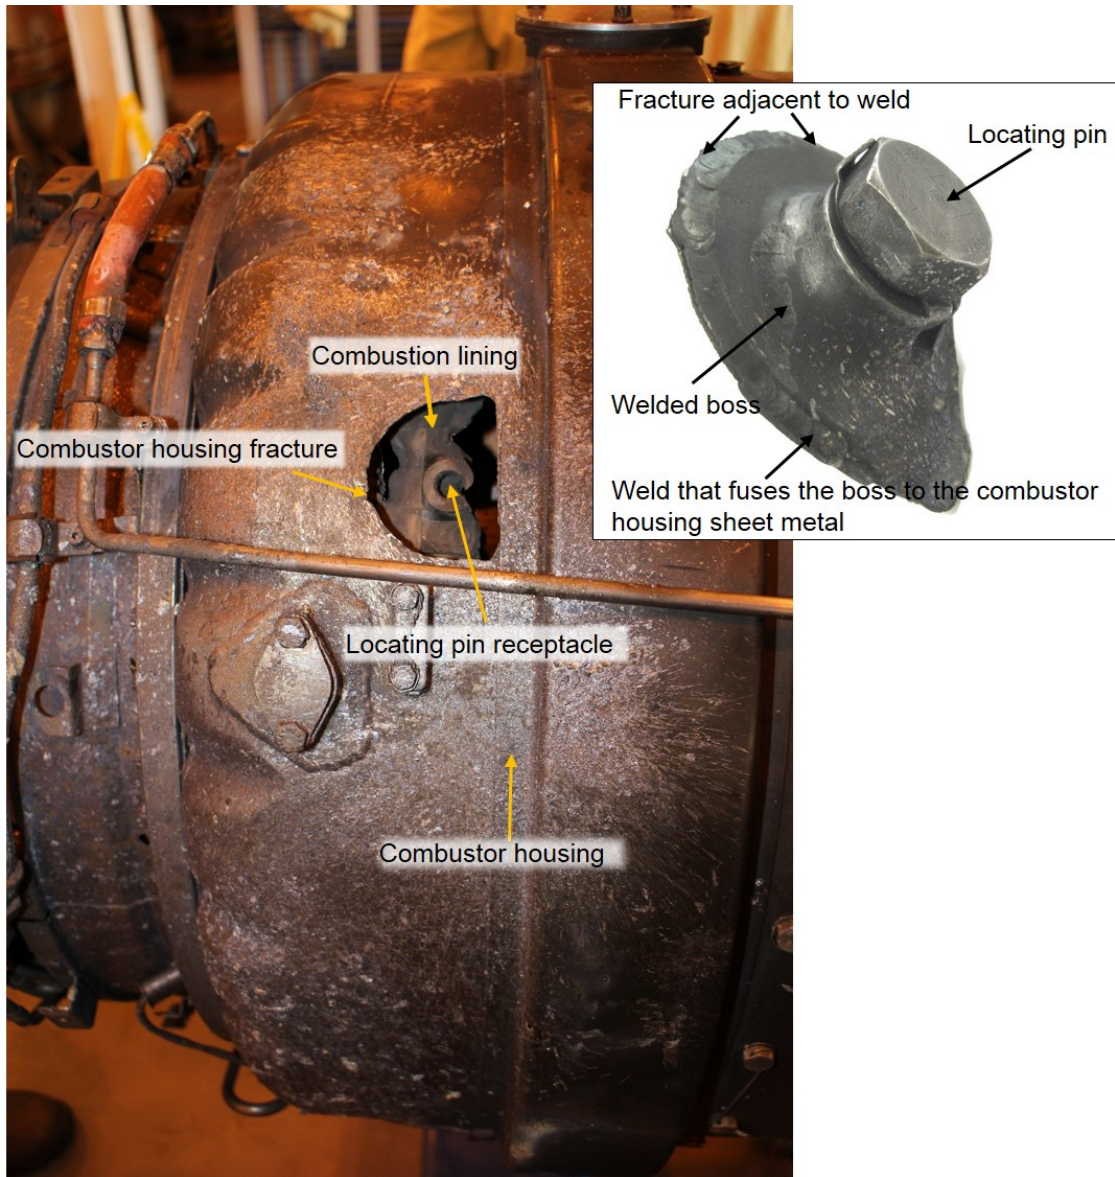
**Figure 4: No. 2 engine showing the combustor housing, combustion liner (seen internal to the combustor housing) and insert image showing the locating pin secured in the fractured welded boss**

The detailed examination in the US identified an area of the combustion liner that had thermal damage and was fractured adjacent to the two o'clock welded boss position. That damage was consistent with the effect of temperature and pressure variations between the combustor housing and the combustion liner once the welded boss fractured from the housing (Figure 4).

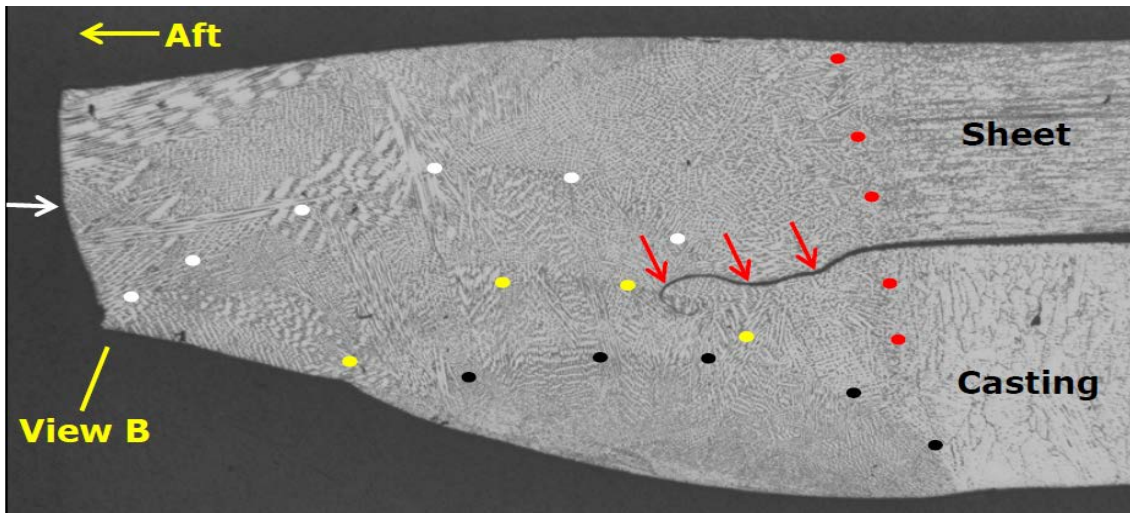
The examination of the fractured welded boss identified three separate weld repairs. These were identified on cross-sectional samples taken through the joints surrounding the recovered welded boss (Figure 5). Honeywell concluded that the fatigue cracking was not directly associated with the weld. Hardness measurements taken from the housing sheet metal, boss casting, and weld indicated that heat treatment was performed on the assembly subsequent to weld repair, as specified by Honeywell.

**Figure 5: Metallographic image of a cross section of the fractured welded boss. The red dots likely indicate the original weld. The white, yellow and black dots likely indicate subsequent weld repairs. The red arrows indicate a crack emanating from the forward side of the weld at the housing/casting interface. The white arrow is the fracture surface, where the boss separated from the combustor housing. The fracture initiated at the outside diameter of the welded boss**

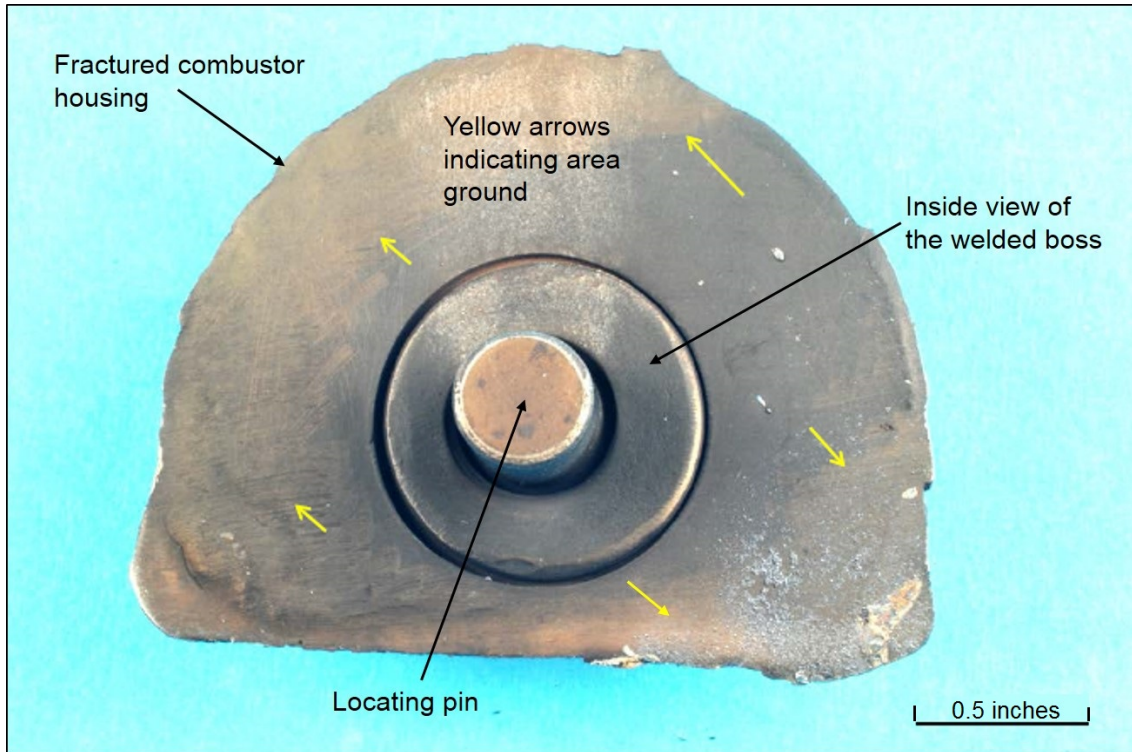
Further examination of the combustor housing in the location of the fractured welded boss found that a section of the combustor housing sheet metal had been thinned at the inside and outside surfaces by grinding (Figure 6). This grinding was associated with a weld repair where the boss was weld fused to the sheet metal. Thicknesses of 0.035 inches–0.040 inches were measured at the CTM housing adjacent to the two o'clock welded boss.

The thickness of the combustor housing sheet metal was specified by Honeywell as nominally 0.049–0.050 inches thick. This indicated that during a repair, about 20–30 per cent of the housing thickness had been removed. In this regard, the combustor housing is a pressure vessel. Honeywell does not approve the removal of material leading to a reduction of housing wall thickness.

The other three welded bosses also exhibited hand finishing, indicating that material removal took place in those locations.

**Figure 6: Image of the inner side of the fractured combustor housing and the locating pin protruding through the welded boss. Areas that have been ground are identified by yellow arrows**
