Breakaway of *Grand Pioneer* and *AAL Fremantle*

Fremantle, Western Australia | 17 August 2014

ATSB Transport Safety Report
Marine Occurrence Investigation
313-MO-2014-009
Final – 4 May 2016

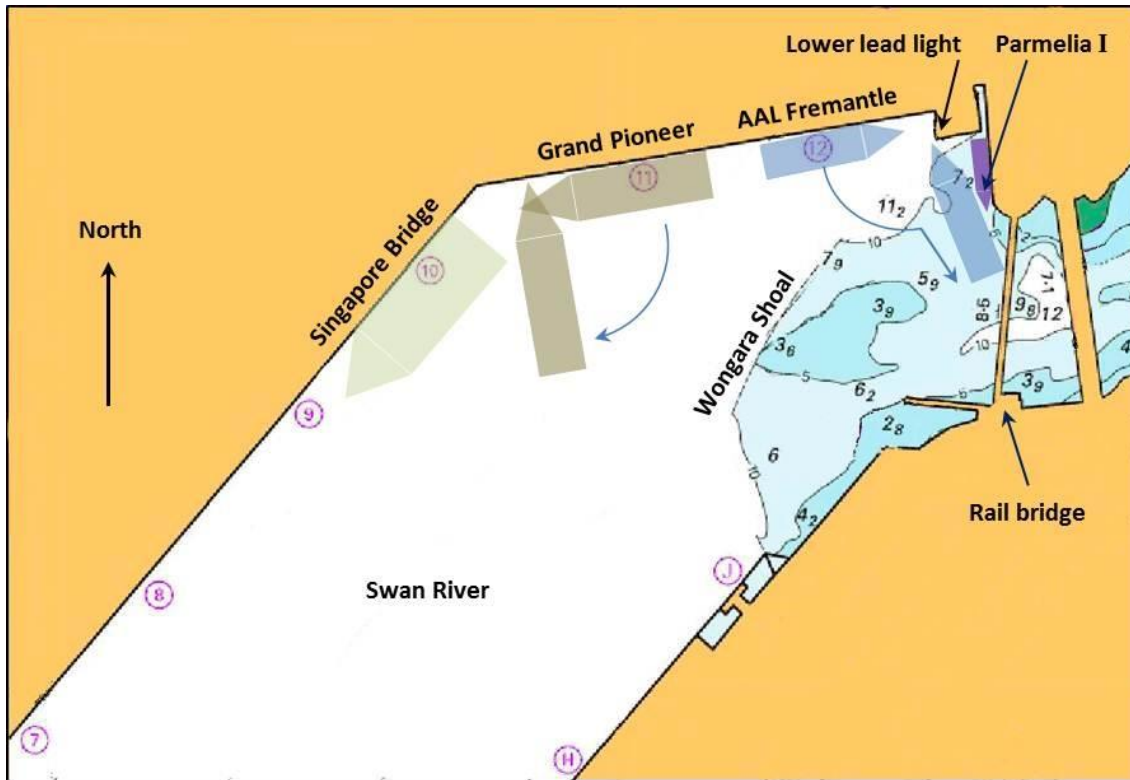
Figure 3: Section of navigational chart Aus 113 showing involved ships at their berths, and the movement of ships that broke away

At about 2210, *AAL Fremantle*'s starboard quarter struck a stanchion⁵ on the rail bridge, bringing it down and cutting power to that section of track. Temporary scaffolding on the side and under the bridge was also damaged, and the rail track's alignment was disturbed (Figure 5). Moments later, *AAL Fremantle*, about midships, contacted the starboard shoulder of *Parmelia I* (Figure 3) at the adjacent berth. *AAL Fremantle*'s two remaining head lines were slack and the remaining forward spring line was still under tension (Figure 4). At that point, the ship's astern movement stopped in the proximity of Wongara Shoal (Figure 3).

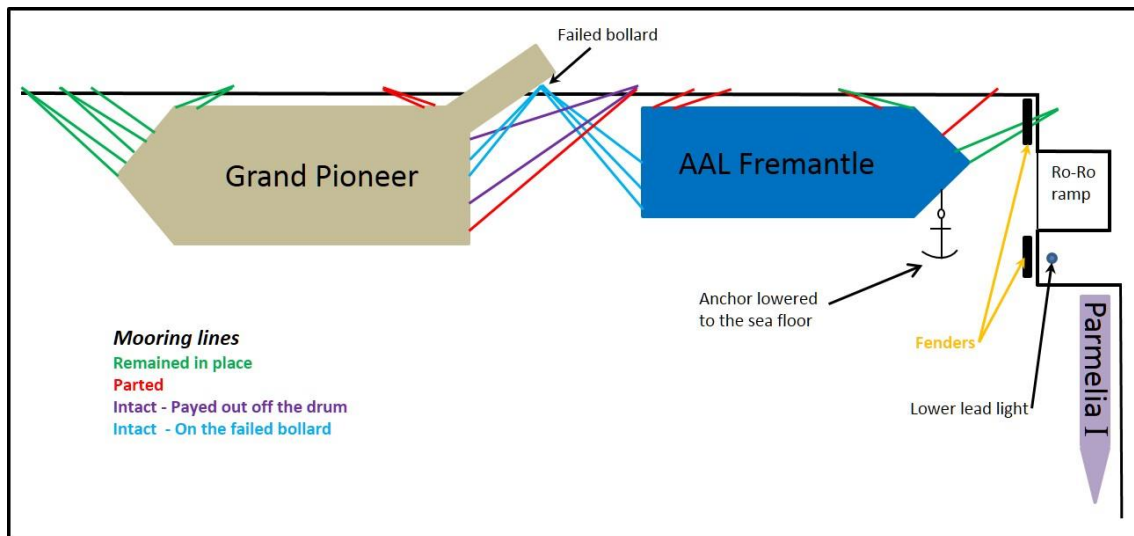
Figure 4: Indicative diagram showing the ships' mooring arrangements (not to scale)

- It is very likely that the ramp's impact resulted in the bollard's failure, leaving *Grand Pioneer* with only two stern lines that payed out under the increasing load. The ship's stern then broke away from the wharf causing the two aft spring lines to part.

- The bollard's failure resulted in *AAL Fremantle* losing its three stern lines. Consequently, the ship's stern broke away from the wharf and then the two aft spring lines parted.

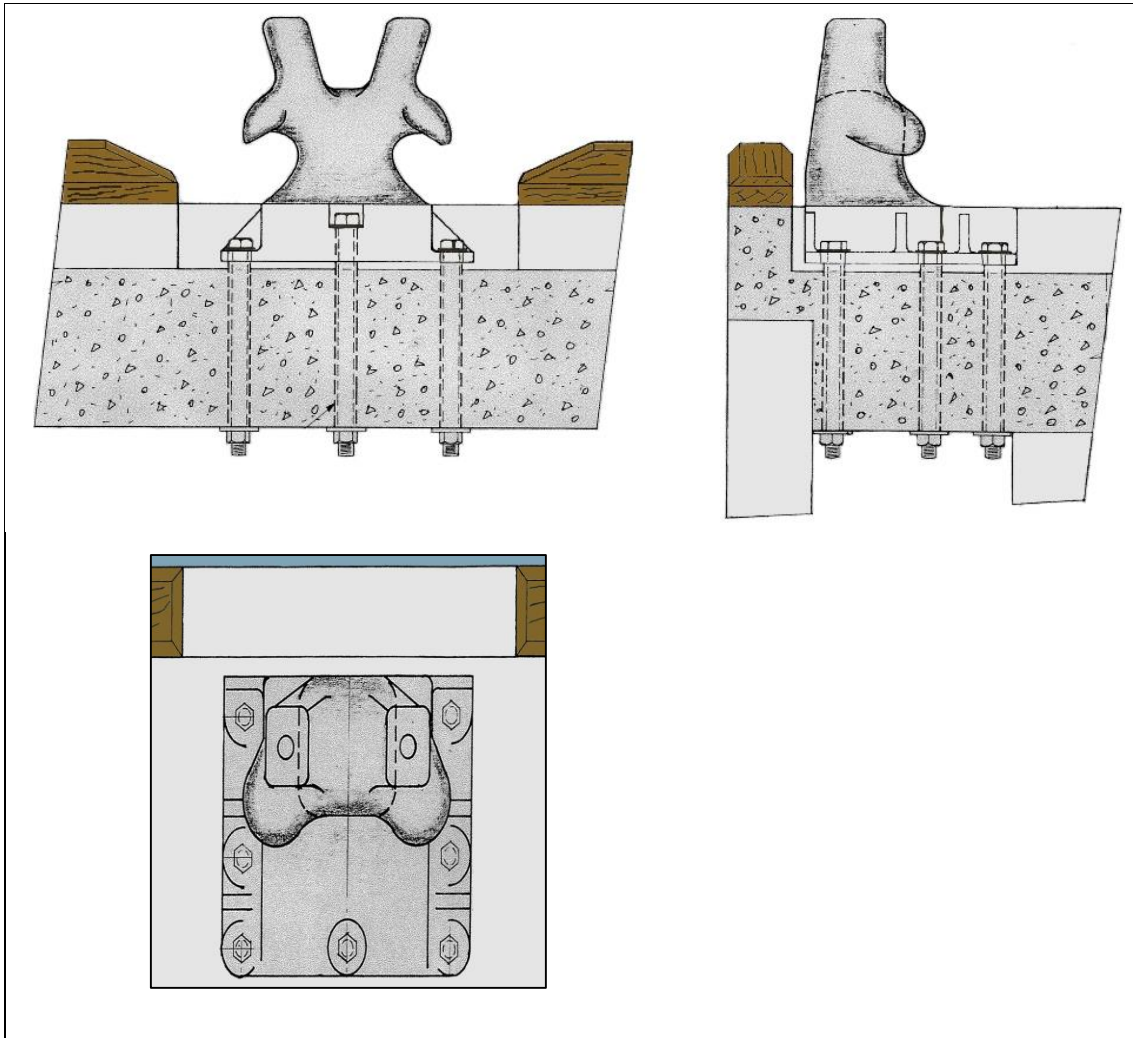
Figure 6: Side, front and plan elevations of the bollard

The bollard that failed was a Bean Type II 10-A-21 (Figure 6). It had been manufactured from flake graphite grey cast iron by EJ Bean, England. It weighed approximately 585 kg, and had a safe working load of about 95 t.

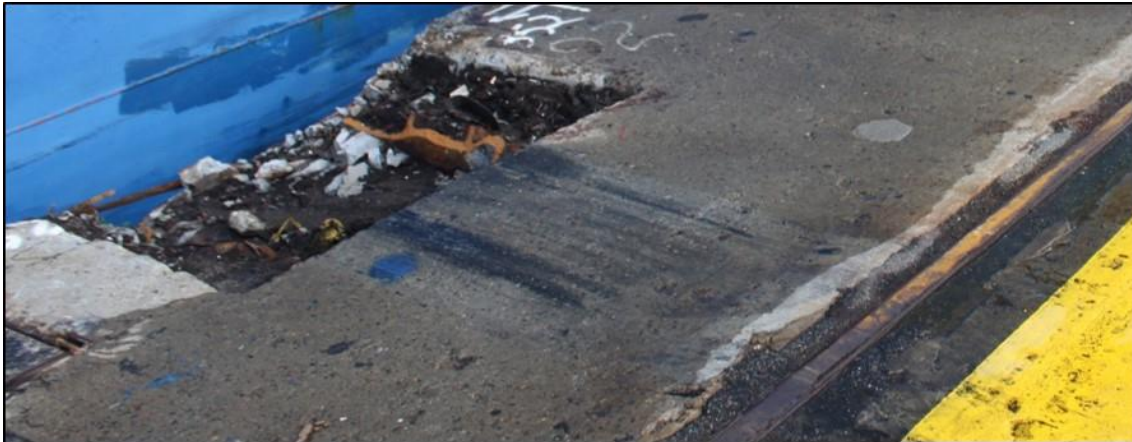
Figure 7: Tyre marks on the wharf near the failed bollard

A distinct rubber mark (Figure 7 and Figure 8), at right angles to the wharf's edge near the failed bollard had a circular pattern at the inboard end consistent with being produced by the outboard tyre under the ramp's footplate. There were no other marks on the wharf apron to indicate that the ramp had moved in any direction other than off the wharf. The tyre mark shows that the ramp only had to move a short distance (Figure 8) for the sheave to be able to make contact with the bollard.

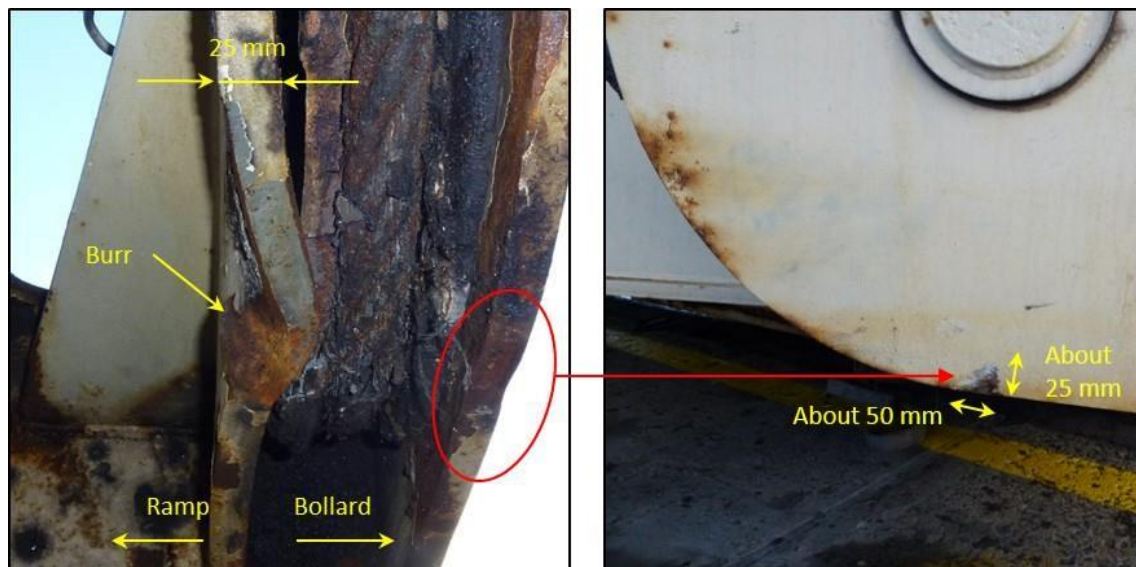
Figure 10: Damage to the ramp's outboard flap sheave

When the ramp dropped off the wharf, it fell about 4 m to the water's surface. The size and shape of the groove and burr (Figure 10, left) was consistent with being caused by the wire rope jumping off the sheave and rubbing on the cheek plate under heavy load as the ramp dropped. Further, the damage was recent. When examined a few days after the event, it only had a covering of light surface rust (Figure 9 and Figure 10) which is consistent with having happened in Fremantle.

The ATSB considered the possibility that the contact damage to the sheave could have been made by a means other than the bollard, such as a vehicle. This possibility was discounted for two reasons: there was insufficient space for equipment to approach the sheave (Figure 8) and a large force would have been required to distort its 25 mm steel plate (Figure 10).

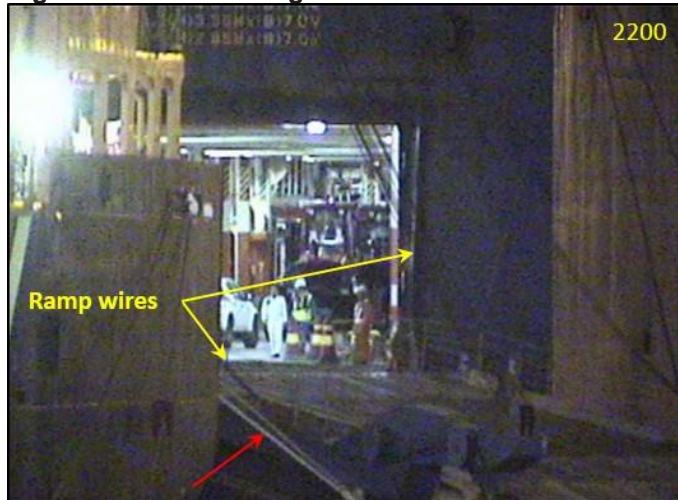
Figure 11: CCTV footage

The 2200 frame, just before the storm's arrival, shows *Grand Pioneer's* two stern lines (red arrow) on the shared bollard that failed. The bollard itself is just outside the frame.

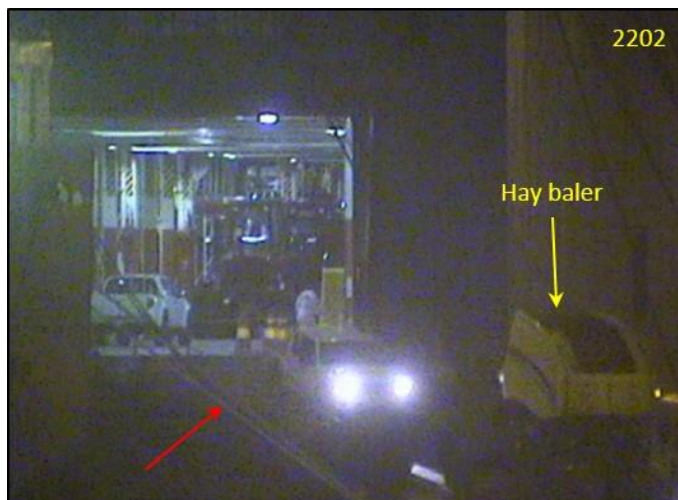
By 2202, the wind speed has increased, and rain has started to fall, with the approach of the thunderstorm.

At about this time, the driver towing the hay baler heard a mooring line part. The two stern lines (red arrow) on that bollard are still visible.

This frame also shows that *AAL Fremantle* has moved slightly off the wharf, as its mooring lines take the weight and then stops moving.

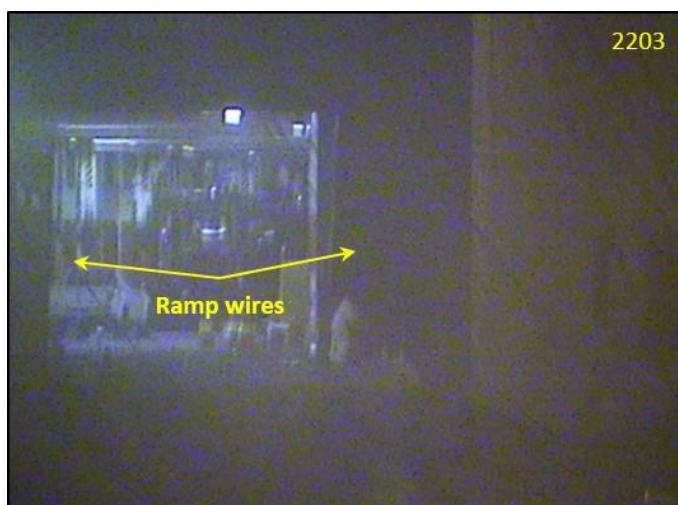
The CCTV footage over the next minute shows heavier rain. *Grand Pioneer* has moved slightly away from the berth. Both stern lines on the shared bollard lines are no longer visible. This is consistent with the failure of the bollard at that time.

The footage that follows shows both ships then moving further away from the wharf.

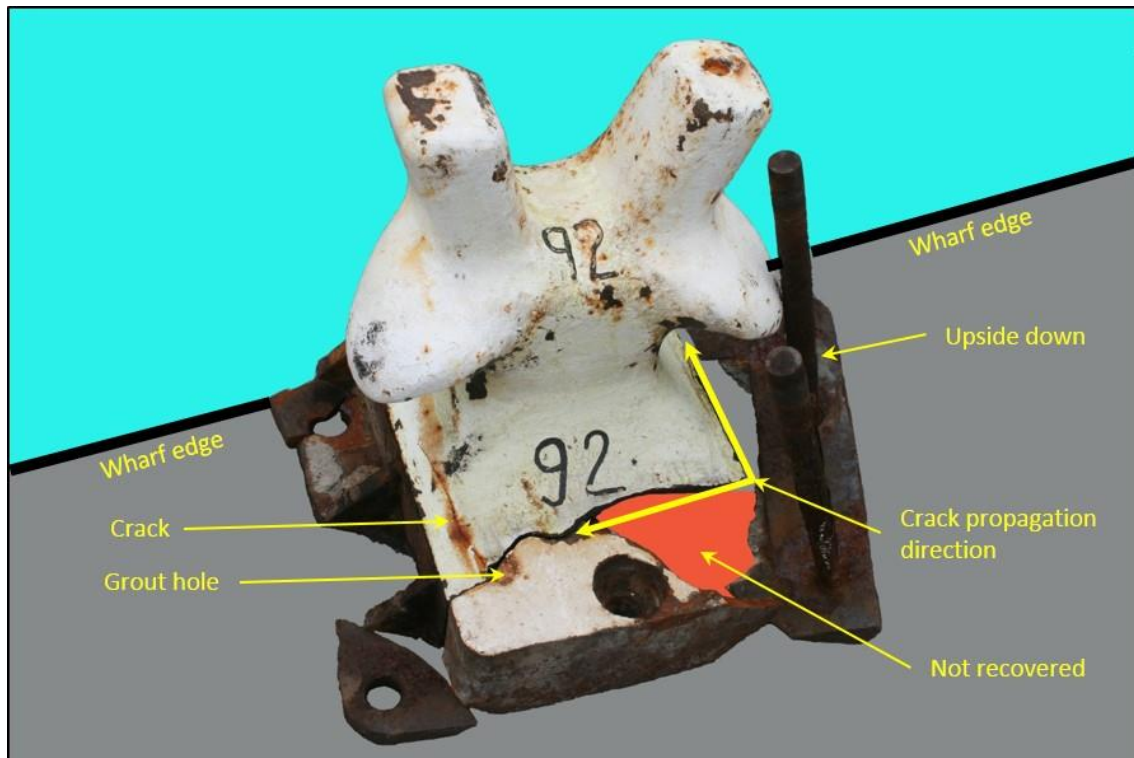
Figure 12: The bollard

However, the examination report stated that the bollard had been made from low quality cast iron with a high phosphorus and sulphur content. Due to these high levels, particles of manganese sulphide and steadite with iron phosphide formed. The brittle steadite phase would have contributed to the fracture of the cast iron bollard, particularly in the areas of the structure where it was present as a network. The network was predominantly at the austenitic grain boundaries and was found to be associated with the fracture surface. The report did not offer any information on how the low quality casting material affected the tensile strength of the bollard.

Examination of the bollard's fracture surfaces identified the corner opposite the grout hole as the point of fracture initiation (Figure 12). This area of the fracture had a finer texture and showed characteristic 'river marks' that propagated away from it.

Exceed Consulting noted that the crack originating from the grout hole was not present before the bollard failed and, thus, had not contributed to the failure. The rust marks around the crack were the result of immersion in seawater after the failure.¹⁴
