# Near collision involving Cessna 210L, VH-TCI, and Cessna 208, VH-PGA

46 km NNE of Broome Airport, Western Australia, 15 July 2015

**ATSB Transport Safety Report**  
Aviation Occurrence Investigation  
AO-2015-083  
Final – 27 May 2016

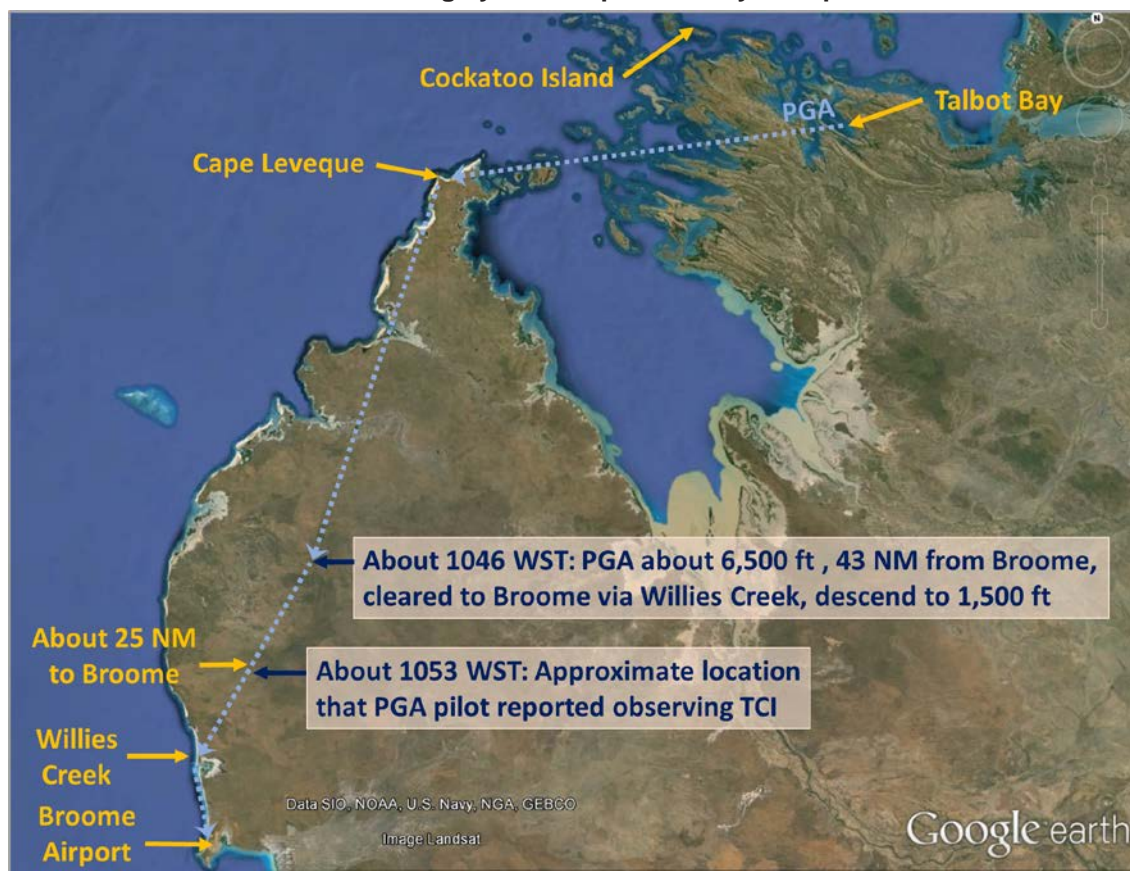
**Figure 1: Map showing the location of Cockatoo Island where TCI departed for Broome and the location of Talbot Bay where PGA departed for Broome via Cape Leveque and Willies Creek (blue track). Map also shows the approximate location of PGA from the aircraft's real-time satellite tracking system as provided by the operator.**

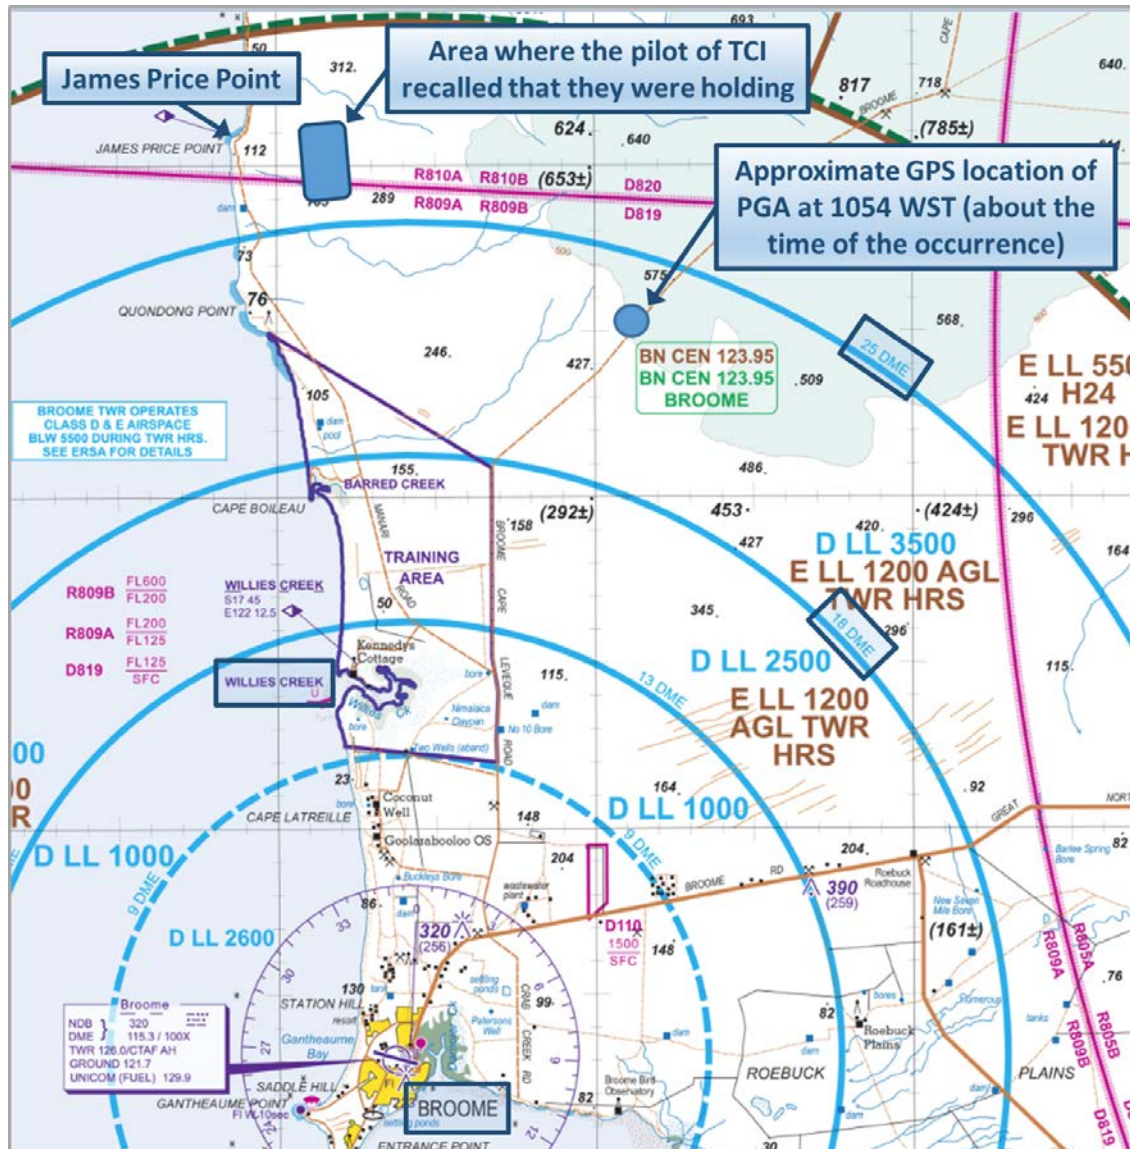
**Note:** The pilot of TCI recalled holding over land, near James Price Point, outside of Class D airspace. Communications between ATC and the pilot of PGA immediately following the point at which the aircraft passed, suggested that the incident occurred further to the east, at about 26 NM from Broome. A later communication between ATC and the pilot of PGA suggested that the incident occurred about 23 NM from Broome. Information provided to the ATSB by the pilot for the incident flight from the tracking data from PGA's real-time satellite tracking system also suggested that the incident occurred near the latter location (Figure 2).

**Figure 2: Broome Visual Terminal Chart depicting the area where the pilot of each aircraft believed they were located at the time of the occurrence.**

The pilot obtained the tracking data from PGA's real-time satellite tracking system for the flight that showed the location of PGA at the time of the occurrence. That location is consistent with the approximate location, as shown in Figure 2, that the pilot of PGA observed TCI.
