Australian Transport Safety Bureau

Landing accident involving Cessna 180C, VH-FDH

Karumba Airport, Queensland, 1 September 2015

ATSB Transport Safety Report
Aviation Occurrence Investigation
AO-2015-103
Final – 27 May 2016

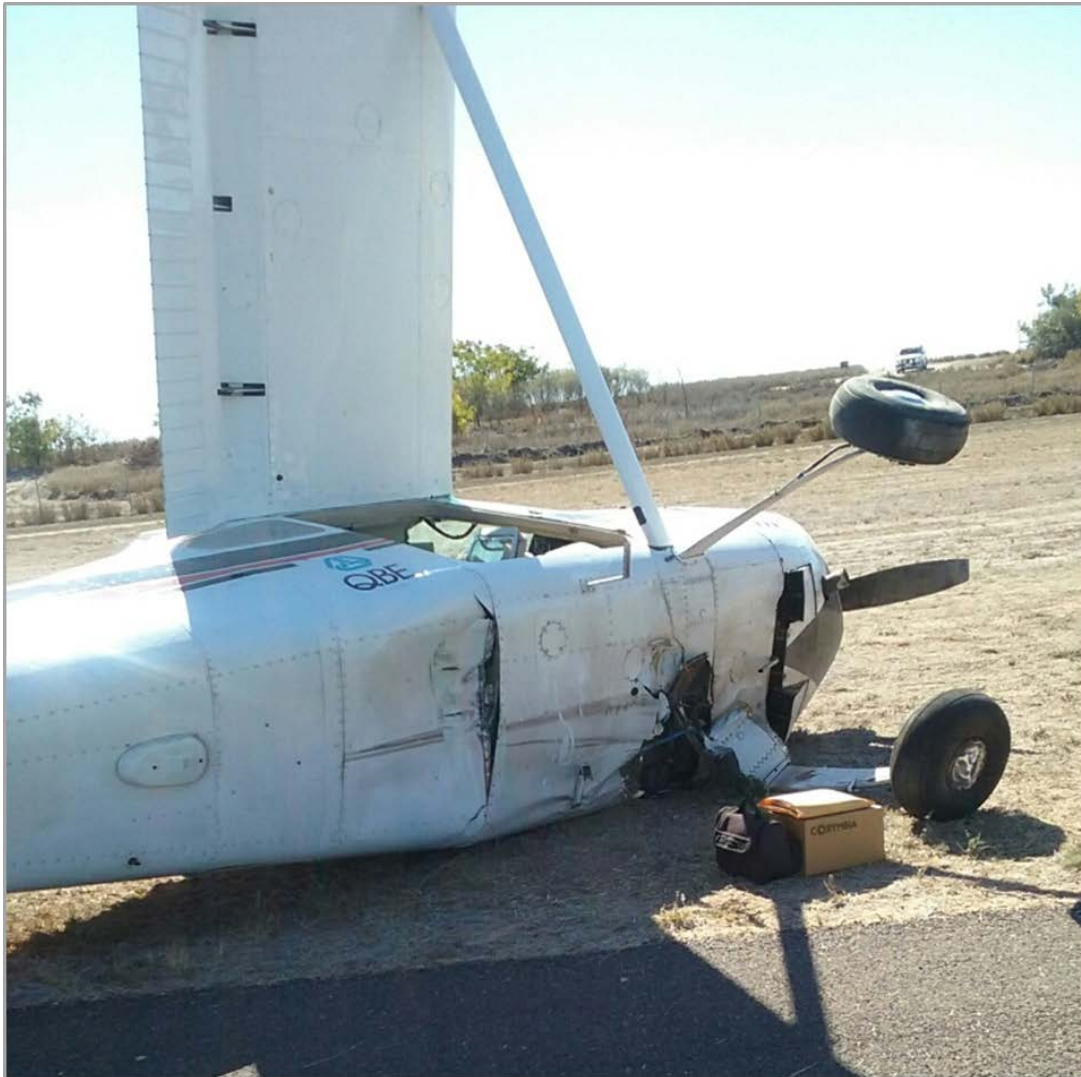
Figure 2: Cessna C180 FDH accident site

The aircraft was established in a stable final approach and the pilot determined that there was no crosswind correction required. The main wheels touched down firmly on the runway and the aircraft bounced about 3 to 4 feet. The pilot moved the control column forward slightly to stop the tail from touching the runway. The main wheels touched again at about the same time as the pilot noted that the nose started to move to the right (turning into wind). The pilot moved the aircraft controls to straighten the aircraft in line with the runway, but the aircraft did not respond to the correction. The tail continued to move quickly around (ground loop)¹ before the pilot could take any other action. The pilot was pushed up against the cockpit door. A very loud bang was heard as the left main landing gear failed, the left wing folded up and the fuselage tilted onto its side where the aircraft skidded a short distance to a stop. The aircraft stopped, almost pointing back in the opposite direction to the landing, partly on the grass beside the runway (Figure 2). The pilot turned off the engine magnetos, aircraft fuel, and electrical master switch. The two passengers exited the cockpit right door with the help of bystanders and then the pilot exited the same way. The pilot received minor injuries and the two passengers were uninjured. The aircraft was substantially damaged.

The US Federal Aviation Administration (FAA) discusses in their publication [*Airplane Flying Handbook Chapter 13 Transition to Tailwheel Airplanes*](#) the importance to land with the aircraft in the longitudinal axis exactly parallel to the direction the aircraft is moving along the runway. If the aircraft lands while in a crab or while drifting, it imposes severe side loads on the landing gear and imparts ground looping (swerving) tendencies. The handbook is available from the FAA website.
