Collision with terrain involving Robinson R22 helicopter, VH-HRW

63 km north-north-east of Mitchell, Queensland | 28 May 2015

ATSB Transport Safety Report
Aviation Occurrence Investigation
AO-2015-055
Final – 26 May 2016

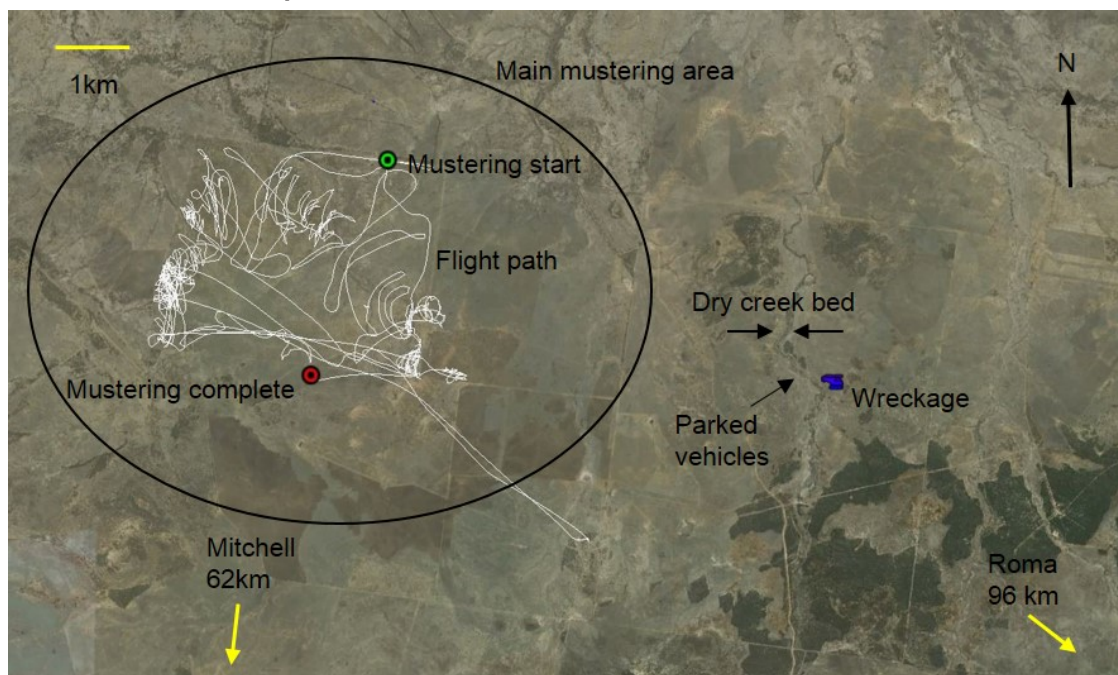
Figure 1: Image showing the helicopter's track (in white) during the morning's mustering. This track was derived from data downloaded from the helicopter's on-board Global Positioning System receiver. The location of the helicopter wreckage is shown (in blue) reference the townships of Roma and Mitchell

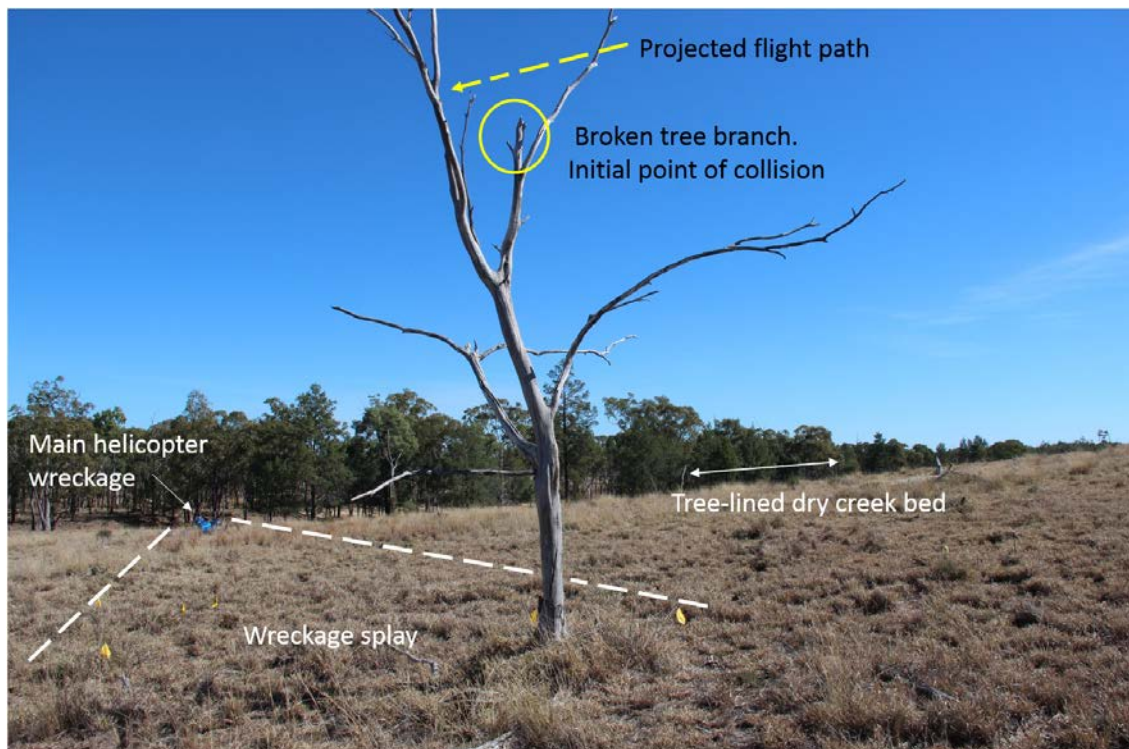
Examination of the helicopter wreckage and ground scars found that the tail rotor blades collided with the upper branch of an isolated, 7 m-high dead and defoliated tree (tree) that was about 100 m to the east of a tree-lined dry creek bed. The terrain sloped down towards the creek bed at about 2°–5° (Figure 2).

Figure 2: Helicopter flight path looking to the west. The estimated right-to-left flight path (indicated by a yellow dashed arrow) is derived from the impact point with the dead and defoliated tree and the position of the main helicopter wreckage

Examination of the wreckage and accident site found that the helicopter struck an upper branch of an isolated, 7 m-high tree about 100 m to the east of a tree-lined dry creek bed. This resulted in the tail rotor blades separating from the tail rotor assembly, followed by the vertical and horizontal stabilisers and structure, then the tail rotor gearbox. Control of the helicopter was no longer possible and the helicopter collided with terrain coming to rest on the right side.

The main wreckage was located about 50 m west of the tree. This was consistent with the helicopter being in forward flight, rather than in the hover, and indicated the helicopter's westerly direction of travel preceding the tree strike.

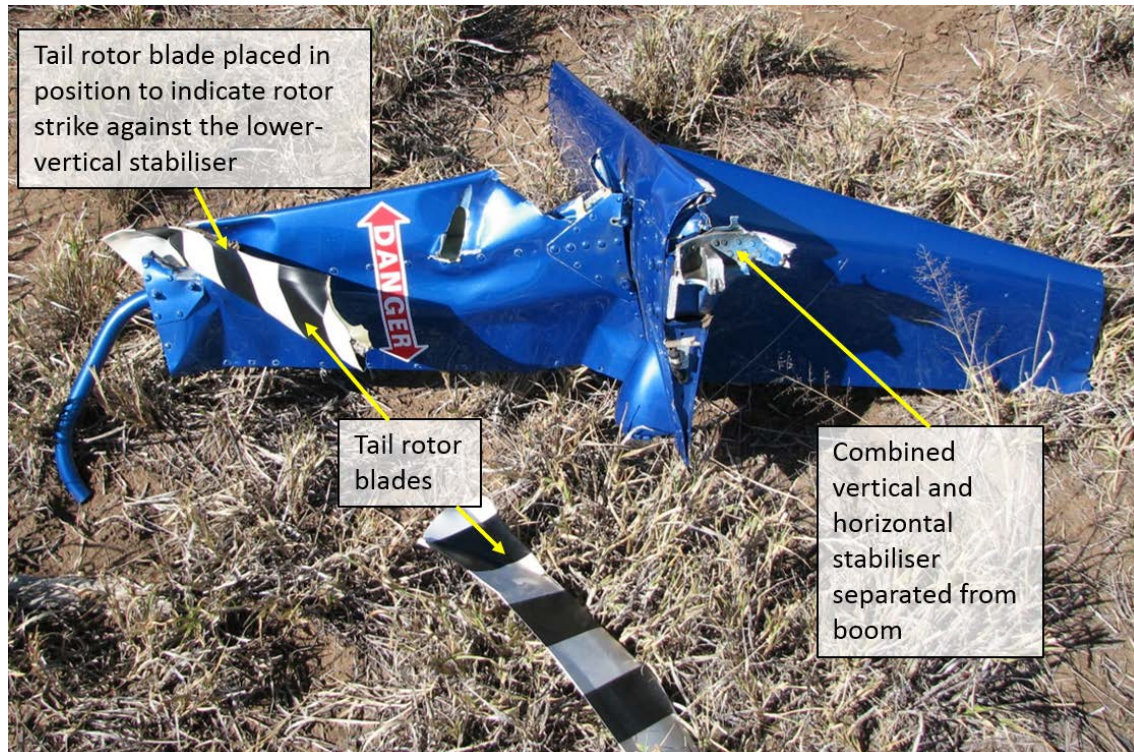
On contact with the tree, segments of the two tail rotor blades separated from the tail rotor. During the ensuing impact sequence, one of these blades struck the lower-vertical stabiliser, causing the combined vertical and horizontal stabilisers² and tail rotor gearbox to separate from the tail boom (Figure 3). The tail rotor blades, combined horizontal and vertical stabilisers and gearbox were co-located in close proximity to the tree.

Figure 3: Combined horizontal and vertical stabilisers and tail rotor blades after their separation from the helicopter. One of the two tail rotor blades has been placed against the lower-vertical stabilizer to demonstrate the impact point after the initial strike with the dead and defoliated tree

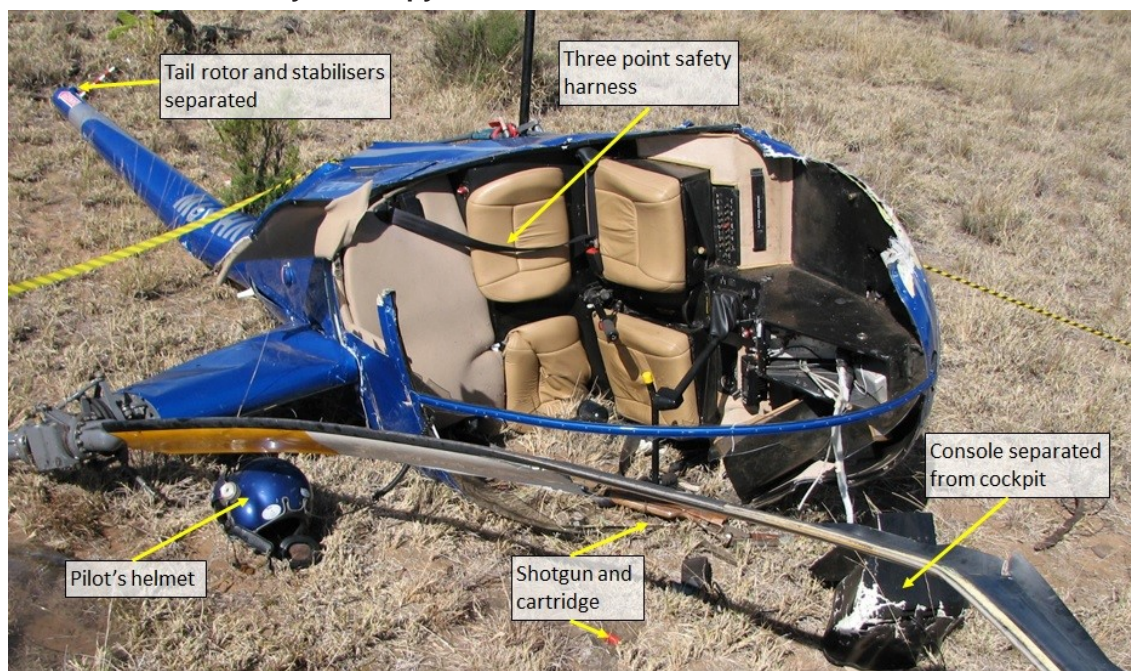
During the accident sequence, the main rotor blade pitch links fractured in overload, consistent with the impact forces. One of the two rotor blades penetrated the acrylic glass canopy. The instrument console was dislodged from its mounting and ejected from the cockpit (Figure 4). The helicopter's clock stopped at 1605, not inconsistent with the helicopter colliding with terrain about 5 minutes after it departed from the property road and the time taken by the station hand to locate the wreckage of the helicopter.

Figure 4: Helicopter wreckage, showing the ejected instrument console, damaged main rotor blade and destroyed canopy

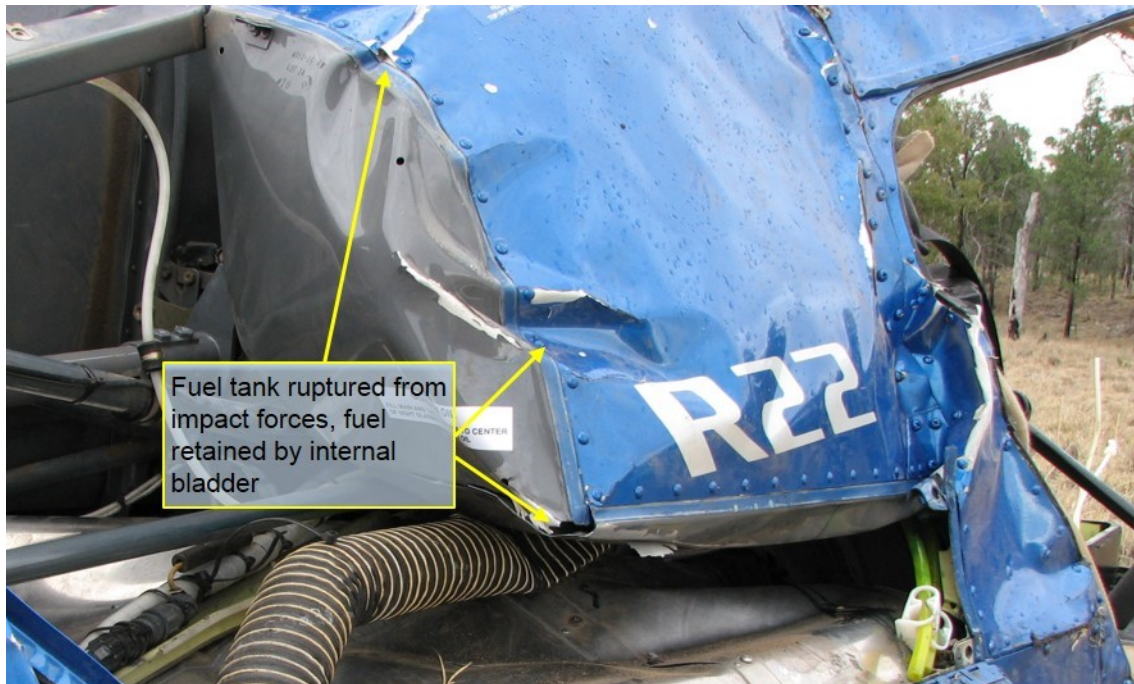
The main and auxiliary fuel tanks contained a significant quantity of fuel. A sample of that fuel was tested on-site and found to be adequate for continued flight. The fuel tanks sustained significant crushing and deformation damage. In addition, the tail rotor drive train flex plate³ coupling penetrated the full thickness of the main aluminium tank. However, the internal fuel bladder was not punctured and did not leak (Figure 5). There was no fire.

Figure 5: Ruptured aluminium main fuel tank. Note that the remaining fuel was retained by the internal fuel bladder

The helicopter was fitted with bladder-type fuel tanks that did not rupture during the accident sequence, preventing fuel leakage and therefore reducing the risk of a post-impact fire. In addition, the pilot's seat structure was compressed, consistent with its design to absorb impact forces during an accident.

- The helicopter was modified to include bladder-type fuel tanks, which did not puncture. This prevented fuel escaping after the impact and reduced the risk of a post-impact, fuel-fed fire.
