Australian Government
Australian Transport Safety Bureau

Aviation Short Investigations Bulletin

Issue 48

ATSB Transport Safety Report
Aviation Short Investigations
AB-2016-044
Final – 27 May 2016

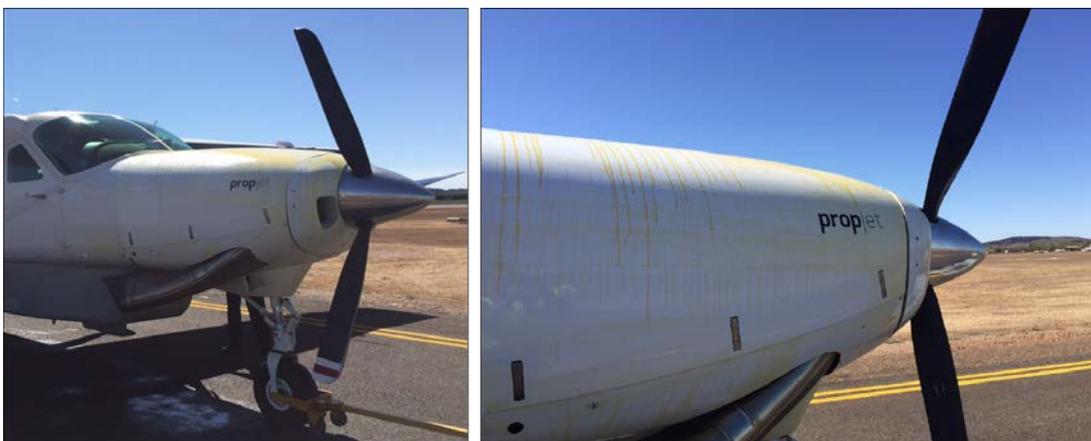
After exiting the runway and coming to a stop, the pilot completed the engine shut-down checks. No reaction was felt or heard when the pilot selected the propeller lever to the feather position as part of the shutdown procedure (normally, there was an audible change as the pitch of the propeller changed). After exiting the aircraft, the pilot found that the propeller was in the feather position, and had seized. The extent of oil loss was also apparent, with oil smeared over much of the forward fuselage, particularly the engine cowls and windscreen (Figure 1).

Figure 1: Photographs of VH-LNH after the aircraft had landed, with oil visible on the engine cowl and forward fuselage

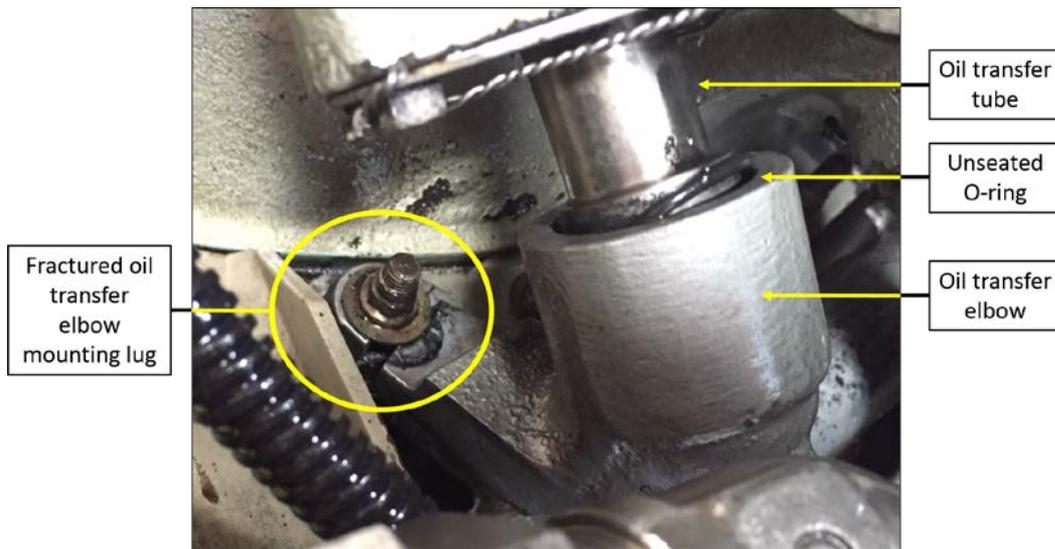
Subsequent on-site inspection of the engine by engineering staff revealed that an oil leak had developed at a join between the oil transfer elbow and oil transfer tube at the forward end of the engine. This assembly was part of a larger assembly that transferred oil under pressure to the reduction gearbox at the front of the engine. One of the oil transfer elbow mounting lugs (that secured the elbow to engine assembly) was found to be fractured, allowing the oil transfer elbow to move and unseat the O-ring between the elbow and the tube (Figures 2 and 3).

Figure 2: Photograph (in situ) showing fractured oil transfer elbow mounting lug and the unseated O-ring seal

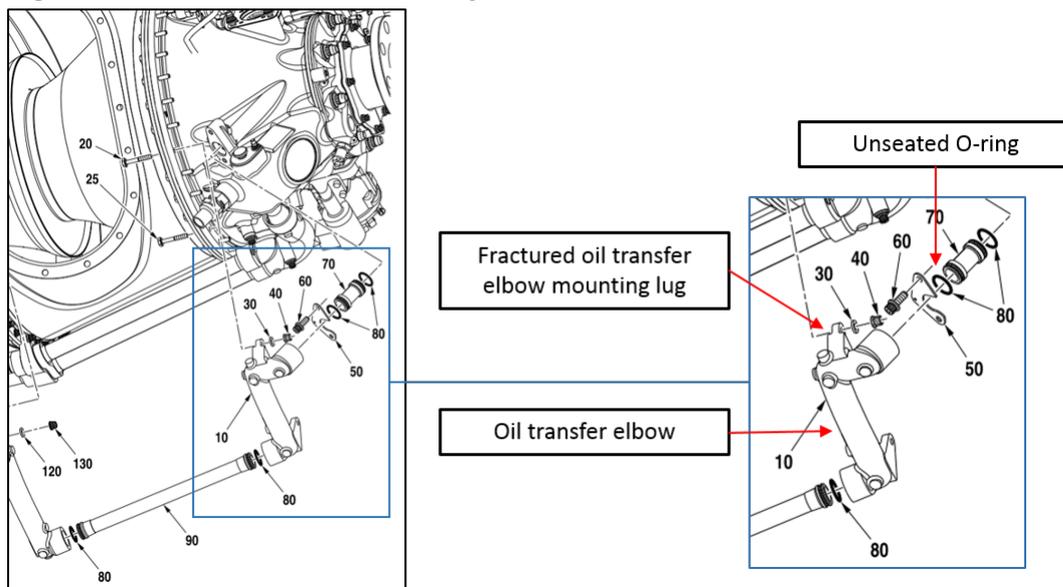
Figure 3: Oil transfer elbow assembly

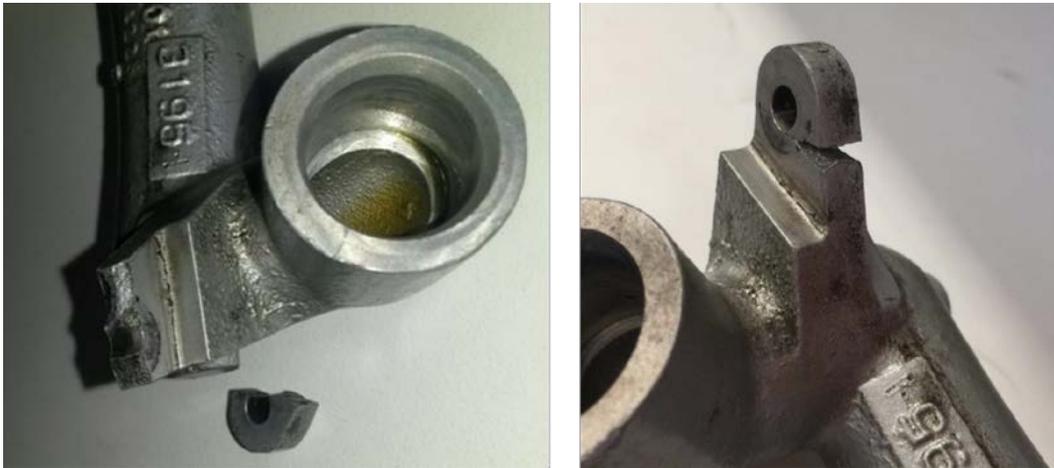
Inspection of the engine confirmed that an oil transfer elbow mounting lug had fractured and the report noted that the ‘hardware holding it in place was loose’. The lug was found to have completely broken through, and it was noted that a segment of the lug was missing (Figure 4). The report also noted that the O-ring (see Figures 2 and 3) had moved.

Figure 4: Fractured lug (the figure on the right shows that a segment of the lug was missing)

- The fracture of the lug occurred due to fatigue originating from multiple locations on the side of the mounting lug that meets with the face of the mounting flange. The fatigue mode was found to be high-cycle, under unidirectional bending.

- Wear and imprint marks on the securing assembly (bolt, nut and washer) and the fractured lug suggested that the bolt was sitting askew in the bore of the flange to which the elbow mounting lug was secured. The report commented that this wear pattern was consistent with a lack of pre-load on the bolt.

- The lack of pre-load on the bolt that secured the mounting lug to the flange was considered to be the initiating factor that led to fracture of the mounting lug. The reason for the lack of pre-load on the bolt could not be ascertained.

Prior to this incident, the operator was already in the practice of periodically inspecting the area of the fractured lug (although those inspections did not alert the operator to the problem in this case). In response to this incident, the operator intends to expand the periodic inspection to include removal of the bolt and an inspection of the internal radius of the mounting lug for signs of crack development.

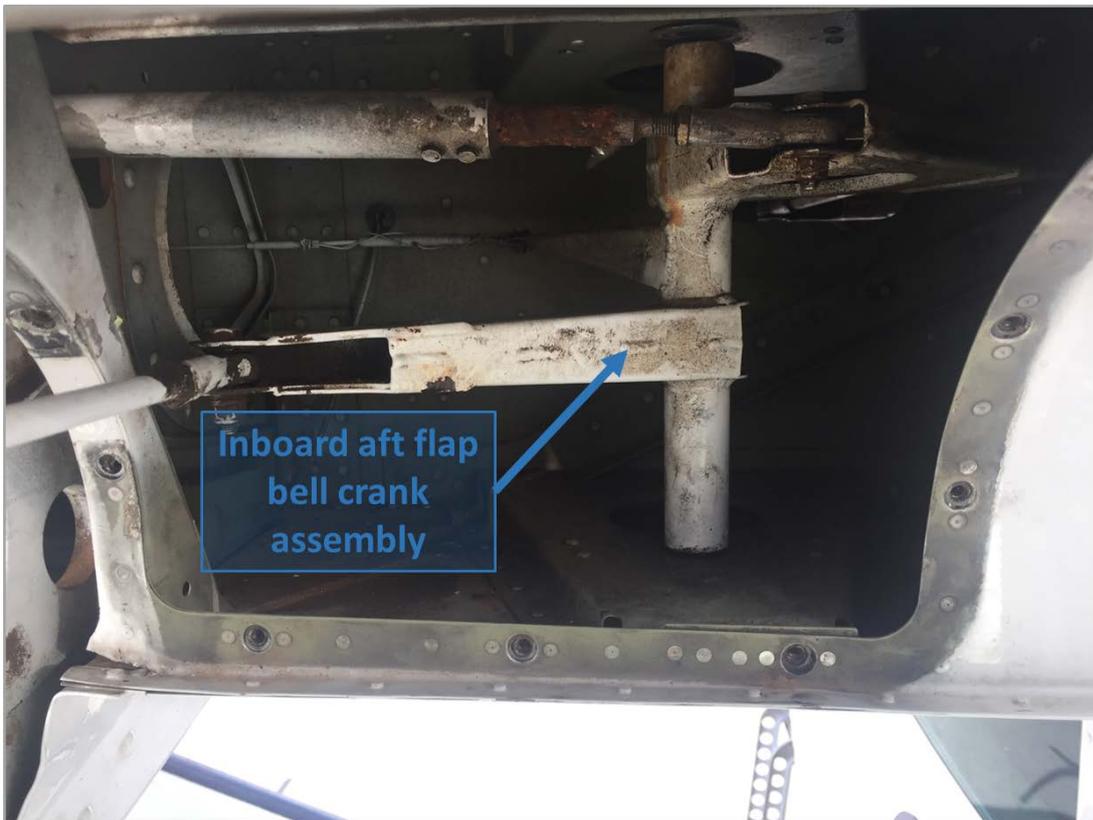
During the taxi to parking, the pilot fully retracted the flaps. With the flaps flush against the trailing edge of the wing, initially, neither the pilot nor the aircraft maintenance engineer could pinpoint the reason for the control issue. However, when the engineer gave the left flap a shake, it fell freely down, unattached on the inboard side. After removing some wing access panels, the engineering inspection discovered a loose flap bell crank retaining bolt.

Figure 1: VH-WZJ inboard aft flap bell crank assembly

The operator advised that a flap bolt had come loose allowing the lower part of the rear aft bell crank to move free. An inspection indicated that the pivot bolt may not have been lubricated for a long period of time.

The reason for the pivot bolt working loose could not be established. However, as a preventative measure the operators approved Maintenance Program has been amended. This amendment included new maintenance actions and new replacement intervals for the affected bell crank, that are additional to the maintenance requirements in the Cessna maintenance schedule tasks.

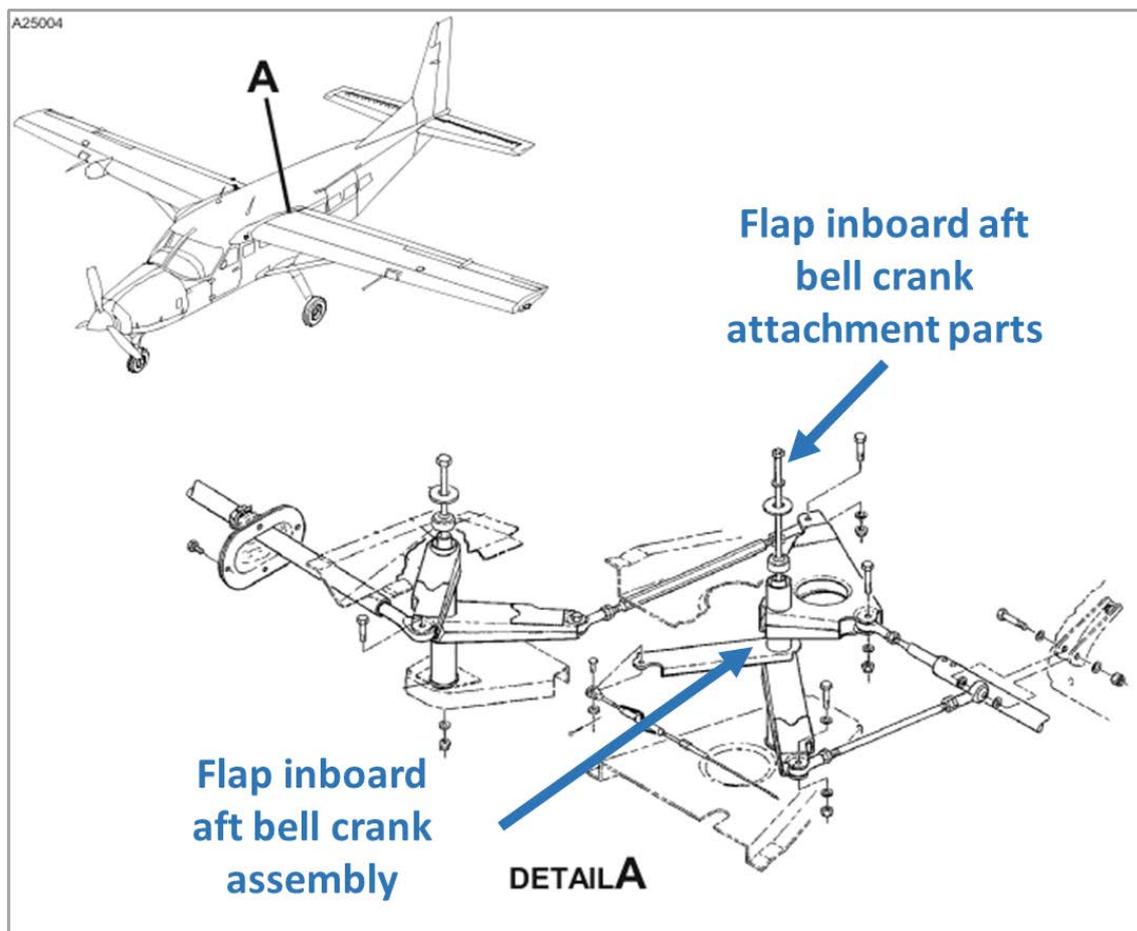
The aft bell crank as referenced to in (Figure 2) showed that the assembly is secured into location with a single bolt securing into an anchor nut assembly on the bottom. According to the operator, there was no secondary locking system.

Figure 2: Diagram showing the location of the left wing flap inboard aft bell crank assembly

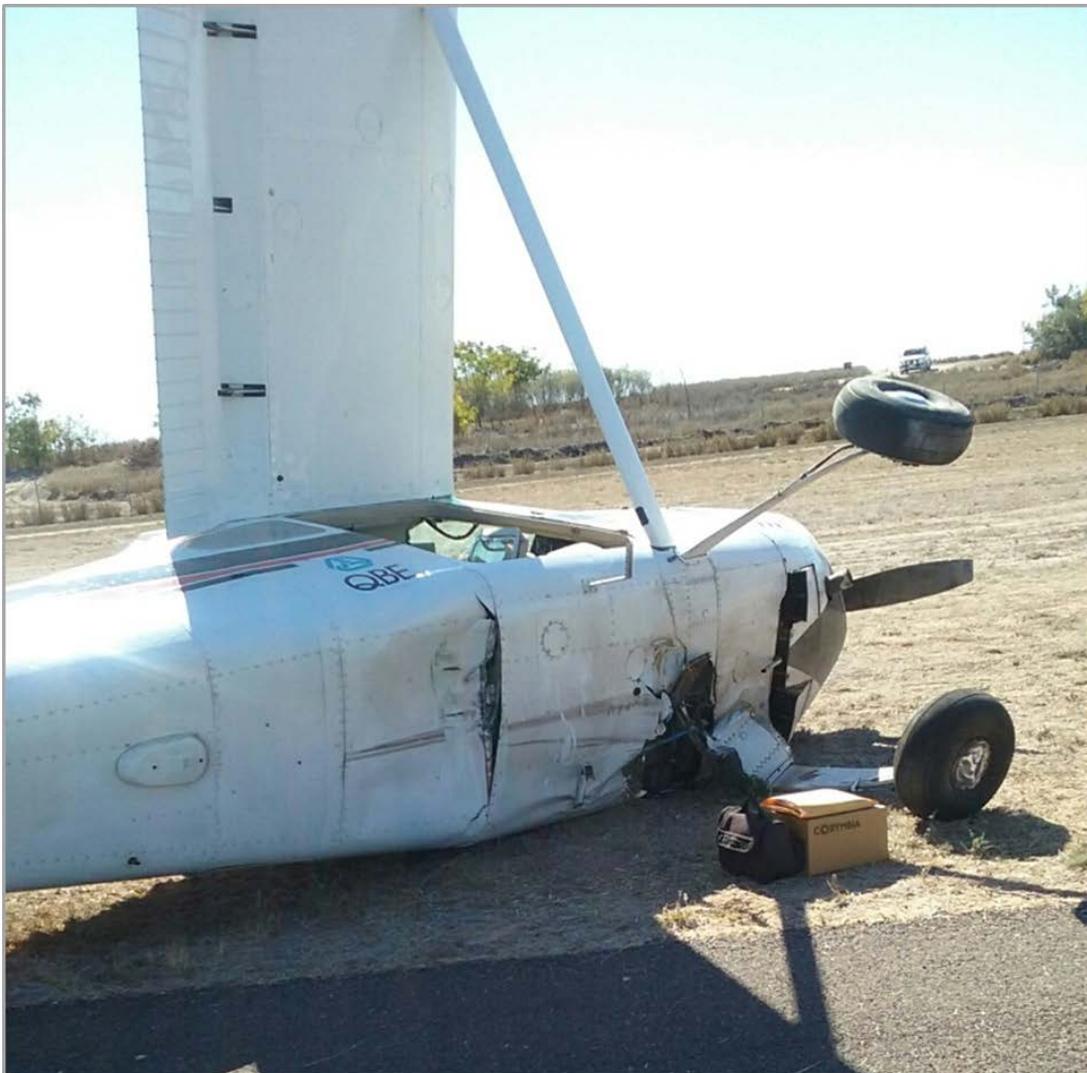
The aircraft was established in a stable final approach and the pilot determined that there was no crosswind correction required. The main wheels touched down firmly on the runway and the aircraft bounced about 3 to 4 feet. The pilot moved the control column forward slightly to stop the tail from touching the runway. The main wheels touched again at about the same time as the pilot noted that the nose started to move to the right (turning into wind). The pilot moved the aircraft controls to straighten the aircraft in line with the runway, but the aircraft did not respond to the correction. The tail continued to move quickly around (ground loop)¹ before the pilot could take any other action. The pilot was pushed up against the cockpit door. A very loud bang was heard as the left main landing gear failed, the left wing folded up and the fuselage tilted onto its side where the aircraft skidded a short distance to a stop. The aircraft stopped, almost pointing back in the opposite direction to the landing, partly on the grass beside the runway (Figure 2). The pilot turned off the engine magnetos, aircraft fuel, and electrical master switch. The two passengers exited the cockpit right door with the help of bystanders and then the pilot exited the same way. The pilot received minor injuries and the two passengers were uninjured. The aircraft was substantially damaged.

Figure 2: Cessna C180 FDH accident site

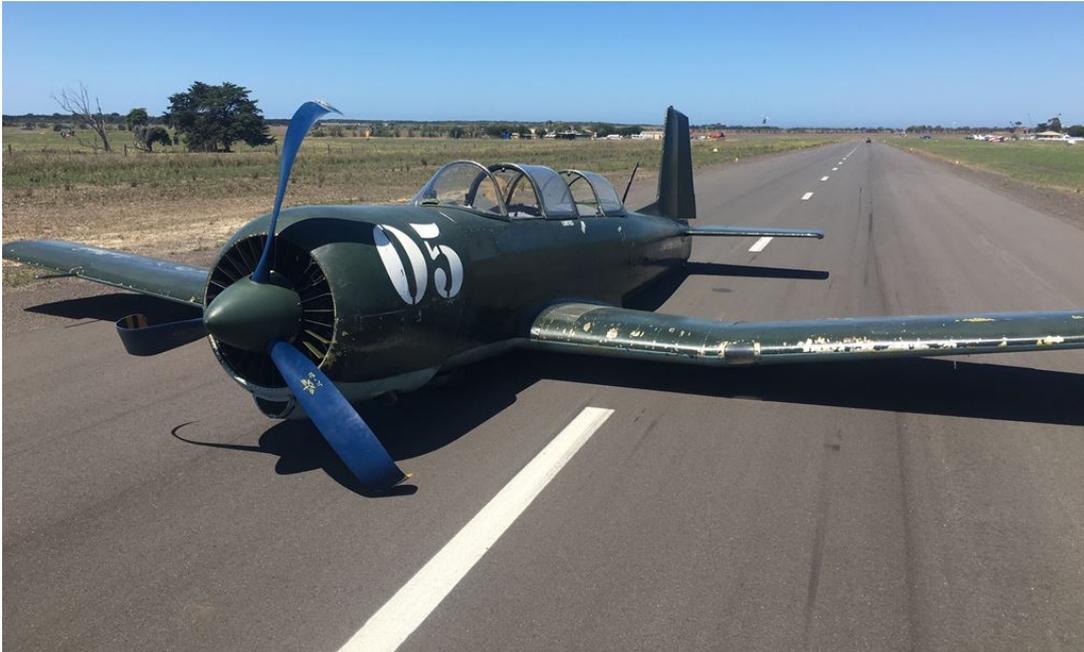
At the chosen ‘break-point’² on upwind, Number 2 positioned ahead of ALO in the circuit. The two Nanchang aircraft remained in this single-file sequence behind a Pipistrel aircraft, which had joined the circuit on the downwind leg for runway 36. The Pipistrel aircraft landed, then rolled through to the end of the runway in order to exit; Number 2 followed suit. As ALO touched down, third in a close landing sequence, the pilot realised that they had not completed the pre-landing checks, and the landing gear had not been extended. The aircraft slid along the sealed runway, coming to a stop just off the centreline (Figure 1). The pilot and passenger were not injured, and were able to safely egress. The aircraft sustained damage to the propeller, engine and the underside of the fuselage.

Figure 1: Nanchang VH-ALO, on runway 36 after a wheels up landing

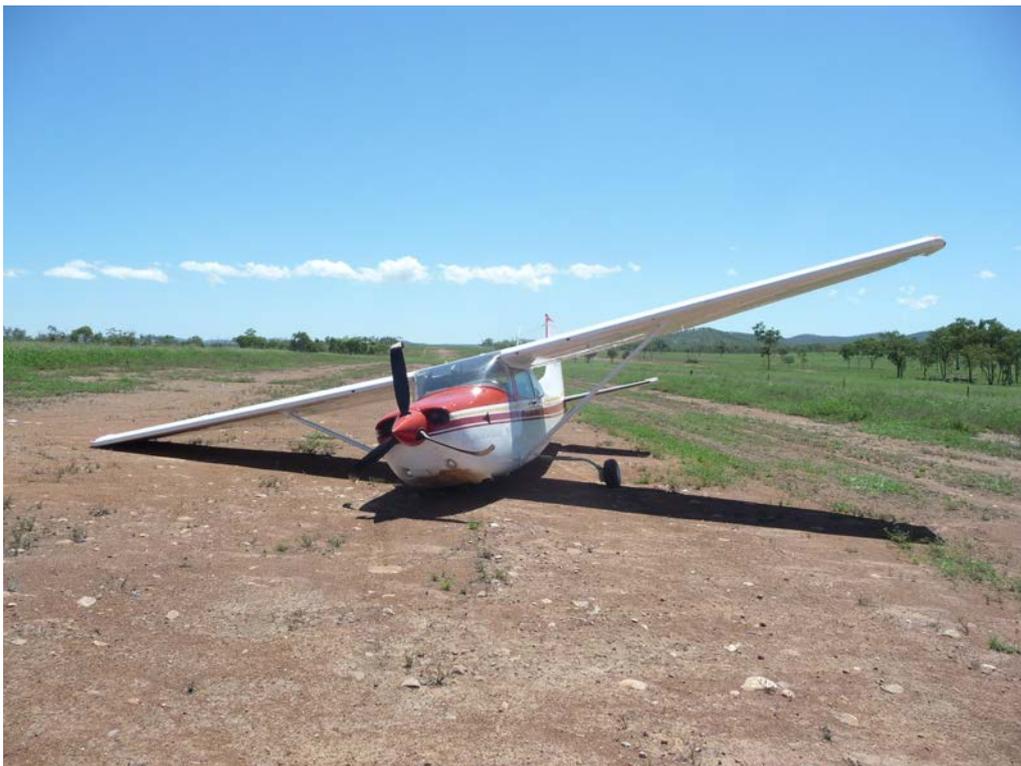
However, the aircraft began to sink, and the nose dropped. Moments later, the main landing gear struck the ground. This second ‘touchdown’ was about 265 m beyond the first, (about 565 m along the airstrip). The pilot attempted to keep the nose of the aircraft raised. However, the propeller struck the ground and the pilot realised that the nose wheel had retracted, so closed the throttle. The aircraft continued to skid along the runway. The propeller stopped rotating when the aircraft had travelled about another 77 m. The aircraft then continued to slide sideways, and the right main landing gear retracted (Figure 2). The pilot was not injured, but the aircraft sustained substantial damage.

Figure 2: VH-PFZ showing retracted nose wheel and right landing gear, and damaged propeller

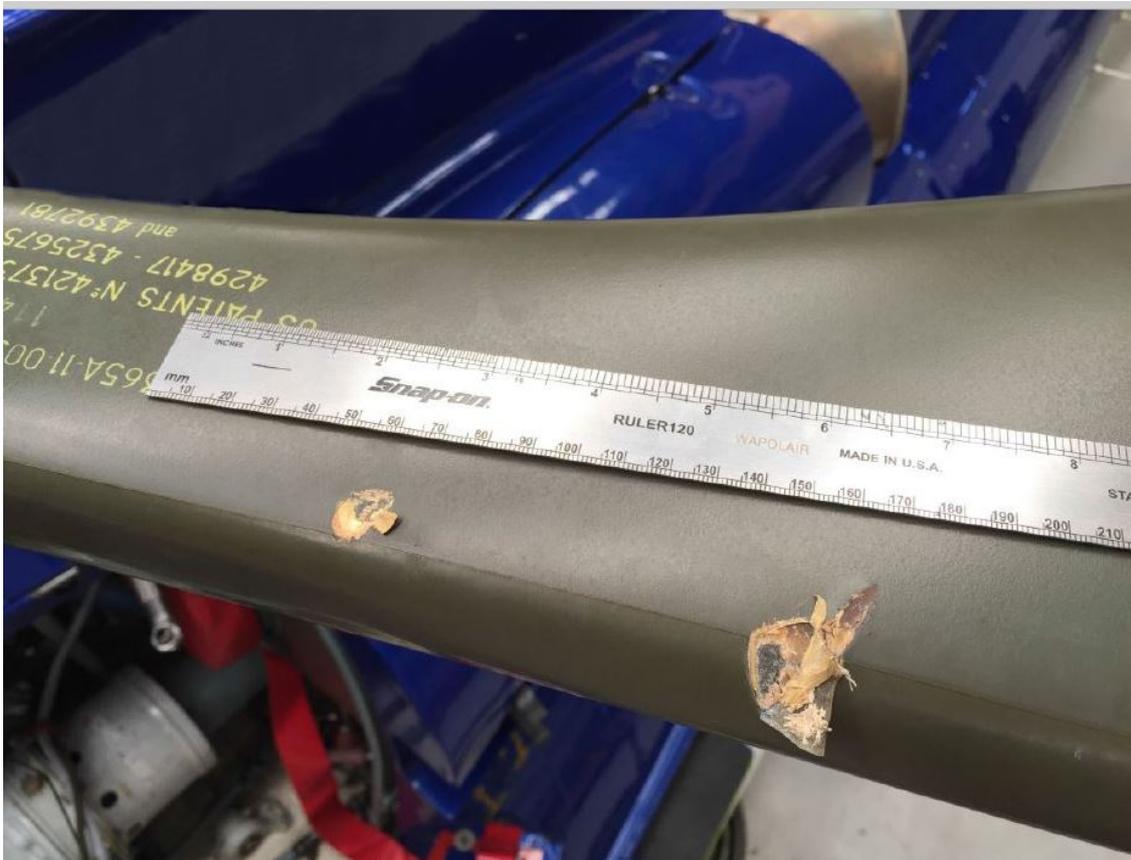
A spanner that had been used during the third track and balance related adjustments could not be located. It was later located on an adjacent taxiway about 43 m from the hangar. Due to the scuff marks and scratches found on the spanner, it was determined that it had been left in the rotor head area and was likely ejected during the aircraft start up.

Figure 1: Damage to leading edge of a main rotor blade on VH-WPX

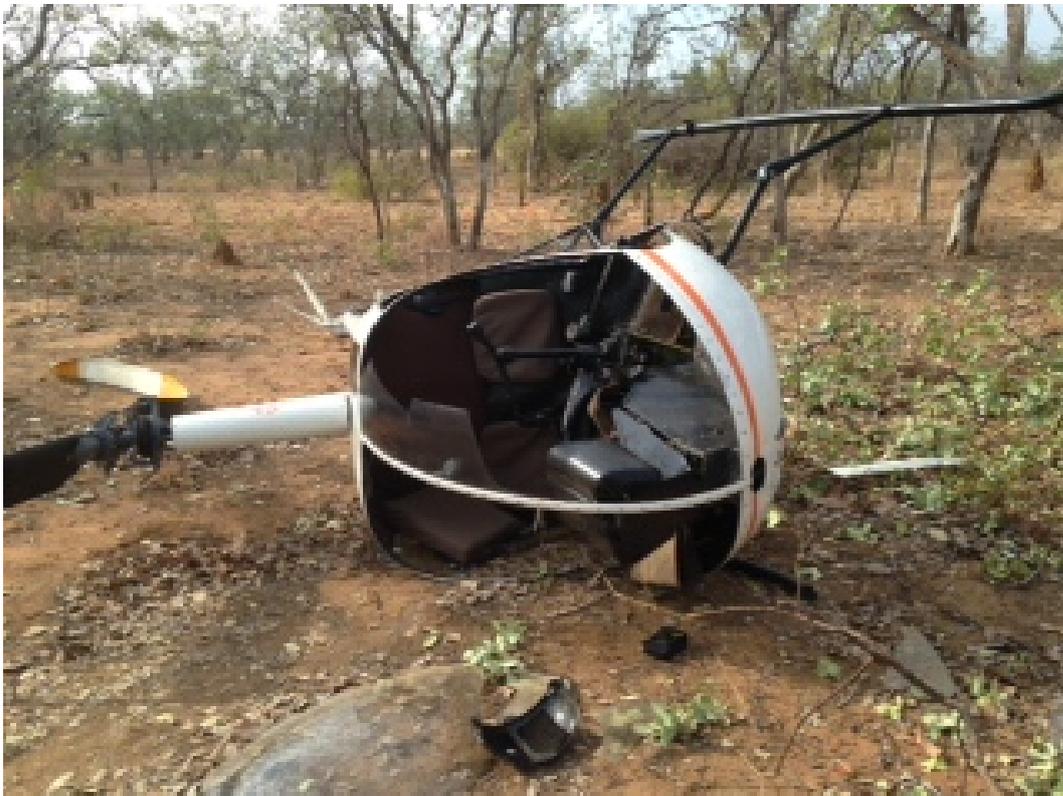
At about 1400 Central Standard Time (CST), as the helicopter approached the cattle yards, it descended rapidly and collided with a tree and terrain. The helicopter landed on its side and sustained substantial damage (Figure 1). The accident occurred about 200 m prior to the cattle yards. The pilot sustained serious injuries and was unable to recall the sequence of events.

Figure 1: Accident site showing damage to VH-HWJ

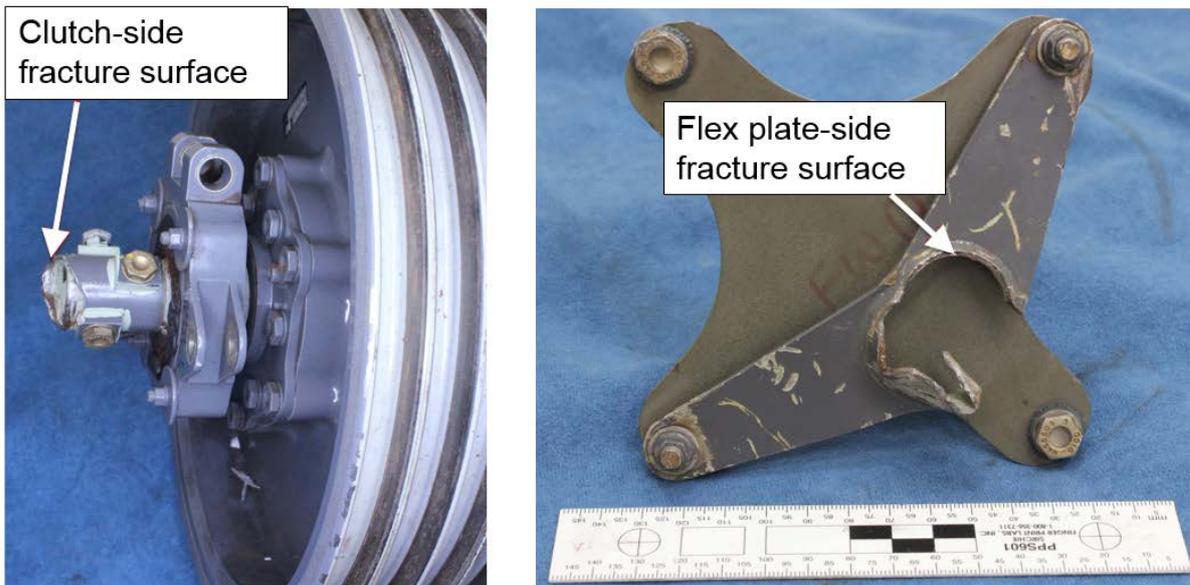
The yoke connecting the clutch shaft to the rearward flex plate was found to have fractured at the connection to the shaft (Figure 2). The ATSB conducted analysis to determine whether the yoke failure may have contributed to the accident, or occurred as a result. The analysis found no evidence of fatigue damage in the yoke, and no other signs of pre-existing damage. The helical fracture was consistent with torsional overstress inducing failure in the yoke.

Figure 2: Fracture surfaces

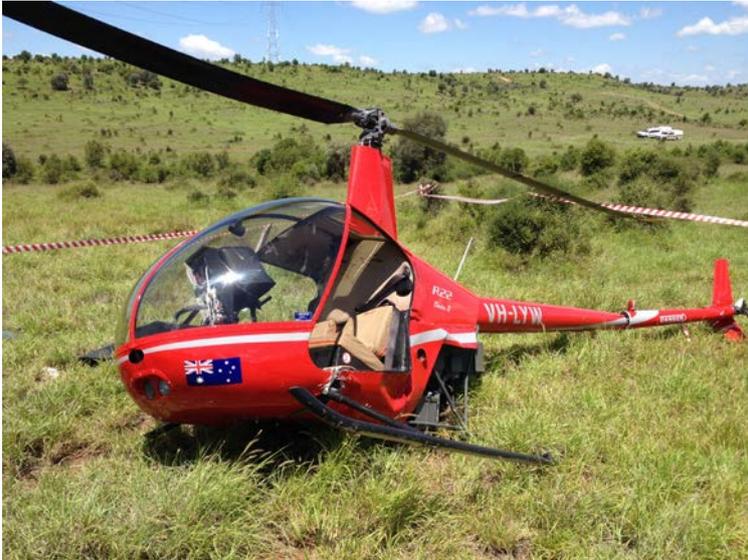
Figure 1: Accident site showing damage to VH-LYW

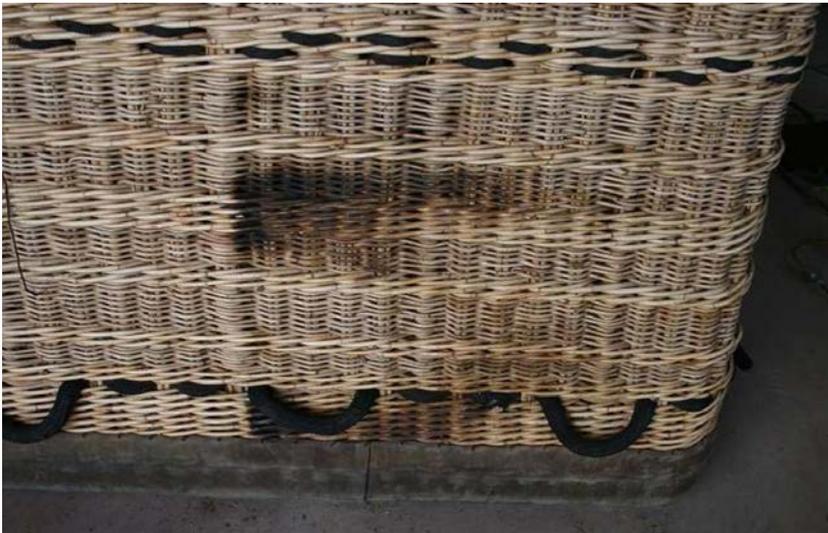
The pilot checked that the passengers were all ok and still in the landing position, and checked that there was no evidence of fire. Due to the amount of heat in the balloon, the balloon was climbing. The pilot then conducted a normal controlled descent and landing into a paddock about 500 m beyond the original planned landing site. The balloon landed without further incident and no one was injured. The wicker basket sustained scorching (Figure 1) and a stainless steel cable fixed to the underside of the basket sustained arc damage.

Figure 1: Scorch marks on wicker basket
